NEW JERSEY OFFICE OF HISTORIC PRESERVATION HISTORIC SITES INVENTORY #
STREETSCAPE SURVEY FORM

STREET NAME: Adams
MUNICIPALITY: Hoboken

CROSS STREETS: Newark, First
COUNTY: Hudson

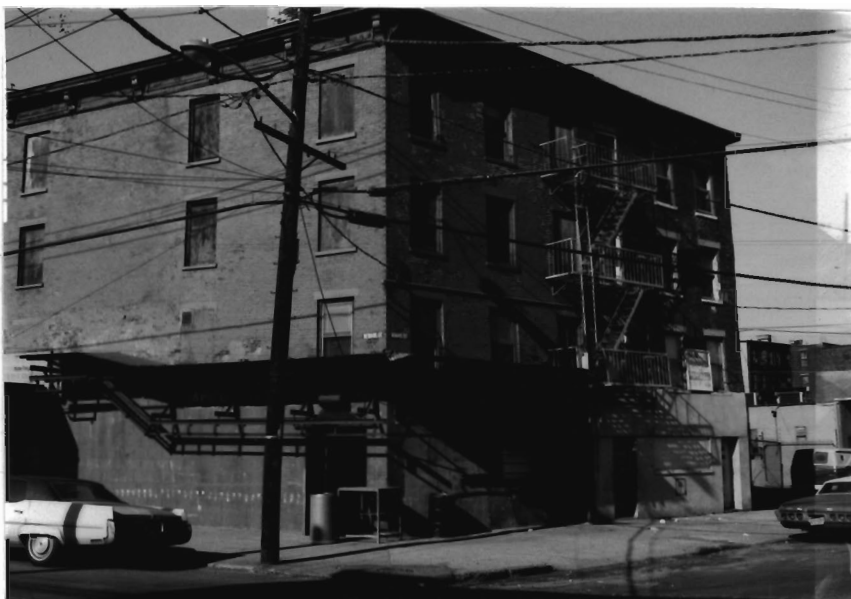
58 Adams St.
neg. # 36-30

58-60 - 2 4 x 3 Italianates with stucco altered first story.

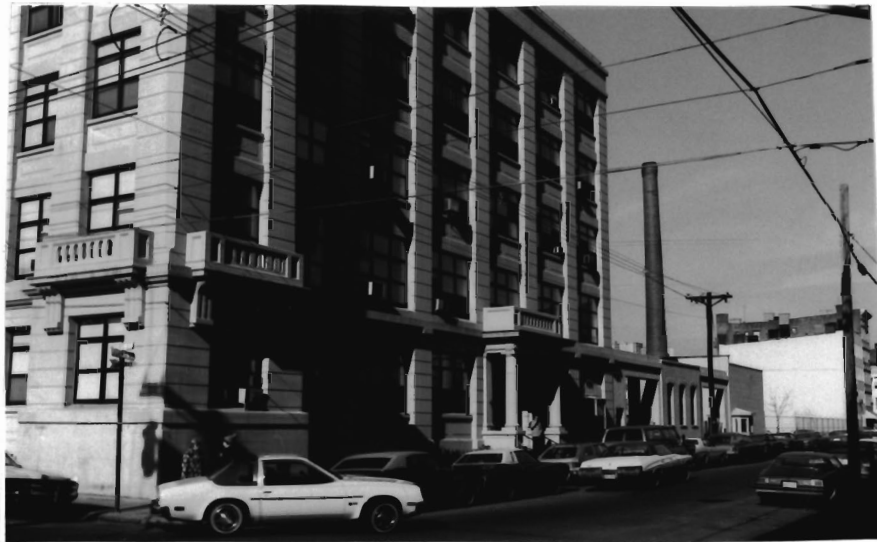
300-26 Adams St.
37-7

300 - K & E building - yellow stucco factory building converted to housing ("Clock Towers") (see individual form).

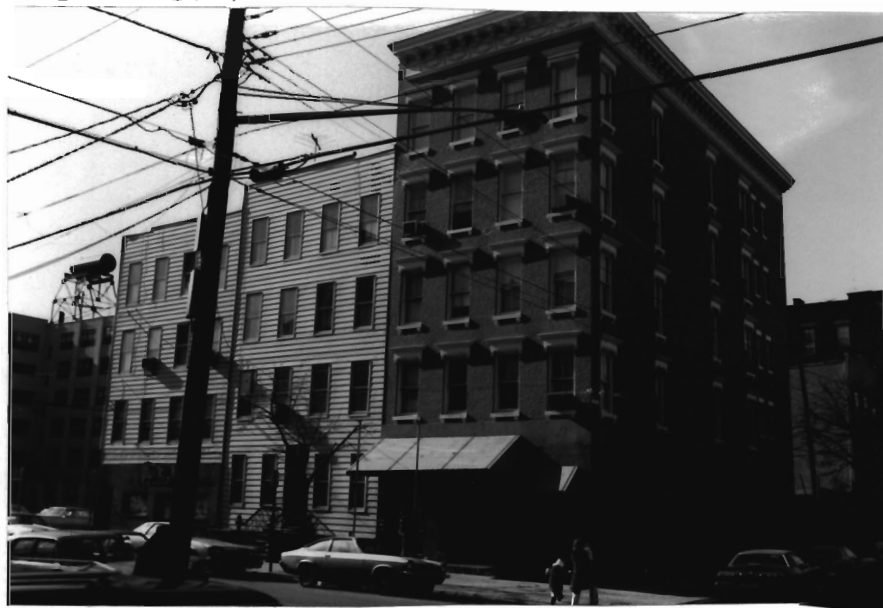
328,330,332 Adams St.
neg. # 37-10

328-300 - 2 4 x 4 aluminum siding. 328 has brick altered first story.

332 - 5 x 4 Italianate with heavy lintels. Brick altered storefront on first story.

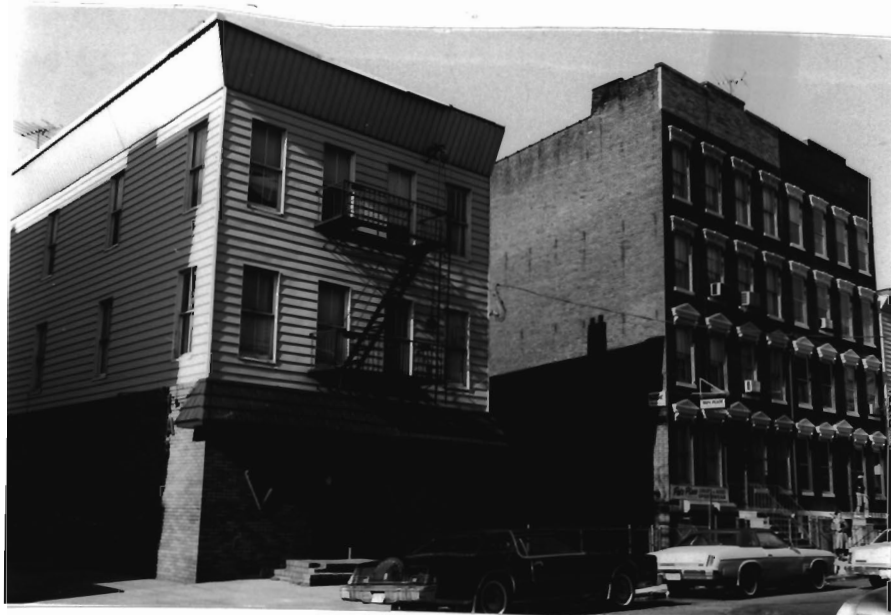
400, 402, 404, 406 Adams St.
neg. # 37-18

400 - 3 x 4 aluminum siding-stripped cornice; first story is brick altered storefront (tavern).

402 - Empty lot

404-406 - 2 intact 4 x 4 italianates with intact doorways, areaways and top parapets (404 parapet altered in orange brick) pedimented lintels (1st, 2nd stories) and keystone (3rd, 4th stories) both types with dentiluration.

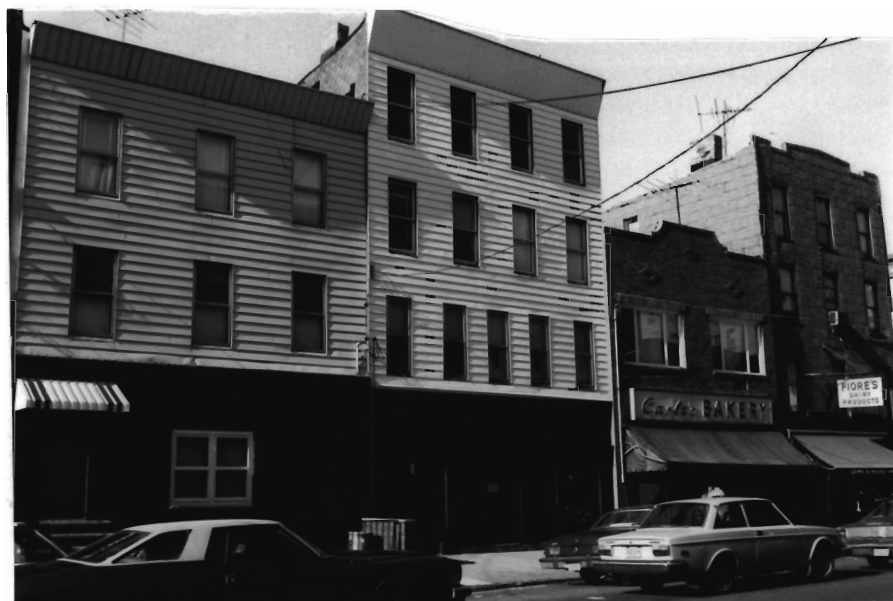
408, 410, 412, 414 Adams St.
neg. # 37-20

408 - 3 x 3 aluminum siding; sheathed cornice.

410 - 4 x 4 aluminum siding, sheathed cornice; 1st story gift shop is fieldstone alteration.

412 - 2 x 2 orange brick veneer; top parapet. First floor is Carlo's Bakery.

414 - Fiore's Dairy - (structural glass storefront) with 4 x 3 perma-stone building.

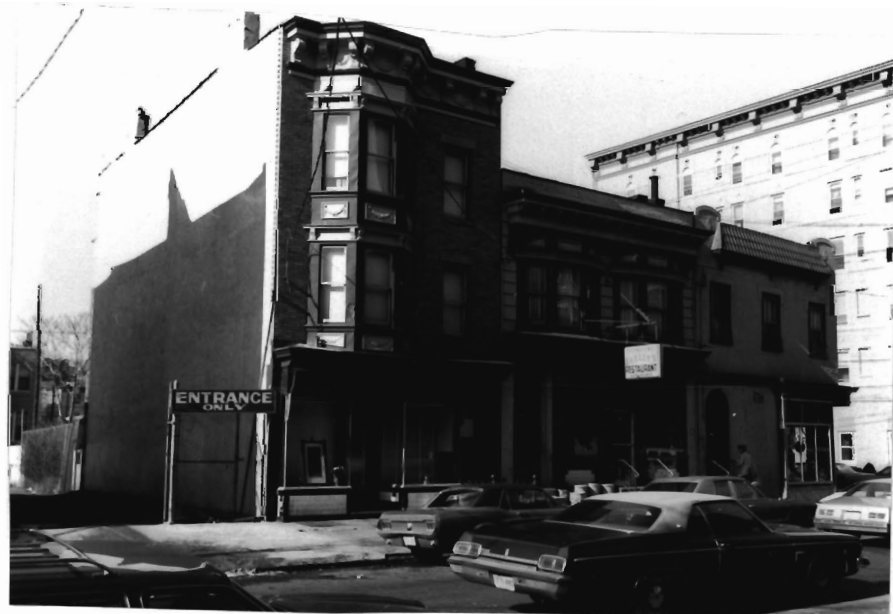
416, 408, 420, 422 Adams St.
neg. # 37-22

416 - Parking lot.

418 - 3 x 2 Italianate with one 3-bay oriel on second and third stories; oriel bays have festooned panels below, mini-cornices above. Top cornice , first floor is intact. Storefront (no sign) and cornice.

420 - Skelly's Restaurant - 2 x 2 brick italianate with oriels on stone facade for second story. Panels above oriel bays; market extends above top cornice. First story is intact storefront except for central door.

422 - Pseudo - spanish stucco with corrugated false roof. Tile-altered storefront has original cornice.
