STREET NAME: Bloomfield Street

MUNICIPALITY: Hoboken

Bloomfield Street, between Observer Highway & Newark Street, East Side #'s running north--south

## NEW JERSEY OFFICE OF HISTORIC PRESERVATION HISTORIC SITES INVENTORY # STREETSCAPE SURVEY FORM

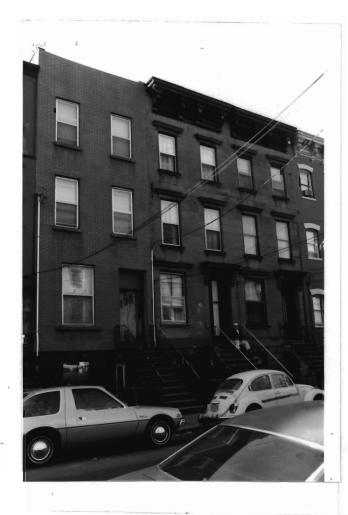
934,936,938 Bloomfield St. neg. # 18-18

- 934-38 Three originally identical 3X2 brownstones. Basement story is only intact feature of 934, which has been refaced in applied false brick and stripped of its cornice. 936 and 938 have flat, protruding lintels and console bracketed door cornices. The intact wooden cornices have console brackets, some of which are decayed.

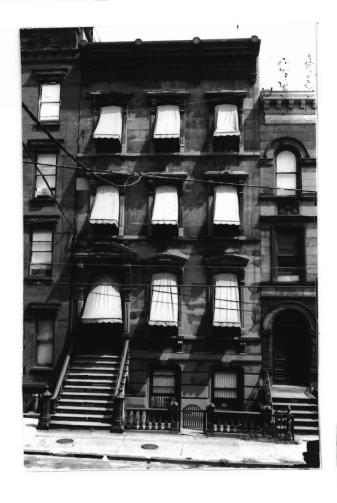
1041 Bloomfield St. neg. # 5-16

1041 - Large 3X3 brownstone rowhouse with a high basement. Balusters are across areaway and support stair rails. Brownstone has been visibly patched but details are in good shape. Basement story has horizontally rusticated blocks; the wall surface above is smooth. The basement windows have rounded corners and wrought iron grills. A grill is also in front of the door under the front stair. All windows are segmental arch type and have full surrounds. Console brackets terra cotta panels with raised detail under the first story windows. First story windows and the doorway have segmental arch pediments with projecting sections over window keystones. Stone courses support surrounds with console bracketed, highly projecting lintels. The cornice has large brackets, corbellike modillions and is extremely thick. This is the most elaborate rowhouse in Hoboken outside of some on Hudson Street.
