NEW JERSEY OFFICE OF HISTORIC PRESERVATION HISTORIC SITES INVENTORY #
INDIVIDUAL STRUCTURE SURVEY FORM

HISTORIC NAME:
LOCATION: 41,43 First StreetCOMMON NAME:
BLOCK/LOT: 223/10A.10BMUNICIPALITY: Hoboken
OWNER/ADDRESS:

LOCATION: 55, 57 First St.

STREET NAME: 1st
MUNICIPALITY: Hoboken

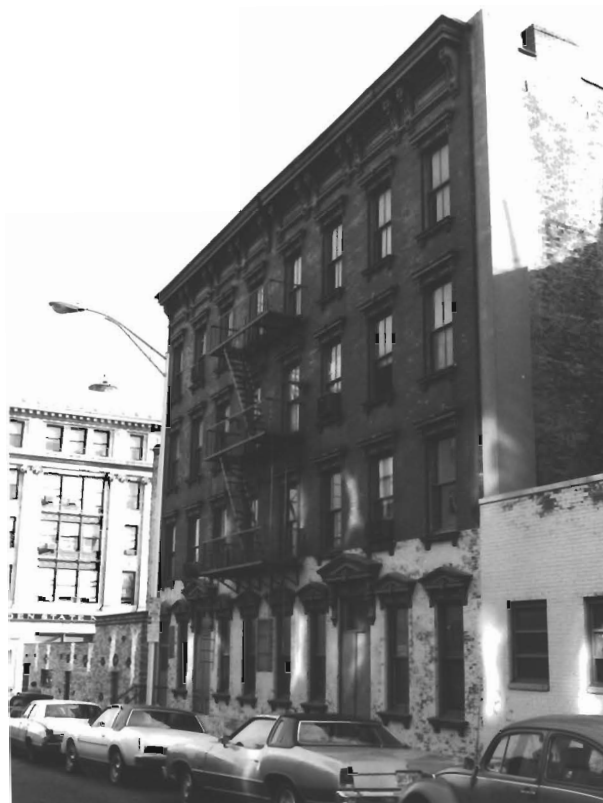
37,39,41,43 First St.
neg. # 24-6

Fenestration: most 2 over 2 sash intact; protruding lintels have small
braquets. 4 window bays on #'s 41, 43.

Additional Architectural Description: doors have large pedimented lintels
and console-like braquets. Window and door elements are cast-iron.
Paired braquets along cornices. Original steps on both bldgs. removed.

PHYSICAL CONDITION: Excellent ☐ Good ☐ Fair ☒ Poor ☐
REGISTER ELIGIBILITY: Yes ☐ Possible ☒ No ☐ As part of district ☒
THREATS TO STRUCTURE: Roads ☐ Development ☐ Zoning ☒ Deterioration ☒
No Threat ☐ Other ☐
COMMENTS:

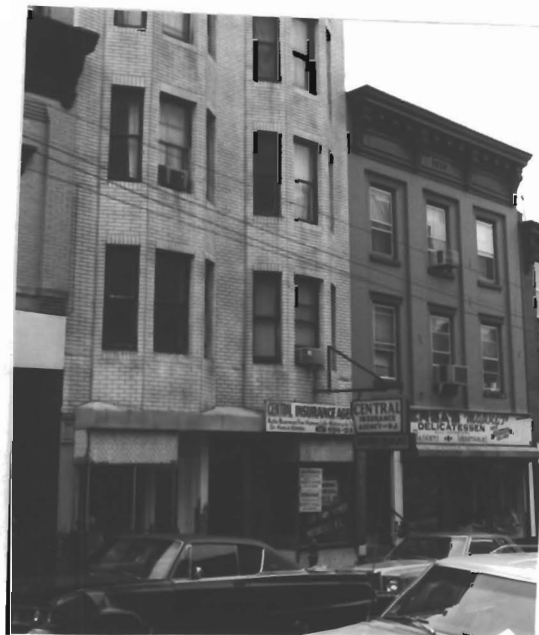
153,155 First St.
neg. # 10-32

153 - Central Insurance Agency - tile altered storefront with doors and colonettes intact. 5X2 (bays) upper structure is white brick veneer with oriel (2nd-4th St.)

155 - Aversa's Market - Glass altered storefront. 3X3 Italianate with recessed window bays.

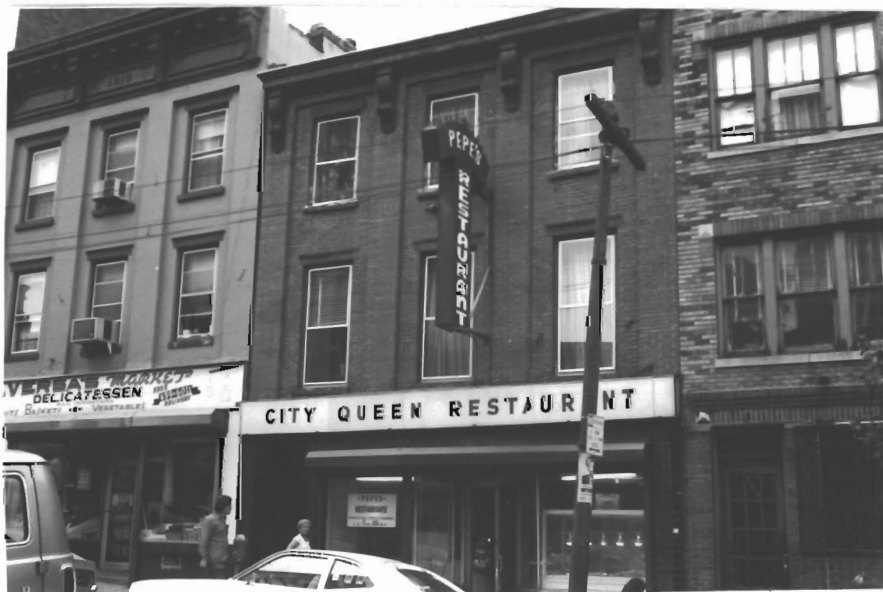
155,157,159 First St.
neg. # 10-33

157 - City Queen Rest. - Tile altered storefront. 3X3 Italianate with recessed window panels.

159 - Apple Bar - 1st St. asphalt-brick altered storefront. 2nd & 3rd story very similar to 160 - yellow asphalt brick; brown brick surrounds top window arches only. Top parapet "1927".

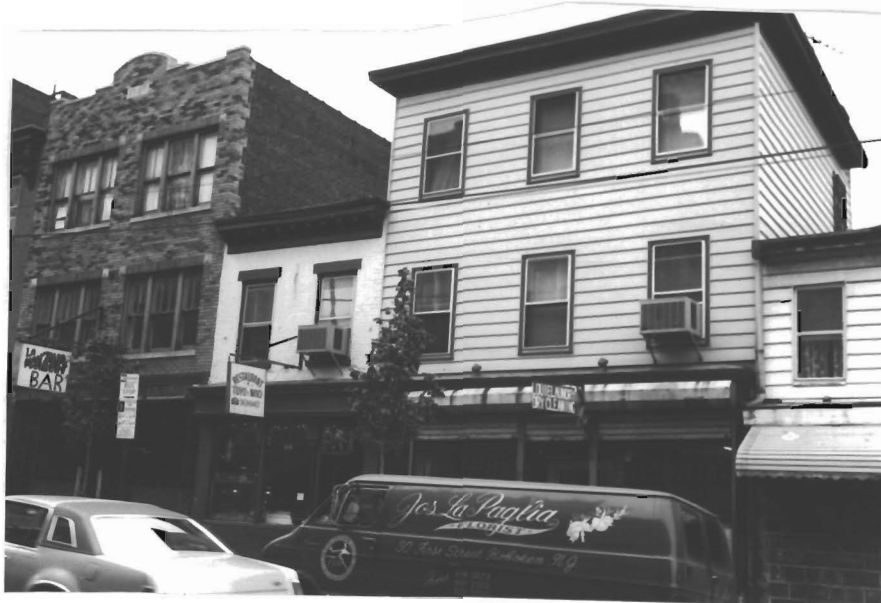
159,161,163 First St.
neg. # 10-34

161 - Restaurant - Yuyo y Mio - 2X2 Italianate brick altered storefront.

163 - Louie Laundry - brick altered storefront. 3X3 facade with aluminum siding.

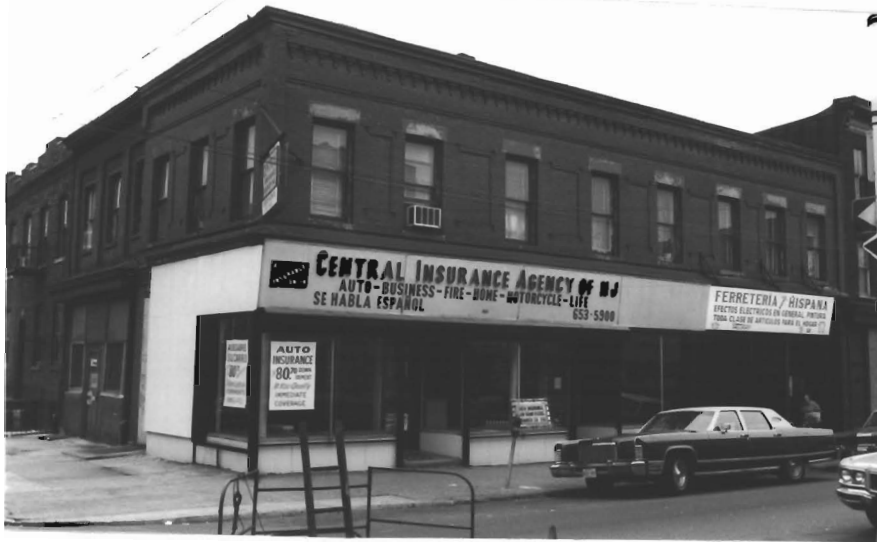
(Garden to Park Sts.)
201-203 First St.
neg. # 25-25

201-203 - Mueble Nagua & Ferreteria Hispana - Glass altered storefront on 1st St. 2nd St. - brick panels recessed between window bays (8 bays). Top panel recessed; triple denticulation below cornice line.

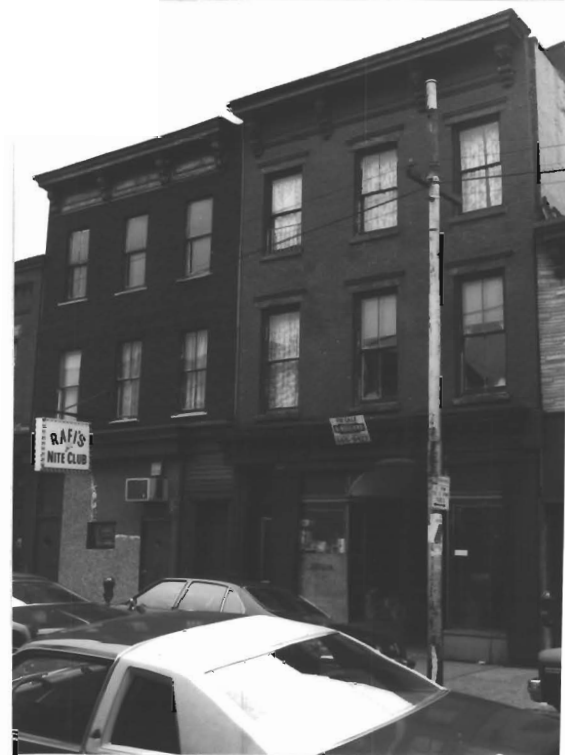
205, 207 First St.
neg. # 25-26

205 - Rafi's Nite Club - stucco altered storefront with intact residence door. 3X3 italianate - permastone.

207 - intact storefront with ornamental paving and storefront cornice 3X3 italianath.

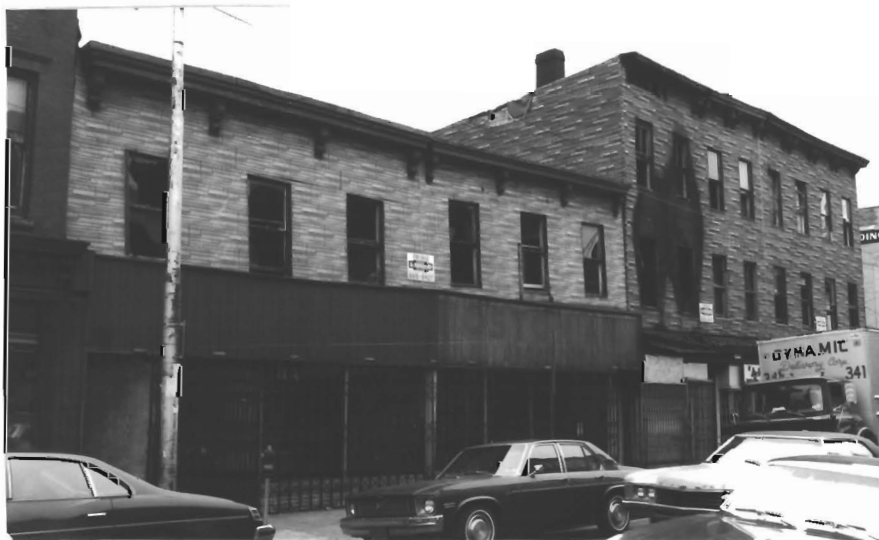
209, 211, 213, 215 First St.
neg. # 25-27

211-215 1st St. - 3 abandoned storefronts. 213 residential door nearly intact. Two 3X4 italianate buildings with top floors covered with permastone.

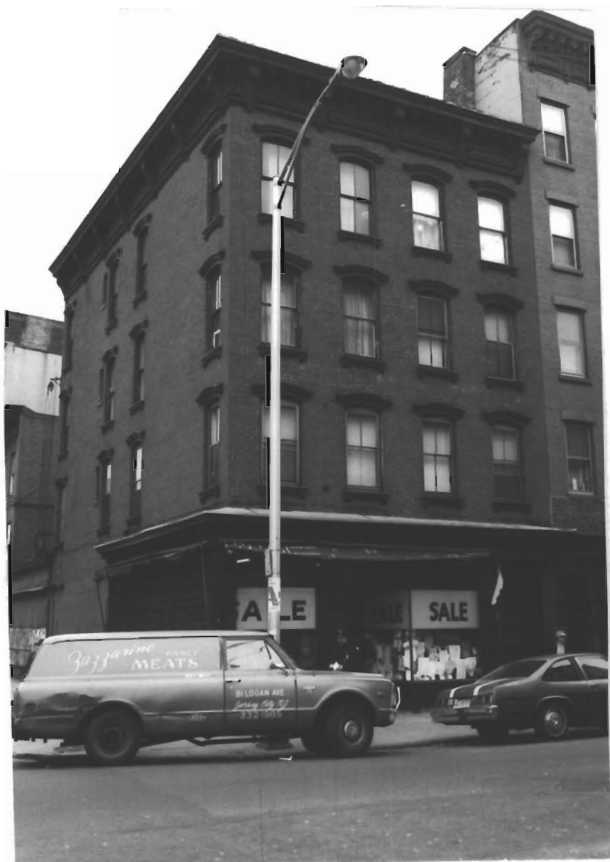
264 First St.
neg. # 25-33

264 - Near Intact store front with residential door and columnettes. 4X4 Italianate with curved lintels.

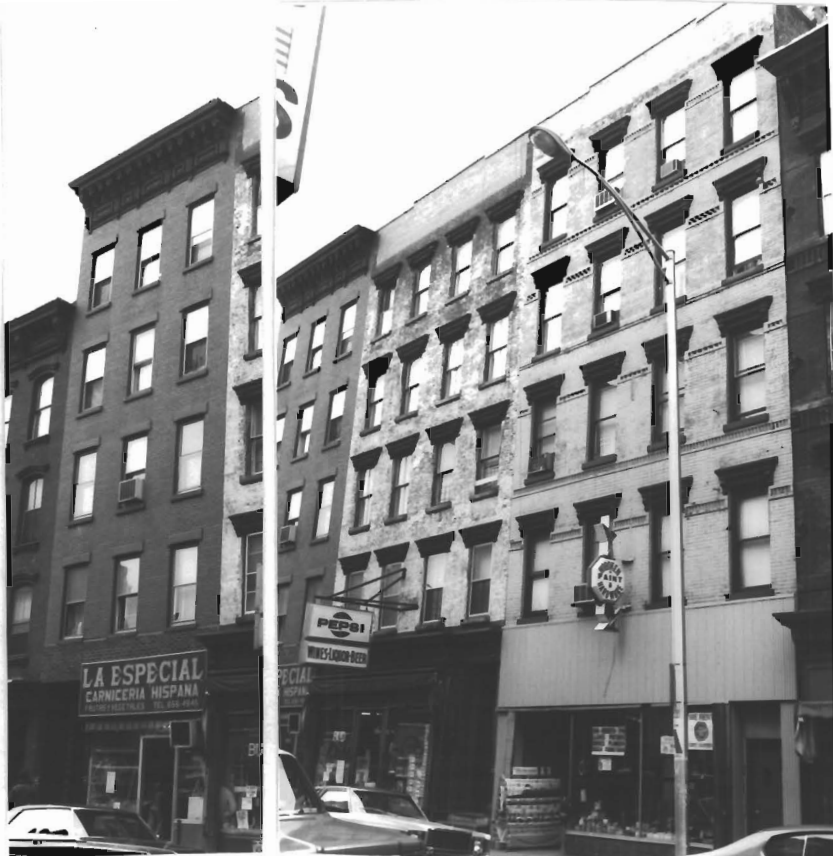
262 First St.
neg. # 25-32

262 - La Especial Carniceria - Glass altered storefront but columnettes intact. 3X5 Italianate.

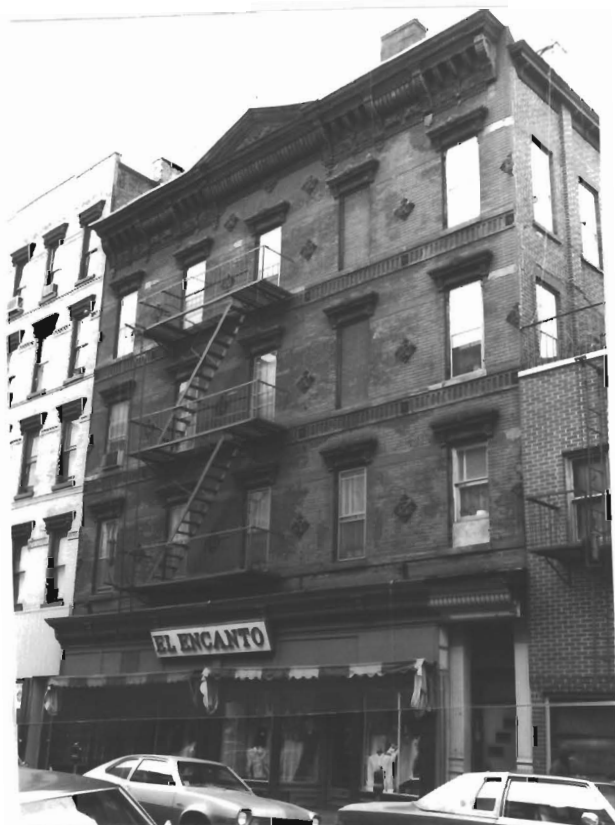
254-258 First St.
neg. # 25-30
photo date: 11-21-78

254-6 El Encanto - Nearly intact storefront and cornice. 4X5 Italianate with ornate brackets (?) and heavy top cornice. Stone coursing at lintels, brick coursing at sills.

258 - Hoboken Hardware - Tile altered storefront. 5X4 Italianate with top parapet; end on brick coursing between lintels.

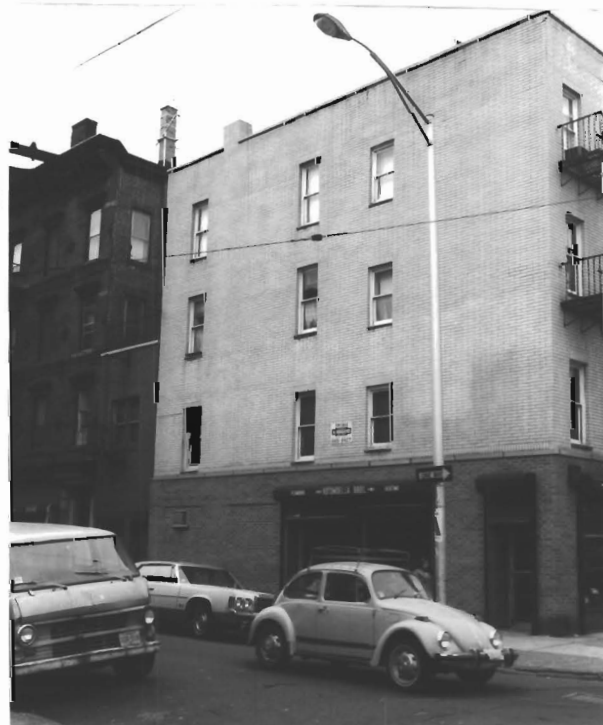
252,250 First St.
neg. # 25-29

250 - Rotondella Bros. - Plumbing & Heating - Brick altered storefront; white brick on top stories.

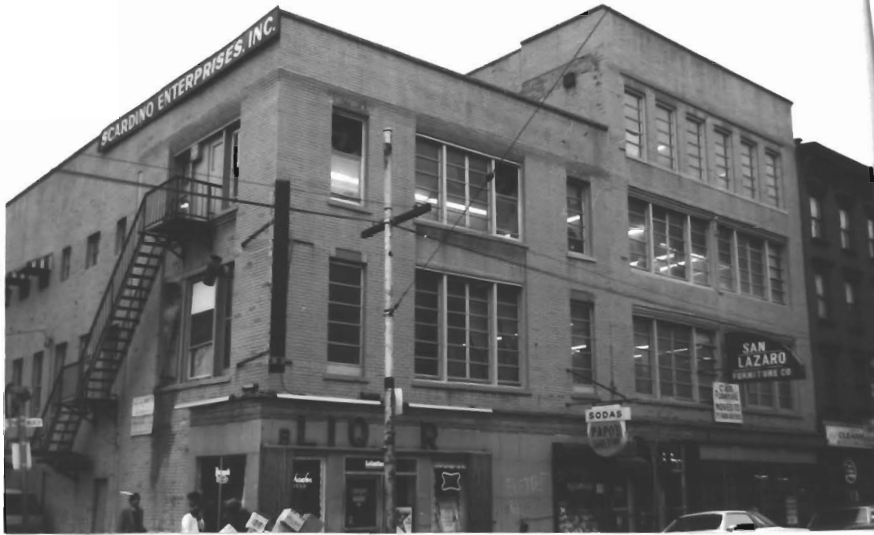
(Park to Willow Aves.)
251-55 First St.
neg. # 26-10

251-55 - Liquor store, Dapo's Candy, C&A Furniture Co. - 3 tile altered storefronts - 1 building. 2nd, 3rd & 4th story of 255 1930's industrial facade (yellow brick) with slat fenestration.

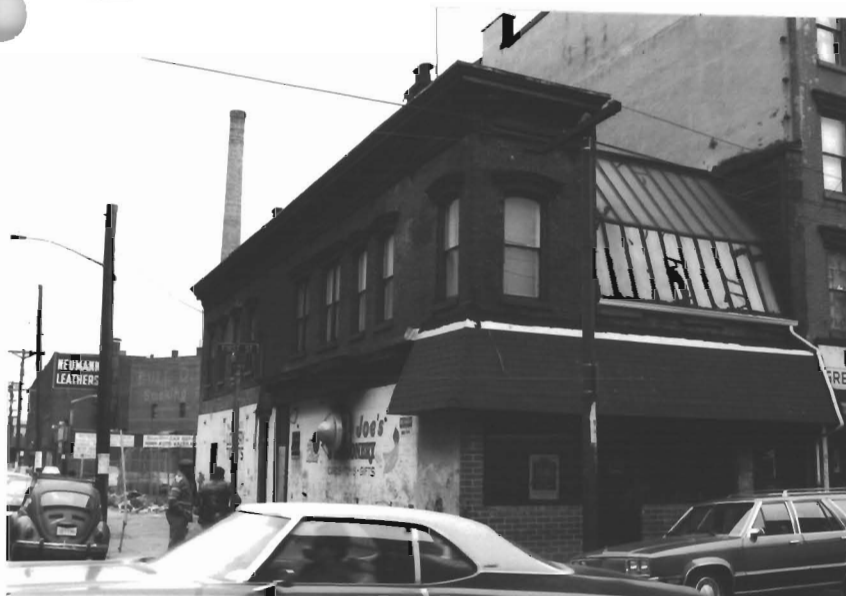
(Willow to Clinton) 301 First St.
neg. # 26-1

301 - 2 story Italianate; altered front facade - 2nd story originally had 4 bays - now has gambrel type roof replacing 3 bays. Intact storefront and top cornice - altered storefront.

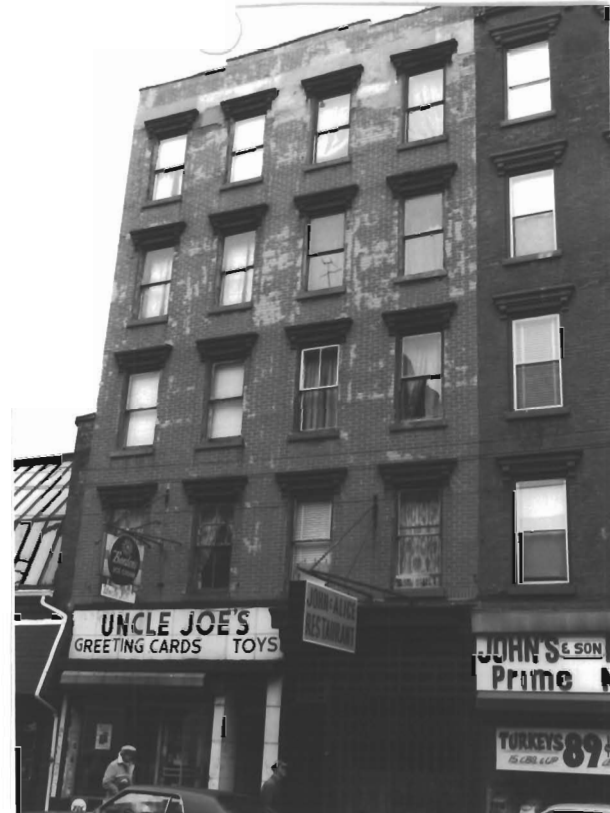
303 First St.
neg. # 26-2

303-307 - 2 5X4 & 1 5X3 brick commercial-residential buildings; 2 larger buildings, each have 2 storefronts intact. Storefronts on right side of 303 and all of 305. Intact cornice 305. All have protruding matching lintels.

303 - Uncle Joe's (altered storefront) & Restaurant (?) with intact cornice. 305 John's Meats & Christina Fashions (subst. intact storefronts - John's sign covers cornice).

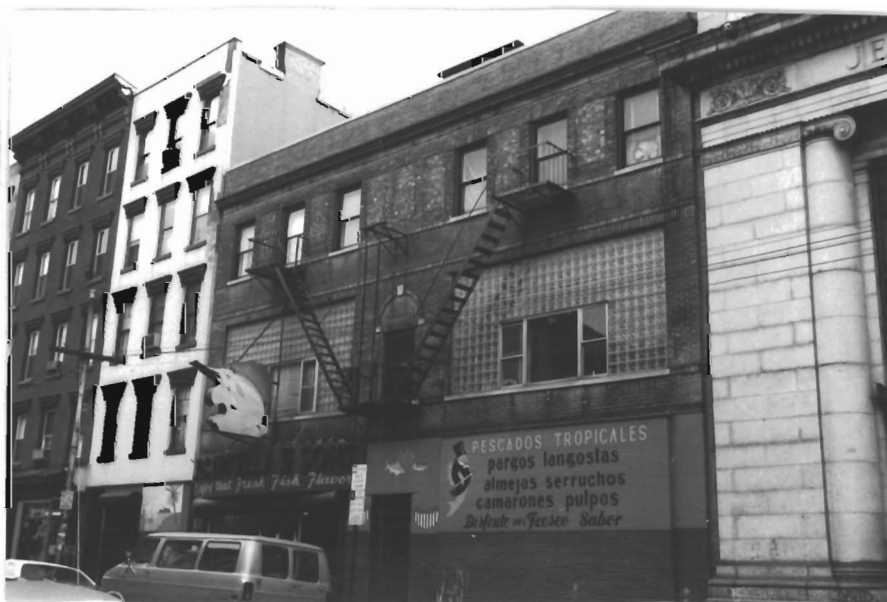
307-309-311 First St.
neg. # 26-4

307 - Bricked up with narrow garage door.

309-11 3X7 Italianate brick; simple, Circa 1925 classic revival. altered storefront (Apicella & Sons). Bricked-over on 311. Fire Escape.

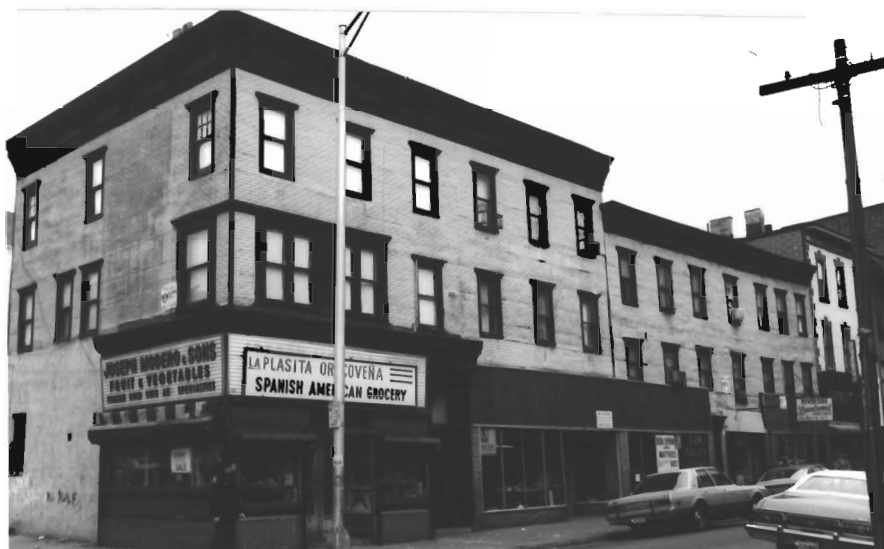
314,312,310,308 First St.
neg. # 25-37

308-14 - row is 2 different heights - 7 bays & 6 bays. False brick sheet metal and intact cornices. Possibly several different build6ngs covered with same surface.

308 - Riverside Laundry - 310 Acevedo's - 312 Sam's Sales - 314 La Plasita Orcovena.

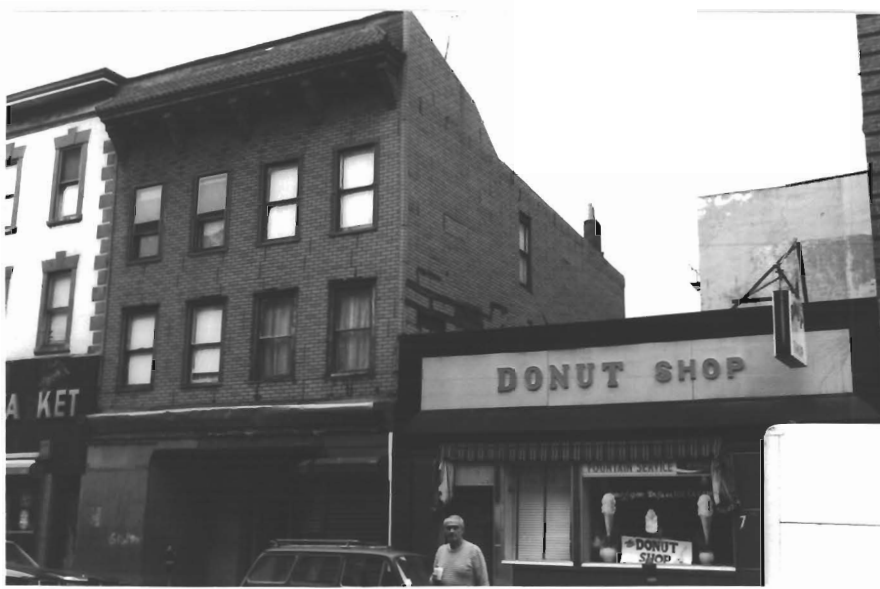
302,304 First St.
neg. # 25-35

302 - 1 story donut shop - enamelled metal panels.

304 - 3X4 badly altered storefront; false brick shingling on upper stories. Cornice original with ^{spanish} tile on top.

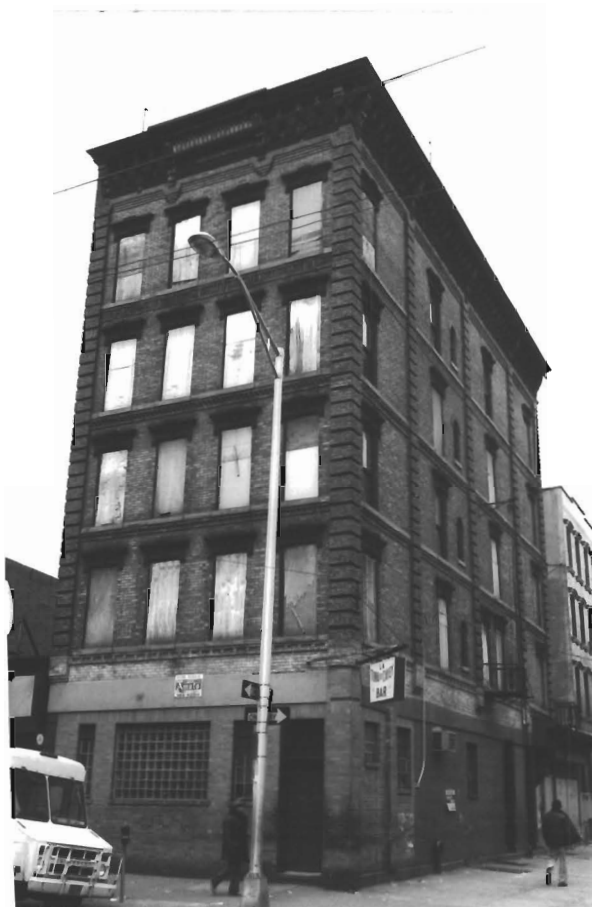
300 First St.
neg. # 25-34

300 - Bar appears closed. storefront cornice visibly stripped (Brick is lighter). Building is 5X4; intact top cornice; heavy lintels and ^{quoins} coigns. 4 large bays separated by brick coigns with single window in each side.

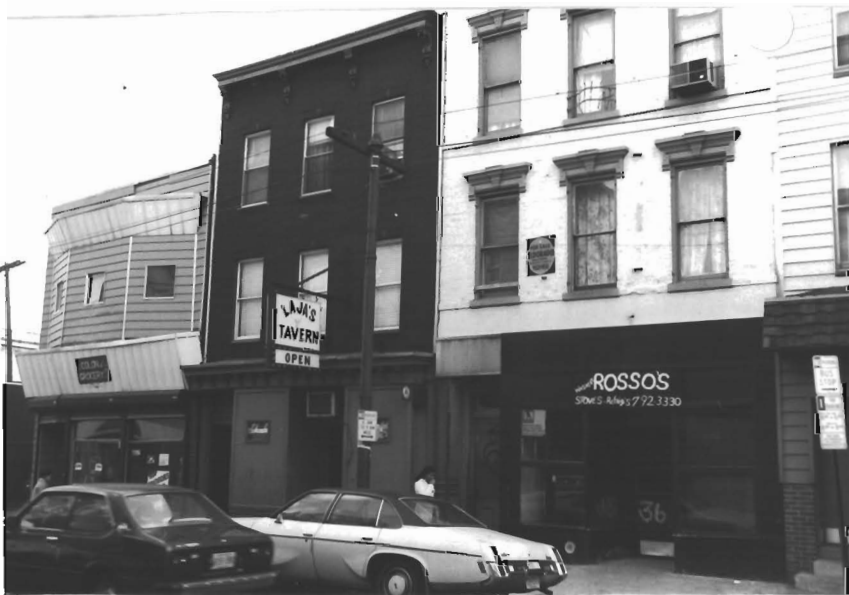
357,359,361 First St.
neg. # 16-23

359 - Laja's Tavern - 3X3 - storefront basically intact with cornice - asphalt false brick above with small console bracketed cornice. Plywood replaces glass in storefront.

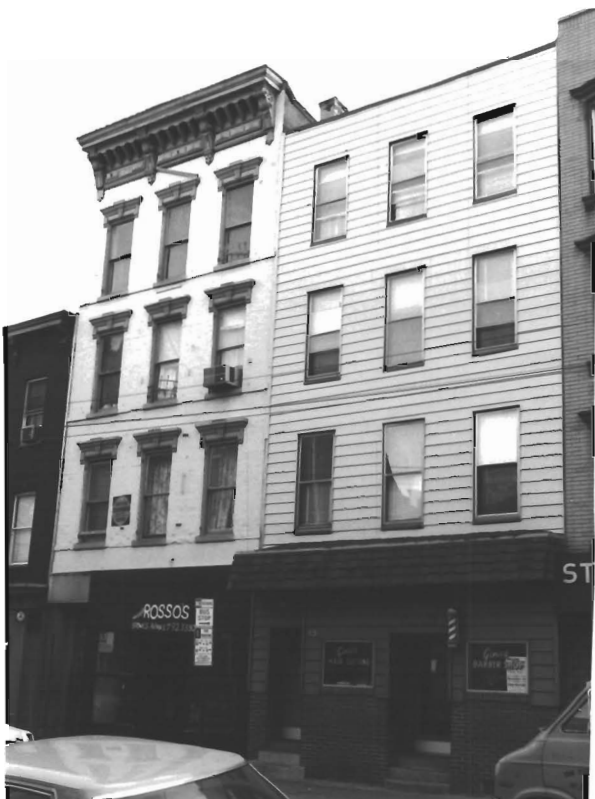
361,363 First St.
neg. # 16-24

361 - Rosso's Stoves, etc. - altered storefront 4X3, cast iron heavy lintels, large cornice with consoles.

363 - 4X3 - Gino's Barber - altered storefront with vinyl siding and cedar shingled "mansard". Aluminum siding above, no cornice.

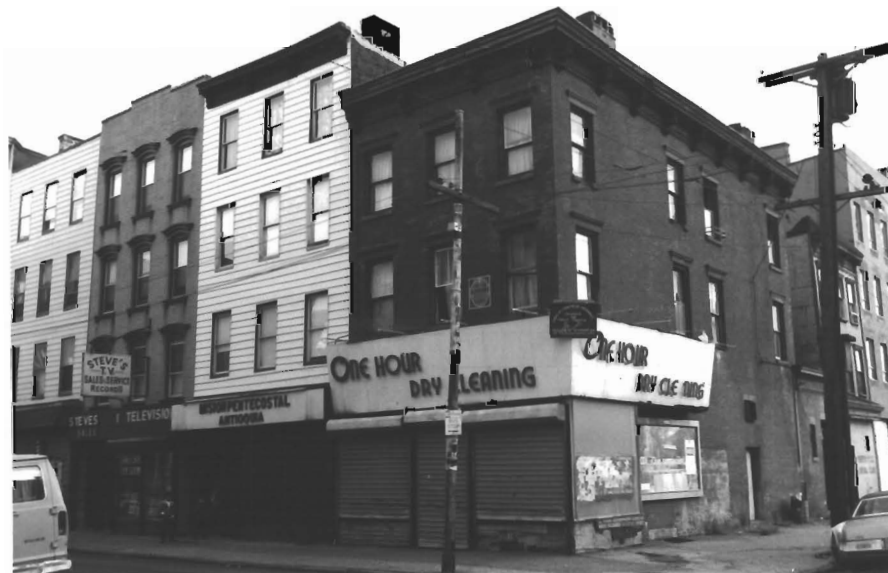
365,367,369 First St.
neg. # 16-25

365 - 4X3 - Steve's Television - altered storefront, with covered cornice and permastone. Applied false brick above with cast iron segmental aicrm lintels with upturned ends.

367 - 4X3 mision Pentecostal Antioquia in altered storefront. Aluminum siding and intact cornice.

369 - 3X3 One Hour Day Cleaning - covered storefront cornice. Intact flat lintels above (brownstone and deteriorating wood cornice).

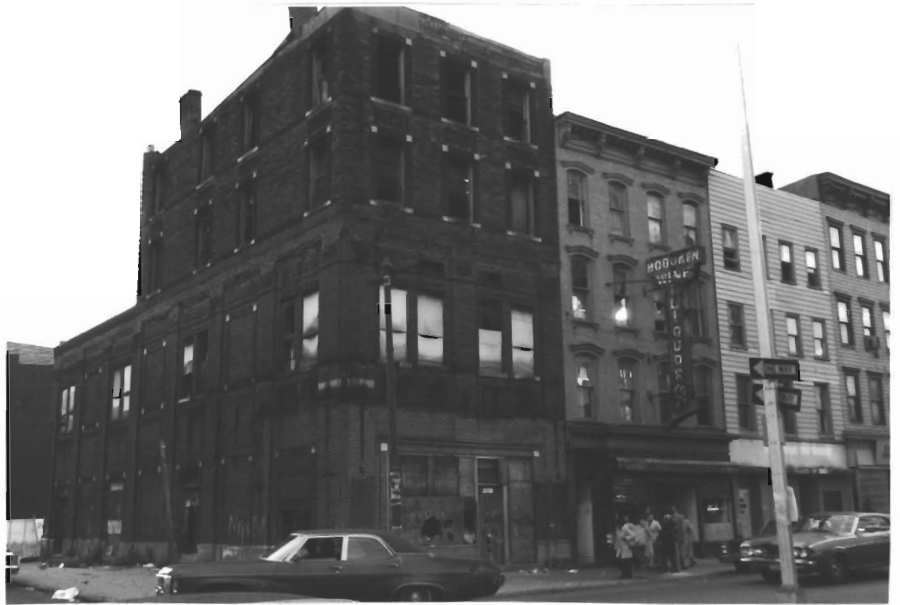
405,407,409 First St.
neg. # 16-27

405 - 4X4 - Church of God - altered storefront - aluminum siding, no cornice.

407 - 4X4 - Botanica Centro Espiritual - relatively intact storefront and cornice. Wood lintels, surrounded above with wood shingled walls, fine wood cornice.

409 - altered storefront, intact storefront cornice, intact fenestration in most windows. Lintels as in 403, fine paired bracketed cornice.

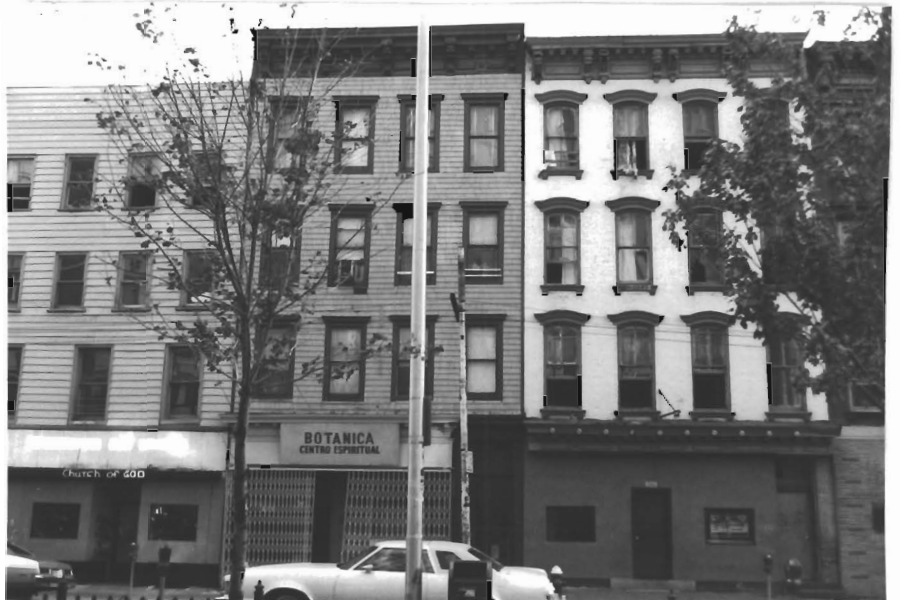
409,411,415 First St.
neg. # 16-28

411, 13 - two 4X4 altered storefronts - permastone at 411, metal storefront surround and cornice substantially intact at 413. Both have heavy cast iron lintels: elaborate, deteriorating wood cornices. Club 17 at 411, Mendoza & Sons at 415 (sign on storefront cornice says S. Zorn).

415 - 4X4 Marra Shoes, intact storefront cornice. Same top cornice as 411, 13 but segmental arch lintels with upturned ends.

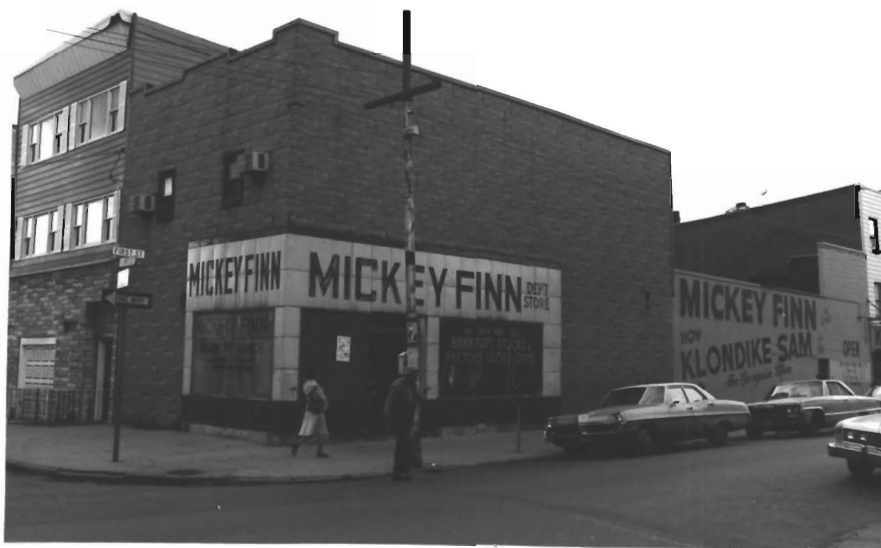
(Adams to Jefferson St.s) 451-53, 455, 457 First St.
neg. # 16-32

451 - asphalt
- Concrete block - Mickey Finn - Now Klondike Sam
- Aluminum Siding
- Permastone
- Last building - paired peaked cornice, fire escape

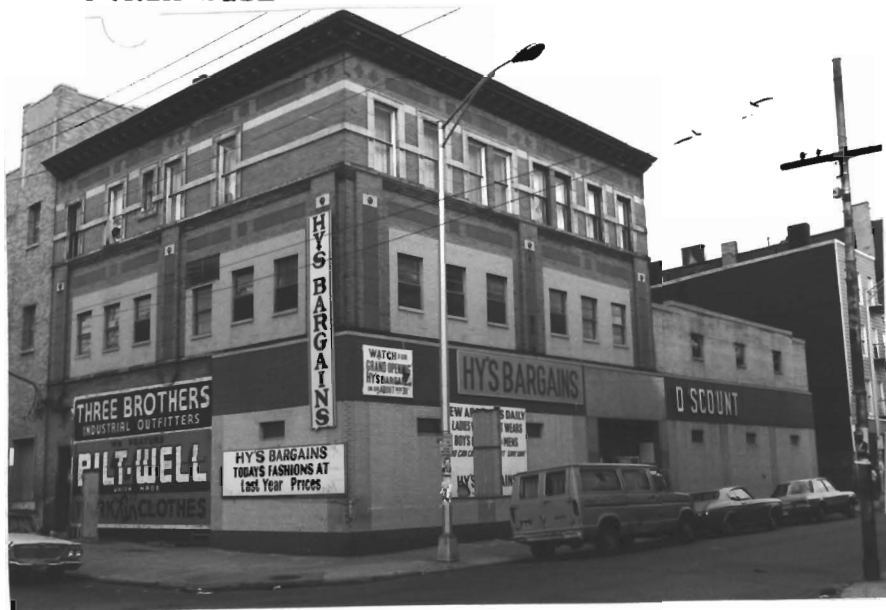
(Clinton to Grand Sts.) 366-360 First St.
neg. # 16-21

360-62, 64 - Hy's Bargains Discount (2 stores) East half is post WW II warehouse with yellow and orange brick. West half (at corner) has altered 1st story and deco with turquoise tile in 2nd and 3rd. Italianate cornice.

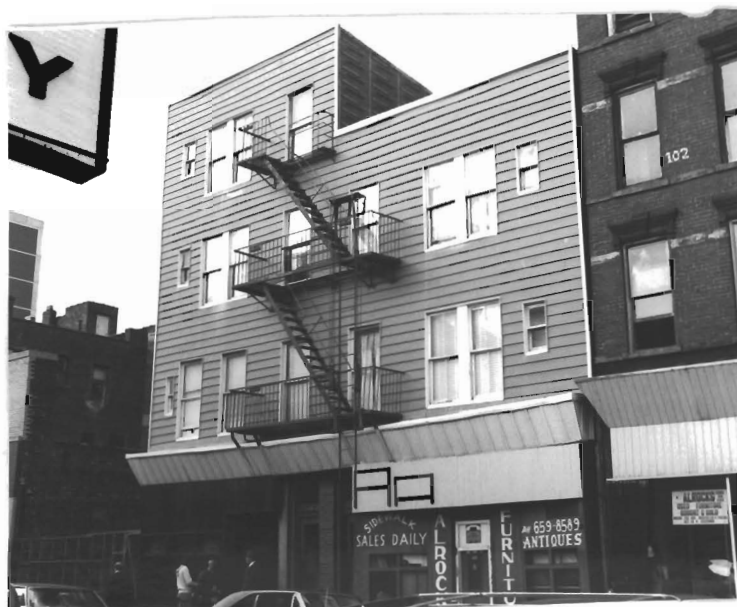
356, 354 First St.
neg. # 16-20

354-56 - Two 3 bay width buildings (354 - 3 stories, 356 - 4 stories). Altered storefront with covered storefront cornices. Vinyl siding above 1st story, no cornice.

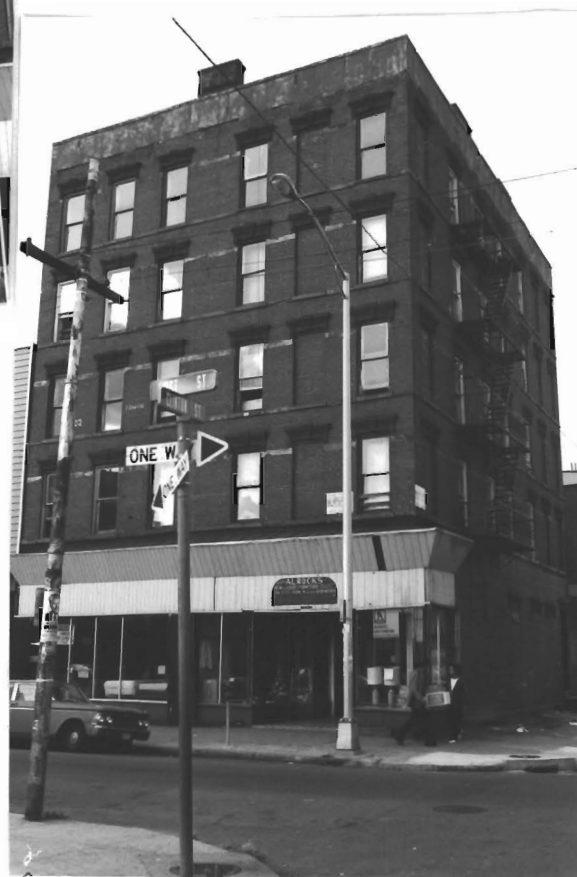
352-350 First St.
neg. # 16-19

350-52 - Double width 5X6 with altered storefront (Alrock's Furniture - storefront cornice may be intact), heavy cast iron lintels, no cornice.
