NEW JERSEY OFFICE OF HISTORIC PRESERVATION HISTORIC SITES INVENTORY # STREETSCAPE SURVEY FORM

STREET NAME: 3rd Street CROSS STREETS: Bloom., Garden, Park,

MUNICIPALITY: Hoboken

NEW JERSEY OFFICE OF HISTORIC PRESERVATION HISTORIC SITES INVENTORY # 34-18-27,28 INDIVIDUAL STRUCTURE SURVEY FORM

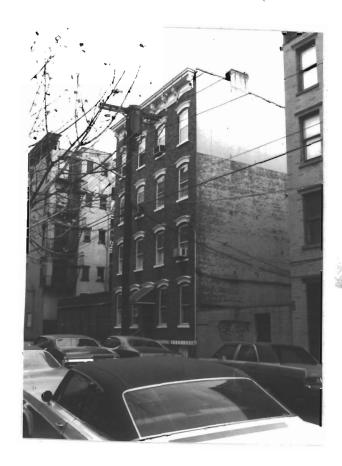
Park to Willow Aves. 251-263 Third St. neg. # 21-2

257 - 1 story red brick commercial - wooden delivery doors

259 - 4X4 italianate altered with asphalt - false brick - segmental arch lintels

4 story italianate faces Willow - wrought iron fence on side facade

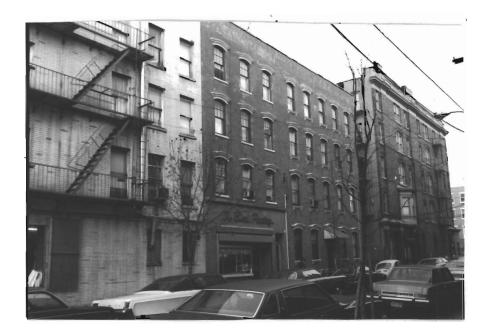
Park to Willow Aves. 262-250 Third St. neg. # 21-1

258 - 4X5 false brick - italianate with segmented arch lintels - top parapet.

260 - identical 4X3 lst floor is Debari Bakery - tile altered store-front.

(4X5 white false brick with fire escape - side of Hernandez Rest. facing Willow.

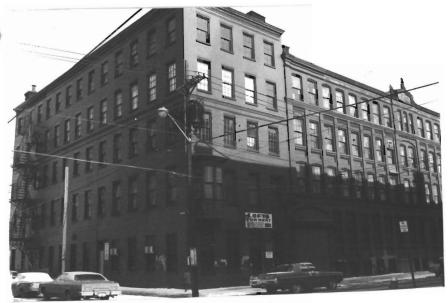
301-07 Adams St., 400-12,414 Third St. neg. # 34-18

The oldest section at Adams and third has an oriel in the second story in the Westermost Third Street bay. Windows are six over six. This section has a denticulated wood cornice and most nearly suggests the italianate style. Lintels are flat and flush.

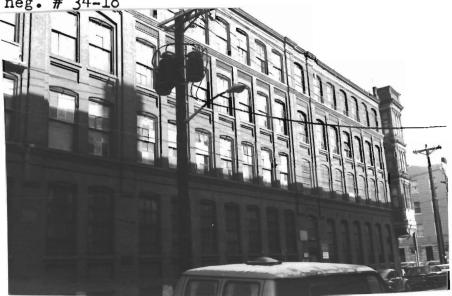
(eastern portion) 400-12 Third St. neg. # 34-21

The section along 400-14 Third and 300-10 Crand is later and has a plain cornice and segmental arch window openings. Most notable is a three story cast-iron oriel that projects out from both sides of the facade over the corner entry at Third and Grand

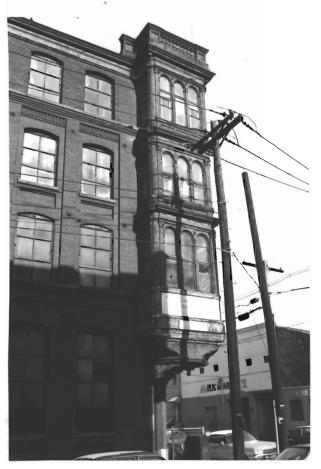
400 Third, 300 Grand Sts. neg. # 34-22

The top two stories at about 308-12 Grand are brick additions with six over six sash. (cont'd below)

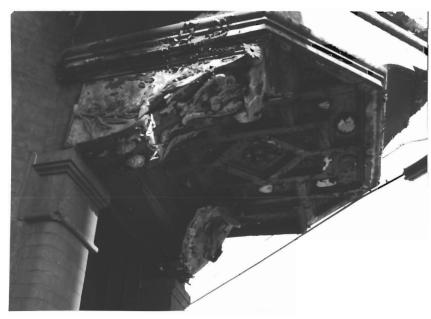
400 Third, 300 Grand Sts., detail neg. # 34-24

The size of the plant and its familiarity to the buildings to South across Third, as well as its relationship to the newest K&E plant make it important. The oriel window at Third and G is exceptional. ORIGINAL USE: PHYSICAL CONDITION: Excellent [] Good [] Fair [X] Poor [X] REGISTER ELIGIBILITY: Yes [] Possible [] No [] Part of District THREATS TO SITE: Roads [] Development [] Zoning [X] Deterioration No Threat [] Other []	
The size of the plant and its familiarity to the buildings to South across Third, as well as its relationship to the newest K&E plant make it important. The oriel window at Third and G is exceptional. ORIGINAL USE: PHYSICAL CONDITION: Excellent [] Good [] Fair [X] Poor [X] REGISTER ELIGIBILITY: Yes [] Possible [] No [] Part of District THREATS TO SITE: Roads [] Development [] Zoning [X] Deterioration No Threat [] Other []	-
The size of the plant and its familiarity to the buildings to South across Third, as well as its relationship to the newest K&E plant make it important. The oriel window at Third and G is exceptional. ORIGINAL USE: PHYSICAL CONDITION: Excellent [] Good [] Fair [X] Poor [X] REGISTER ELIGIBILITY: Yes [] Possible [] No [] Part of District THREATS TO SITE: Roads [] Development [] Zoning [X] Deterioration No Threat [] Other []

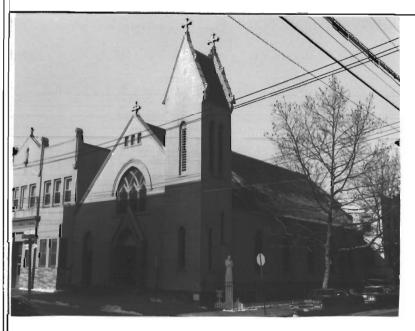
Two low-style Gothic Revival buildings altered with a stucco brick treatment.
