NEW JERSEY OFFICE OF HISTORIC PRESERVATION HISTORIC SITES INVENTORY #  
STREETSCAPE SURVEY FORM

STREET NAME: 9th Street  
MUNICIPALITY: Hoboken

NEW JERSEY OFFICE OF HISTORIC PRESERVATION HISTORIC SITES INVENTORY #  
INDIVIDUAL STRUCTURE SURVEY FORM

NEW JERSEY OFFICE OF HISTORIC PRESERVATION HISTORIC SITES INVENTORY # 31-3,4,7,8  
INDIVIDUAL STRUCTURE SURVEY FORM

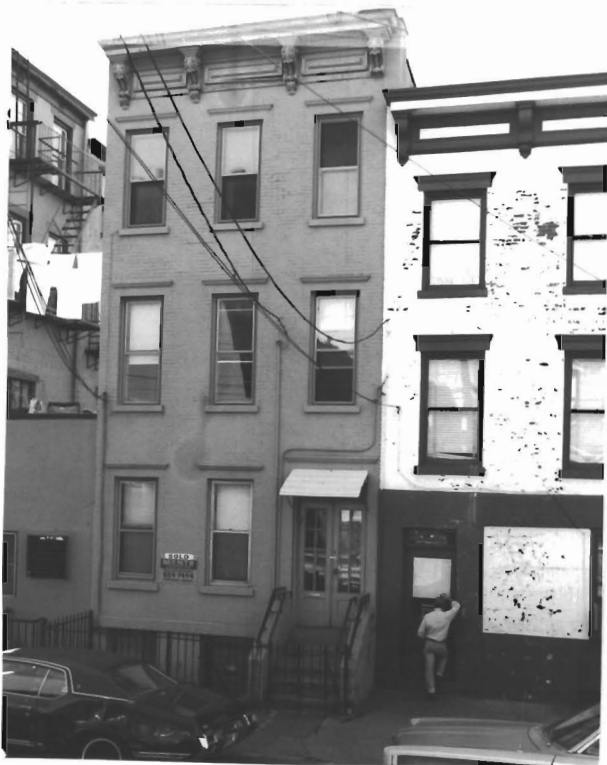
(Bloomfield to Garden Sts.)  
157,159 Ninth St.  
neg. # 15-31

157 - 3X3 italianate with intact flat lintels, cornice. (intact doors?)

159 - wide 3X3 italianate intact, although 2 left cornice consoles are decayed. Intact outer door.

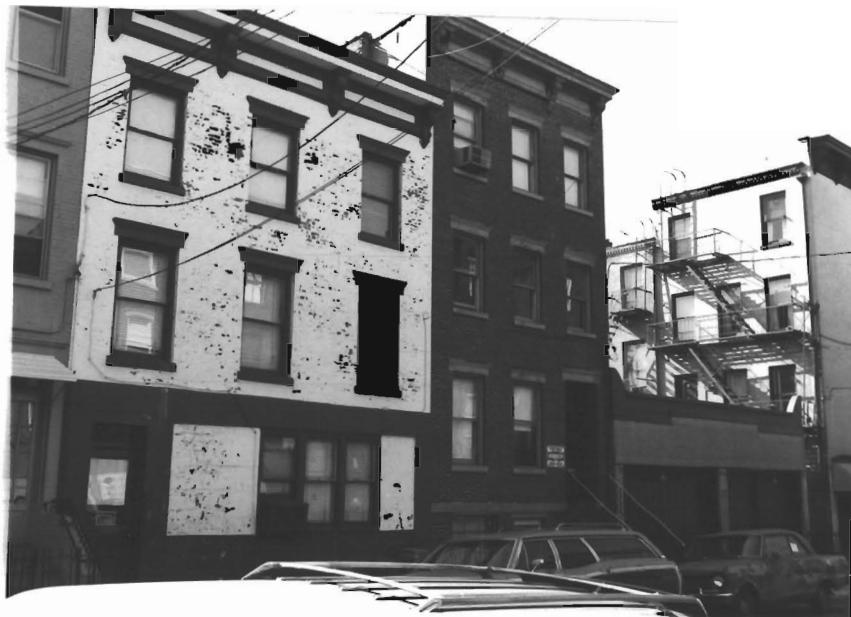
159,161,163-65 Ninth St.  
neg. # 15-32

163-5 - 1 story garage - 2 door - yellow brick - flared concrete pieces at top ends.

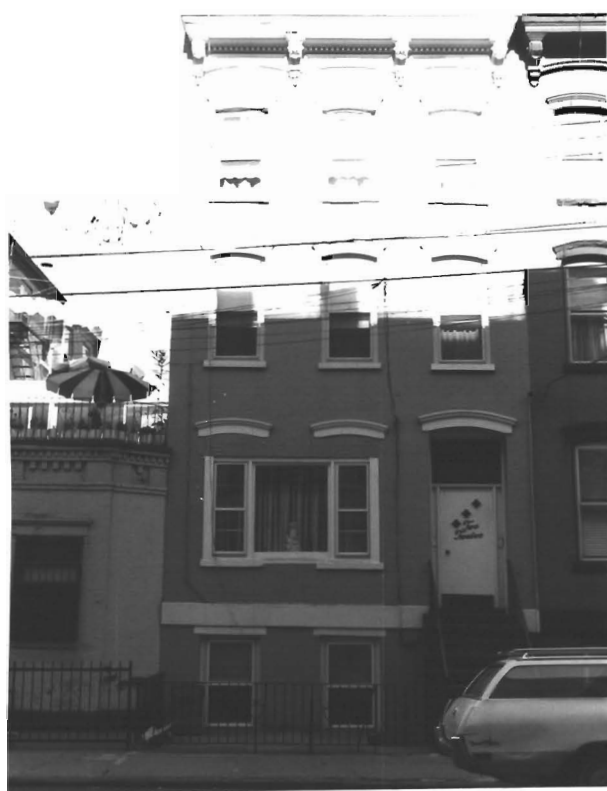
(Garden to Park Ave.)  
212 Ninth St.  
neg. # 15-36

206-12 - four 3X3 italianate row houses with intact segmental arch lintels and wood console bracketed and denticulated cornices. Intact cast iron rail and fence at 208. Altered 1st story window at 212 - but old lintels remain - all have basement entries under front steps.

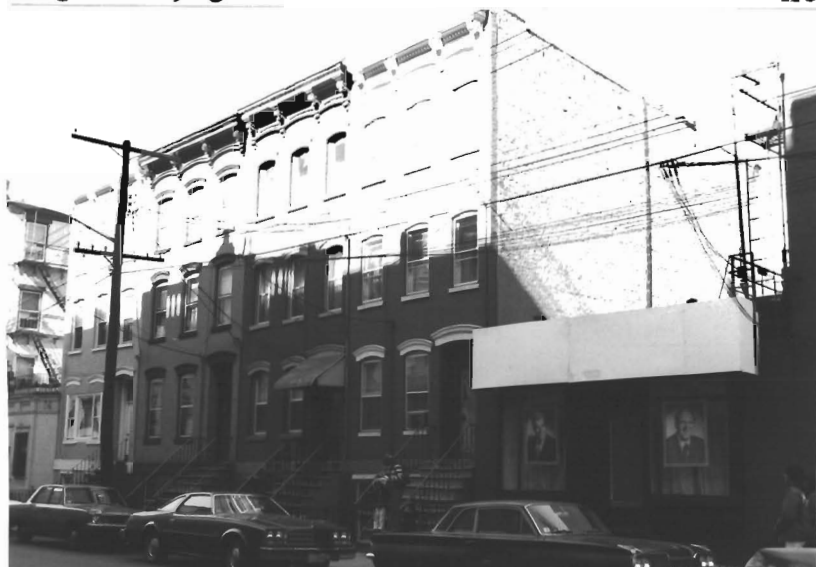
214, 212, 210, 208, 206, 204 Ninth St.  
neg. # 15-34

204 - 1 story storefront - cornice intact behind plywood cover

214 - connected to store (1 story)

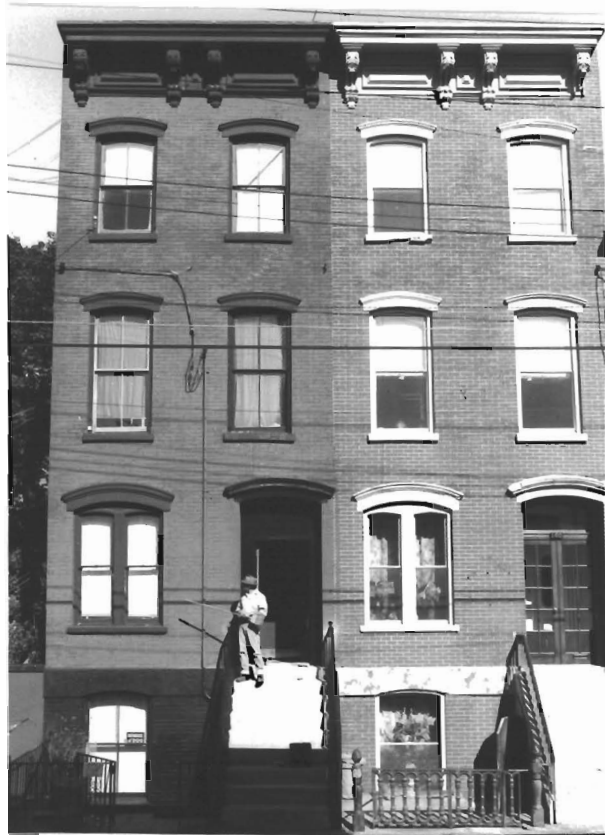
(Bloomfield to Garden Sts.)  
162,160 Ninth St.  
neg. # 15-30

160-62 - 2 matching 3X2 row houses with segmented arch lintels. First story in each has paired segmented arch window under large lintel. Only inside door and fence of 160 are intact. console brackets in cornice.

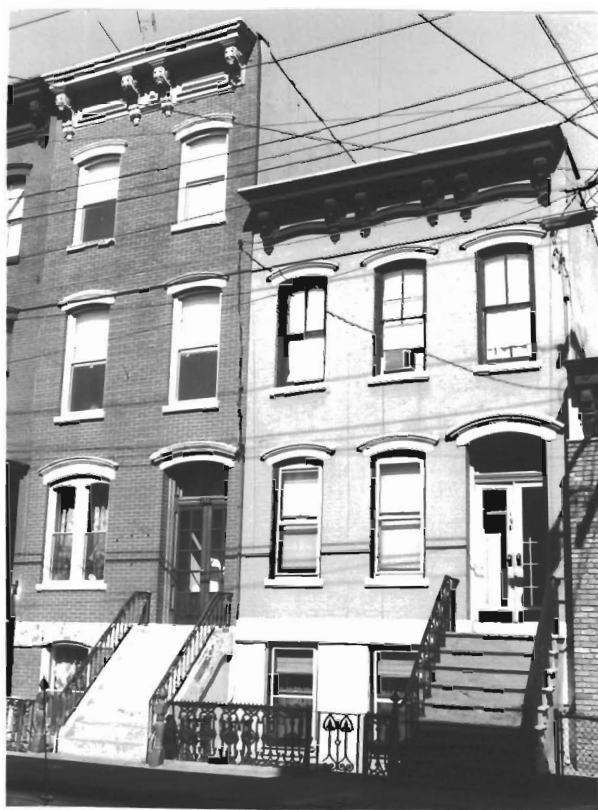
160,158 Ninth St.  
neg. # 15-29

158 - 2X3 italianate which is almost wholly intact (with exception of gate on fence). 1st story aluminum storm windows. Intact segmental arch lintels, arched frieze panels between cornice console brackets.

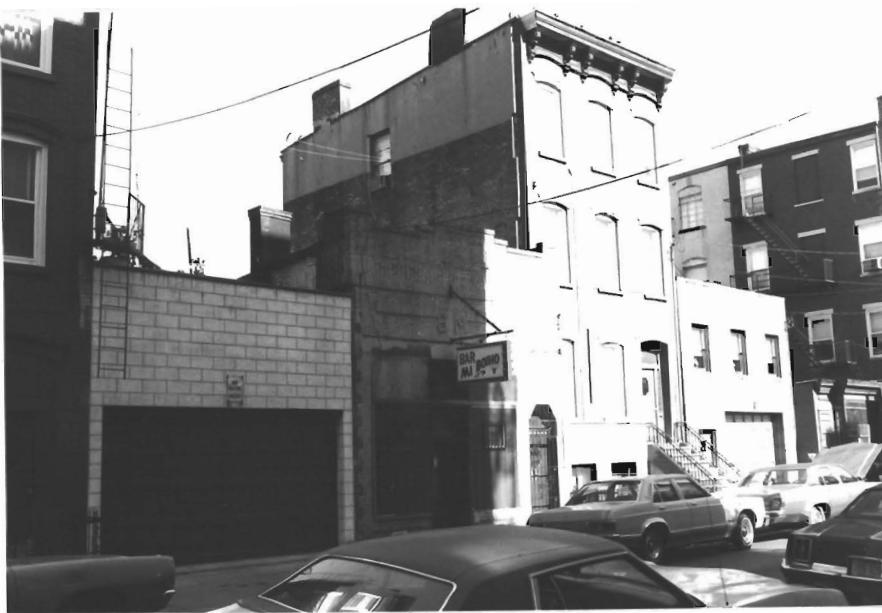
(Park to Willow Aves.)  
262,260,258,256 Ninth St.  
neg. # 16-2

256 - 2X3 brick veneer with garage in 1st story

258 - 3X3 italianate with deteriorating segmental arch - brownstone lintels and wood console bracketed cornice.

260 - 1 story MI BOIHO Bar - yellow brick with parapet

262 - 1 story garage - stuccoed to look like concrete block

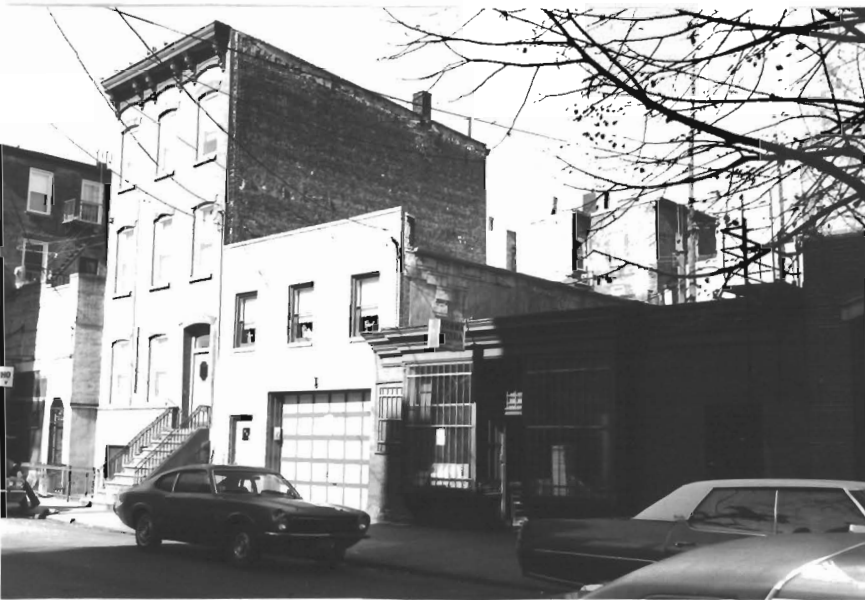
260,258,256,254 Ninth St.  
neg. # 16-1

254 - 1 story intact storefront - bars on windows - Torna Pizzeria

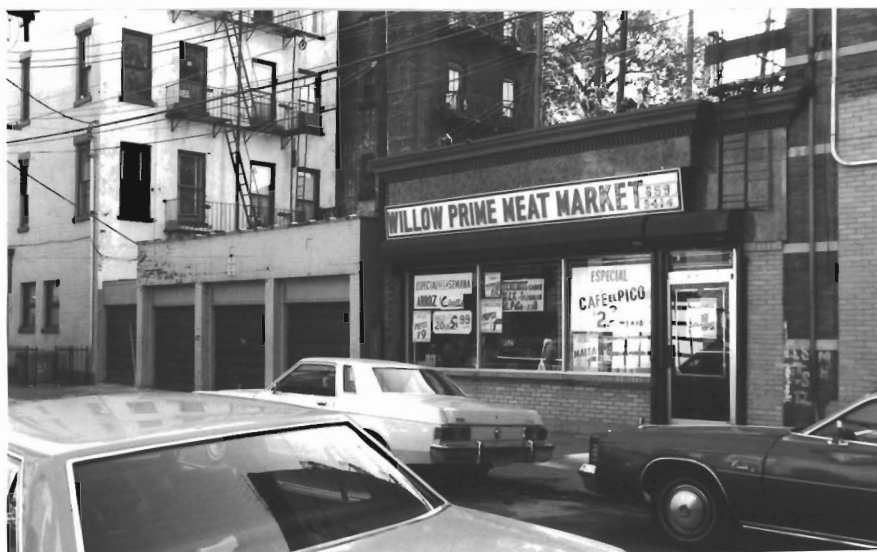
(Park to Willow Aves.) 253,255 Ninth St.  
neg. # 16-3

253 - 4 bay - 1 story brick garage

255 - 1 story - partially intact storefront, cornice  
Willow Prime Meat Market

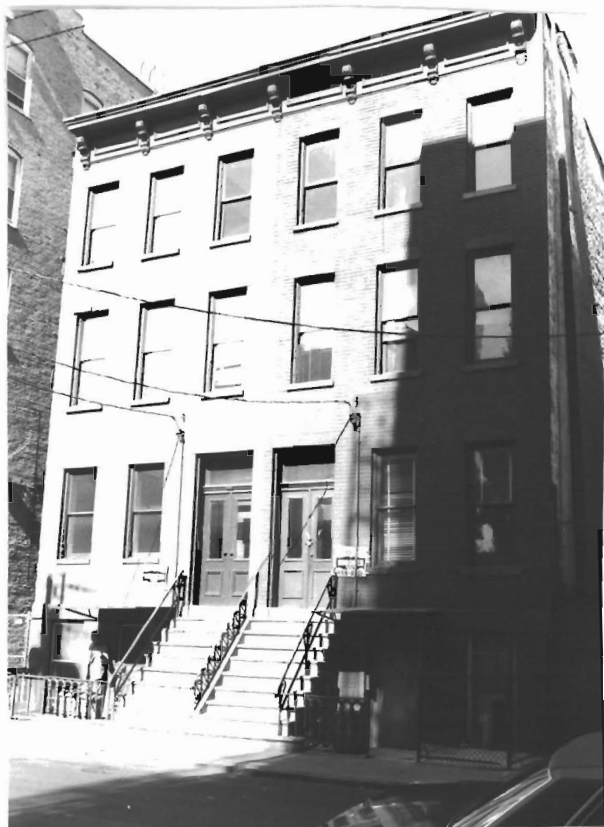
(Willow to Clinton St.)  
310,318 Ninth St.  
neg. # 16-4

308-10 - two 3X3 vernacular italianates with high basements.  
Flat, flush brownstone lintels. Applied false brick on 308.

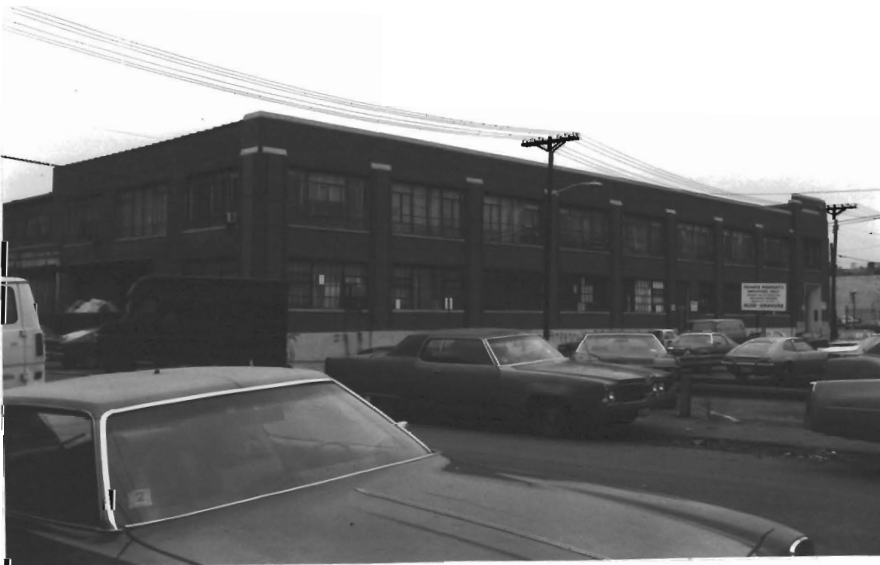
Taller section (2stories) at North end matches middle, single story section.

South portion is brick office wing on Ninth Street.

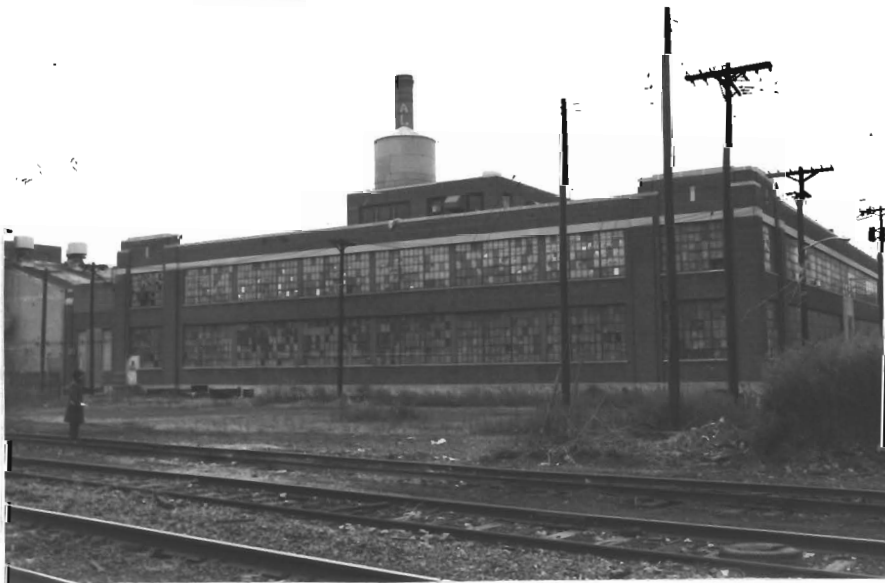
Fenestration: Factory sash - many broken windows on West side along shore line tracks.

Clerestories in North wing.

Brick section at South is probably earliest and appears to be 30's moderne (streamlined style).

Large plant with impressive size and features - such as - roof-top clerestories (sawtooth roof) in paper storage area and finish of stone copings and courses in brick portion.

Many broken windows on West side, along shore line tracks (Erie Railroad).
