CHURCHES
LOCATED ON GARDEN STREET

NEW JERSEY OFFICE OF HISTORIC PRESERVATION HISTORIC SITES INVENTORY #12
STREETSCAPE SURVEY FORM

STREET NAME: Garden Street
MUNICIPALITY: Hoboken

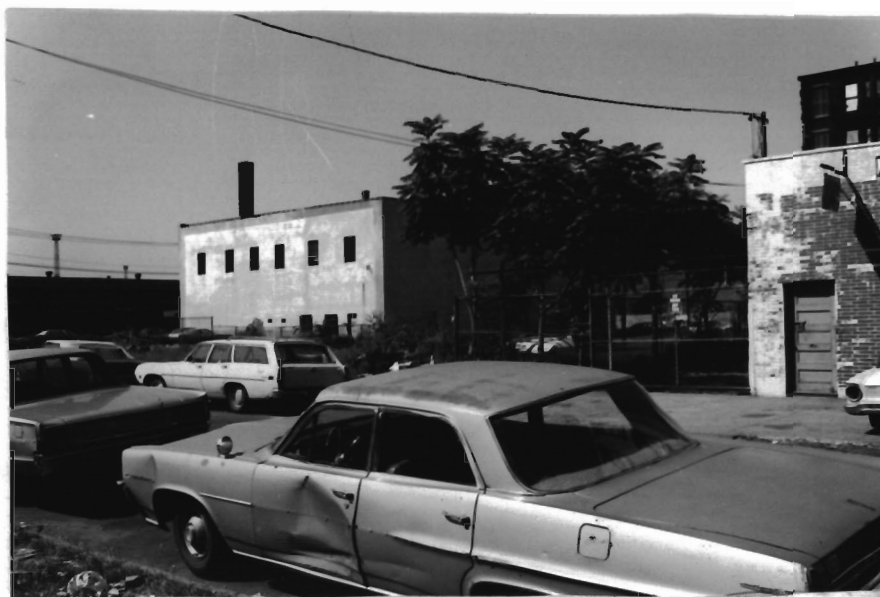
Observer Highway to Newark
(Vacant)
neg. #: 7-1

7 residential buildings remain with intact storefronts on WEST SIDE of Street.
At least 1/2 of the two sides of the street (mostly the portion along the Highway) are vacant.

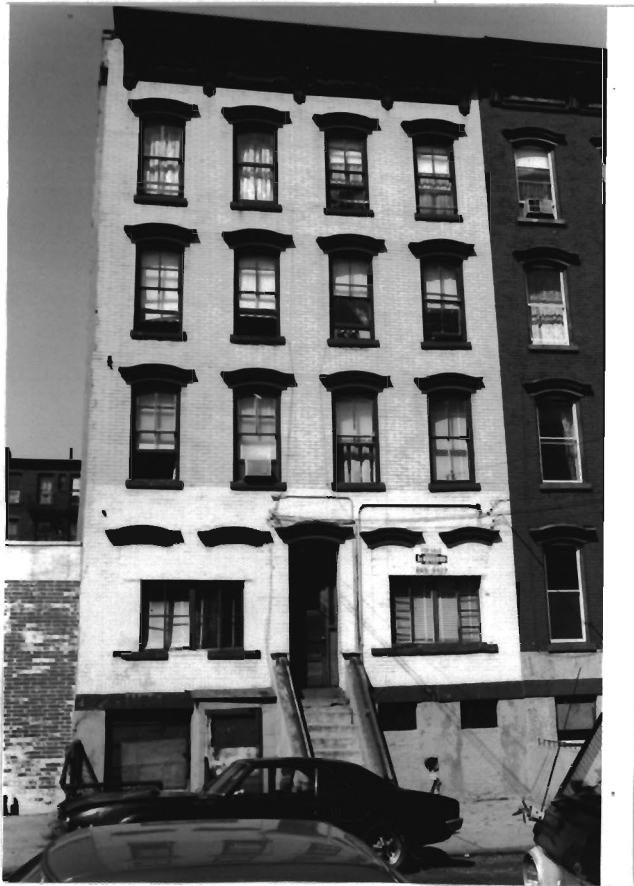
72 Garden Street
neg. #: 7-3

- 70 - garage
- 72 - 4 story x 4 bay residential - brick, altered 1st storey window
- 74 - 4x4 brick
- 76 - wood frame with asphalt (false brick) sheathing - storefront intact
- 78 - brick - storefront intact - "Galaad Pentecostal Church, Inc."

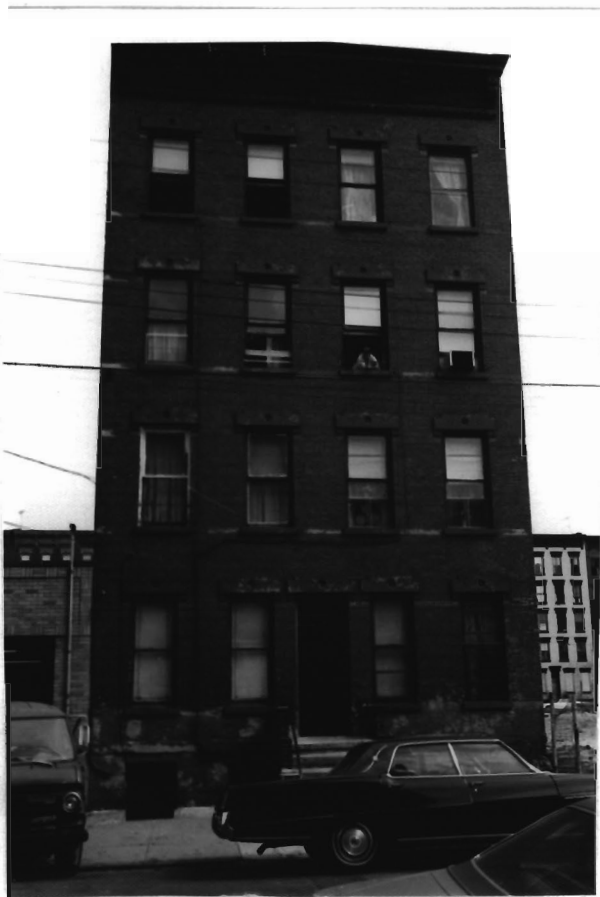
73 Garden Street
neg. #: 9-1

73,77,79 - residential - brick 4 story x 3 bays - intact cornices.
77,79 have intact rail and fences - 75 garage

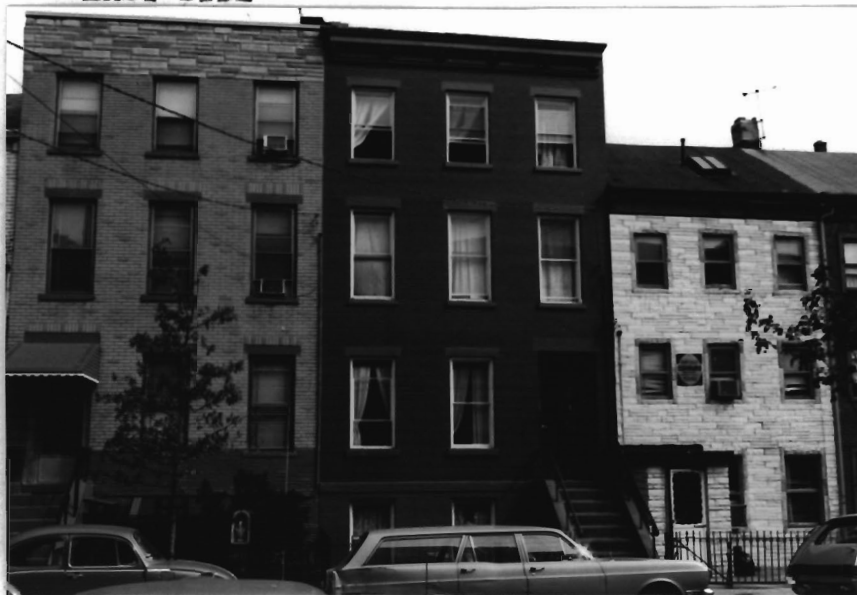
117, 115, 113 Garden St.
neg. # 9-9

- 111-113 - Two smaller scale buildings - 111 with tin false brick sheathing - 113 permastone. Roof beams visible, obviously in poor condition.
- 115-117 - 3 x 3 - original stone but latter altered with false brick and permastone.

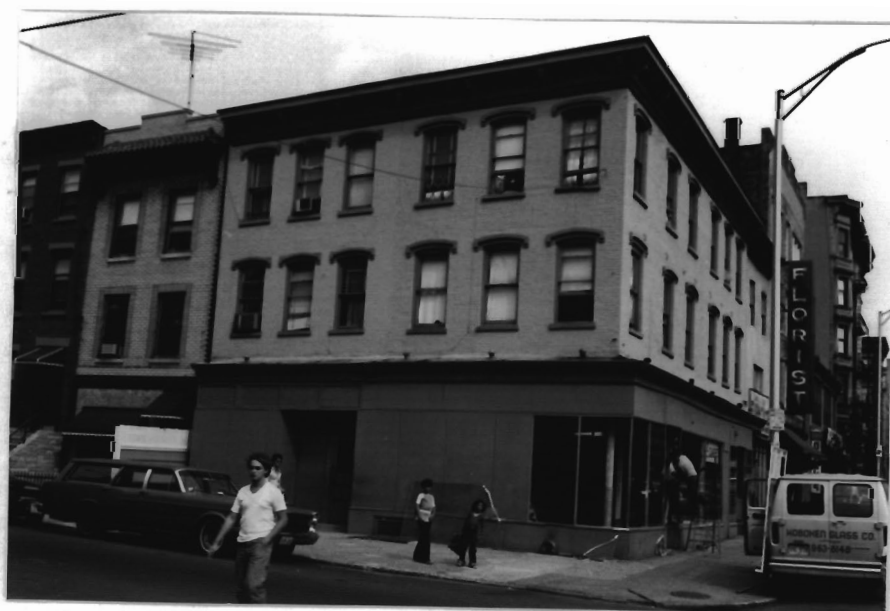
105, 103-101 Garden St.
neg. # 9-7

- 101-103 - Intact cornice on building of double width with storefront cornice.
- 105 - White brick with green Spanish tile, (3 x 3)
- 107-109 - Brick double row house, each 3 x 3 with high basement.

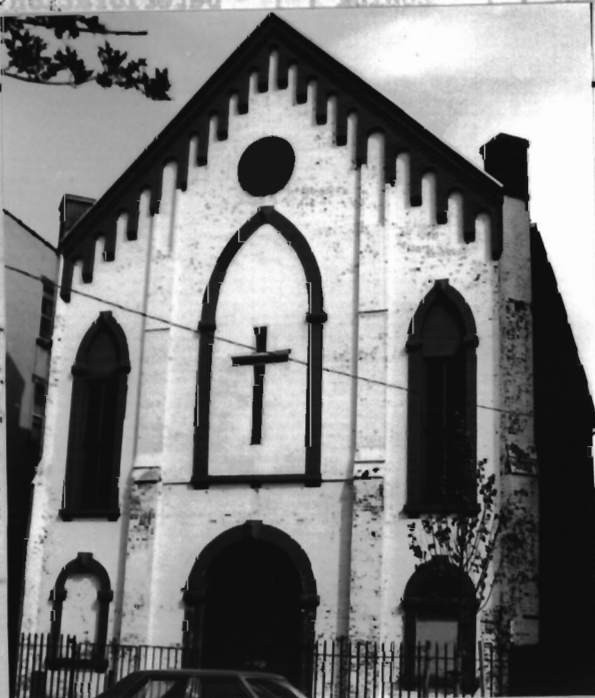
HISTORIC NAME: St. Matthew Baptist Church **COMMON NAME:** (private home)

Exterior Wall Fabric: Red and white painted brick, stucco

Fenestration: Two small bays flank large one; 5 bays on side with buttresses

Arched fenestration on first and second floors; arches round first story, pointed on second; lancet window at center obviously filled in.

Note diagonal axis of corner buttresses.

Exterior badly needs paint

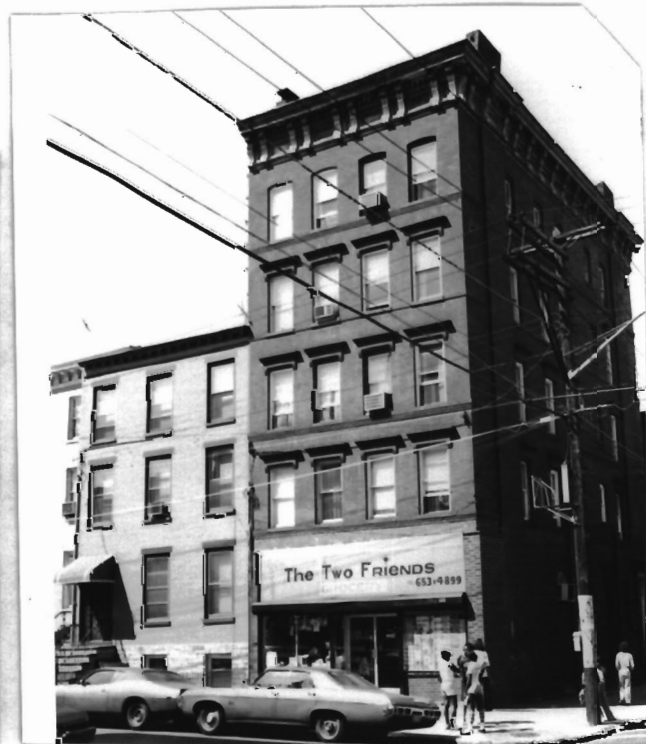
238, 240 Garden St.
neg. # 7-24

- 238 3x3 closer to street than 204-34 units. Intact cornice with modillions.
- 240 5x4 Italianate with altered S.F. (The Two Friends); heavy second and fourth story lintels; segmental arch fifth story lintels and massive console bracketed cornice

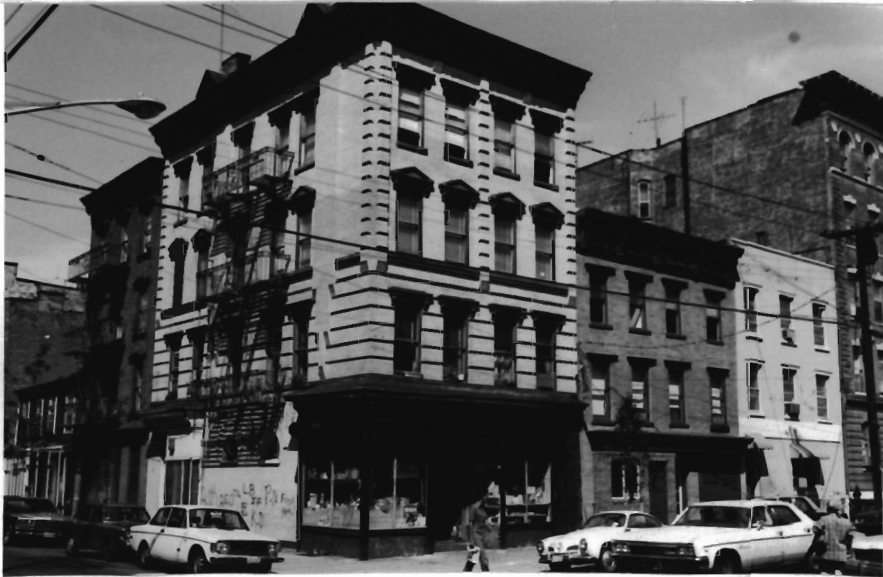
300, 302-4, 306 Garden Street
neg. #: 7-25

- 300 Elaborate 4x4 Italianate with five bays on Third Street. Intact
S.F. cornice, with display galss somewhat altered. Small S.F. also
at left rear. Fire escape on Third Street. Brown (painted?) bands
in second story brick. Heavy bracketed lintels in second and fourth
stories that is corbelled out above second story pediment lintels
in third story. Cornice has two steep pediments facing Third Street.
- 302,04 3x4 Italianate with altered first story on left (302) side but
intact garage door at right. Lower cornice. Intact lintels. Massive
bracketed cornice with modillions.
- 306 3x3 altered first story; intact lintels, cornice removed.
- 308,10 5x4 Classical Revival apartment building. The "Theresa", with
horizontal rusticated joints in brick at first story

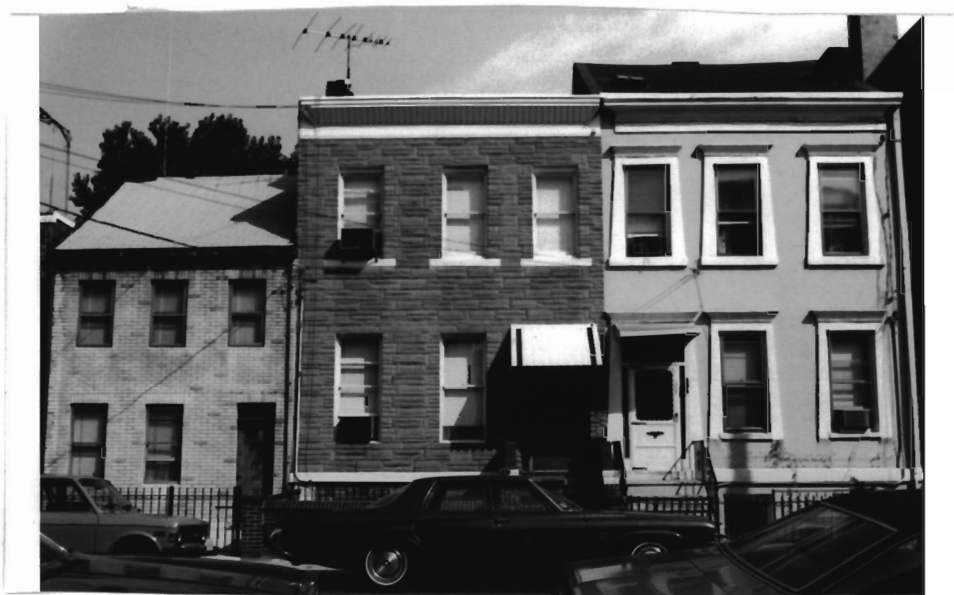
327, 325, 323 Garden Street
neg. #: 9-27

- 301-21 David E. Rue School (see individual form) with fenced yard at
323,25 Two 2x3 units. Original styling is uncertain. 323, has Egyptian
esque "pylon" effect around windows and doorway and a sloping
roof. Intact cornice. 325, is perma stone with a new cornice
replacement in modern materials and a flat roof.

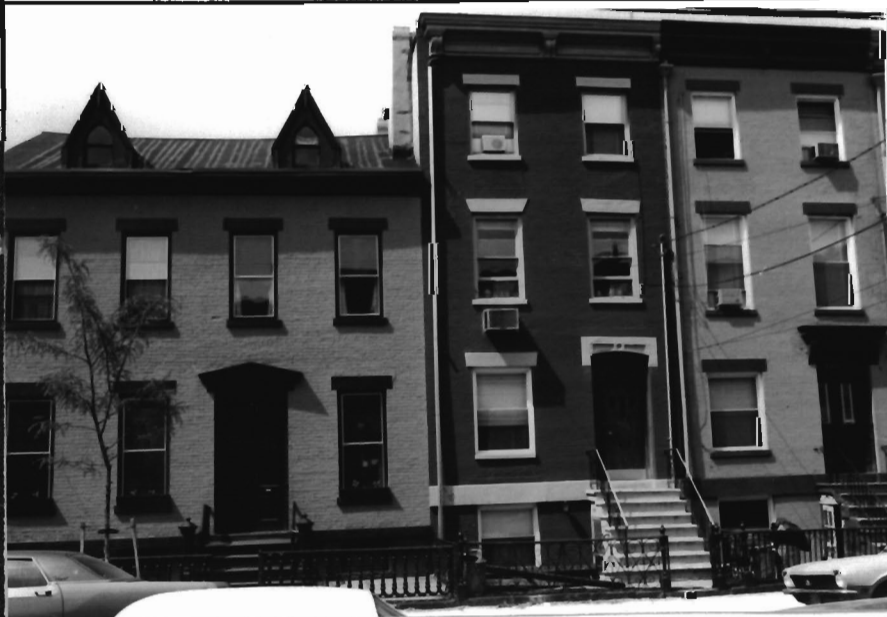
Next to church yard - three story row buildings abut rectory on north side

Roof sags in middle - may need major repair

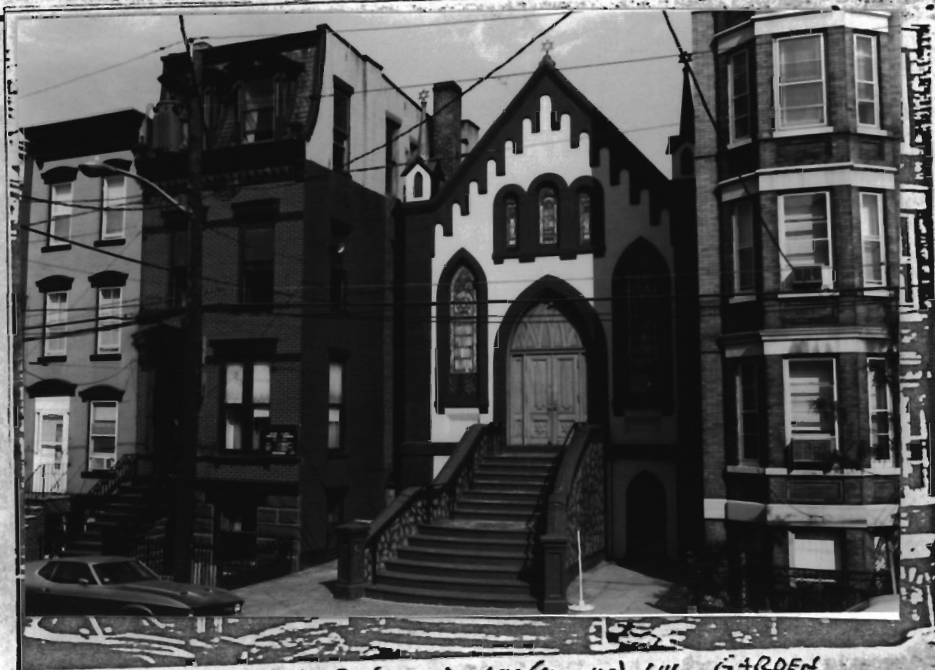
HISTORIC NAME: Congregation Adas Emuno
LOCATION: 637 GARDEN STREET

Original interior windows are intact and in excellent condition.

Very high ceiling in its original round shape.

A unique structure in which the Gothic Revival Style was used for non-Christian use. The building is an excellent example of the Gothic Revival Style and retains all of its original features. Housed the oldest Jewish congregation in Hudson County. Founded on October 22, 1871.
