Located on Hudson Street

NEW JERSEY OFFICE OF HISTORIC PRESERVATION HISTORIC SITES INVENTORY # 30-30

INDIVIDUAL STRUCTURE SURVEY FORM

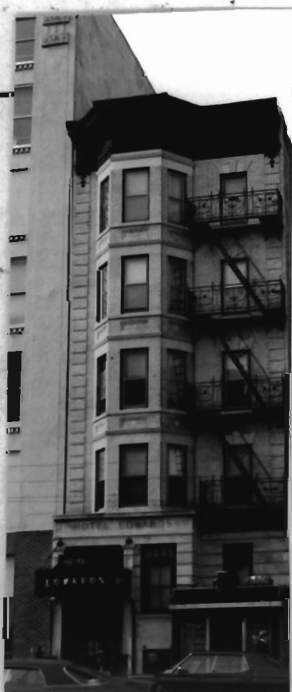
photo:
11-22-78

Additional Architectural Description: 1st story limestone with horizontal rustication suspended canopy over door. Quoin-like brick projecting along outer edge on first story. Intact, ornamental wrought-iron fire escape. To the right is the "ladies entry," in black glass.

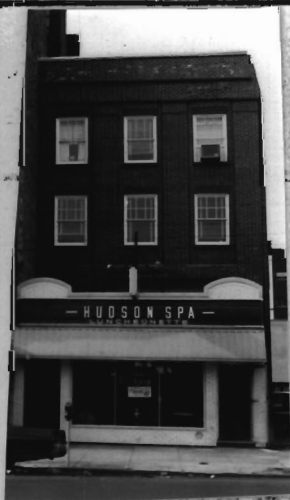
photo: 44-22-78

Hudson Spa Luncheonette is a white, glazed brick addition that projects out from 1st story. It is quite likely that there is historical precedent for such 1st story projecting storefronts, present one may be expanded version of the original. Brick pilasters surround flank three bays in second and third stories.

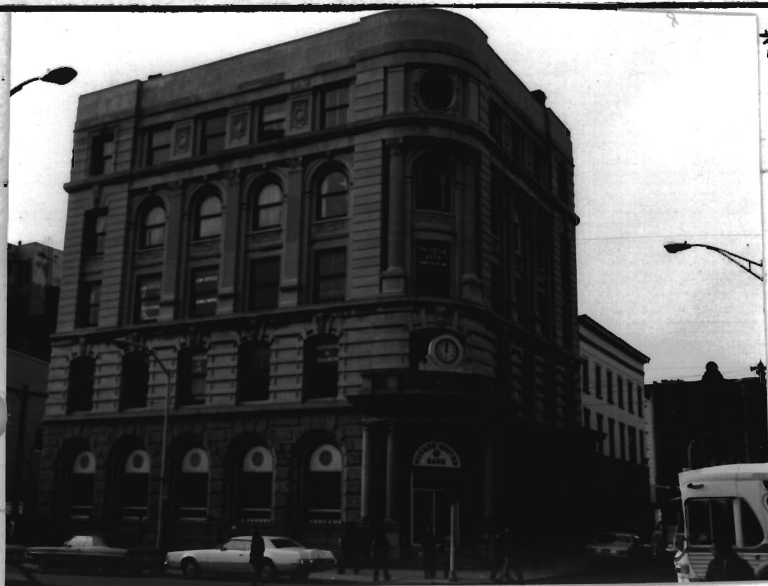
photo: 11-22-78

Fenestration: Double hung sash. Openings are found arched in first and fourth stories; (J.S.) segmental arched in second, and flat topped in third and fifth. The east

Additional Architectural Description: The building has a rounded corner with (J.S.) paired Tuscan columns to each side of the door and support a curved entablature with a balustrade and a round clock above. The first story has rough, rusticated blocks; the second has a smooth surface with raised courses. The third and fourth stories have 2 story composite orders. The end bays and the space between the corner and side bays have rusticated stone surfaces. Three plasters are on the east side, two on the north. Recessed half columns flank the single corner window. The third story is shorter than the rest with similar location of rusticated stone, panels over the pilasters and Tuscan half piers over the columns. A round window is in the corner bay. A parapet appears to have replaced a cornice.

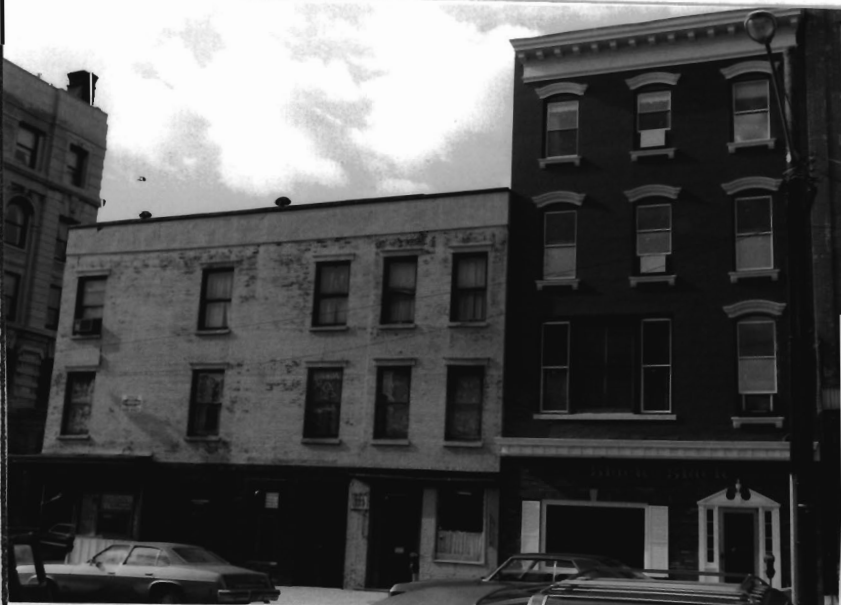
#90

segmental arched windows, footed window sills, handsome cornice with modillions

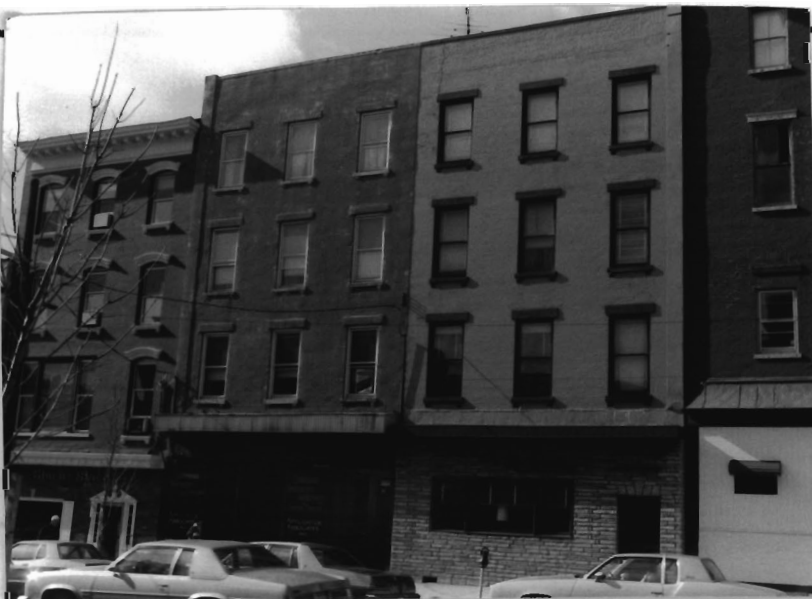
92 has a covered storefront cornice, 94 storefront altered w. permastone, neither has a cornice, lintels on #94 are flat, flush, those on #92 are covered.

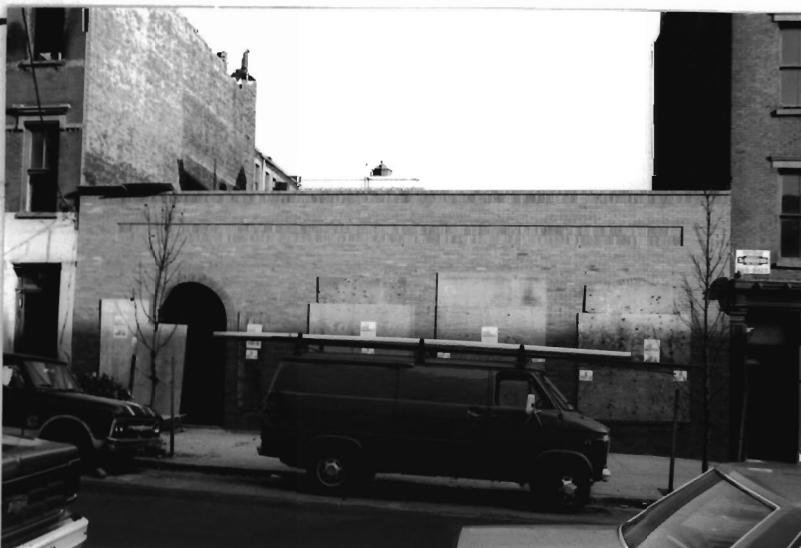
photo: 11-20-78

1978 refacing of a concrete fronted printing house; parapet with recessed panel just below that, stretches across facade. Attempt to match scale of storefronts^w adjacent four storey Italianates to either side is fairly successful, but style has no similarity.

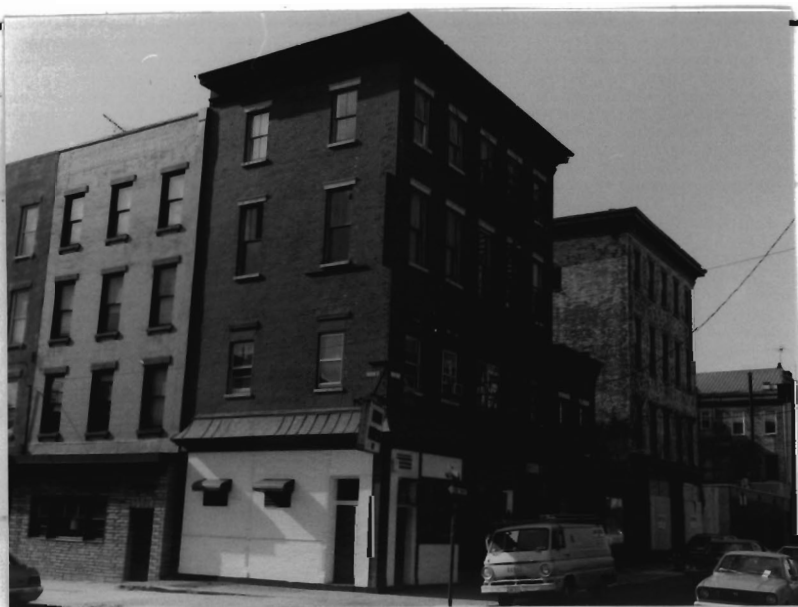
storefront has pagoda-like roof replacing cornice; 2 storey addition at rear

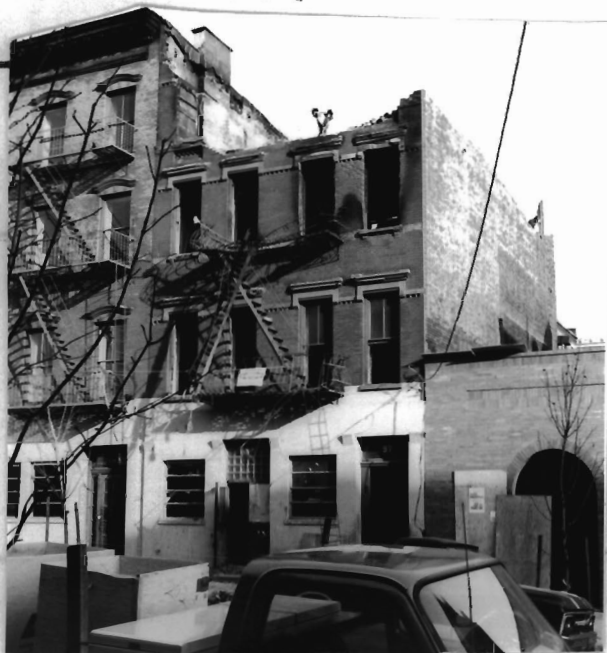
photo: 11-20-78

1st storey completely altered with stucco, glass block, and large pane jalousie window sash. Brick course with corner-out patterning at lintel level on 2nd storey through top; curved wrought-iron fire escape

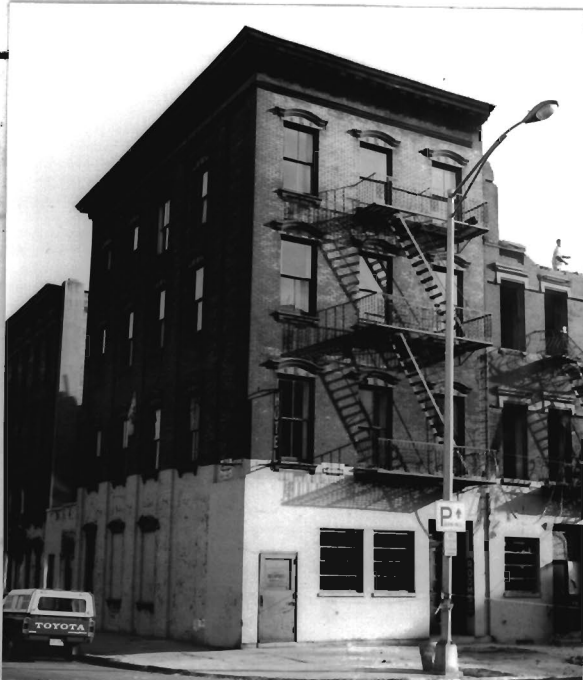
photo: 11-20-78

1st storey is concrete stucco with large-paned jalousie window-sash. The side facade has four bays, w. 3 windows in the 1st storey that are bricked up. The 1st storey is painted white to match the stuccoed front but the brick is intact. A 1-storey, 1-bay extension is at the rear on the 1st St. facade. Fire escape on front facade; cornice has modillions and dentils.

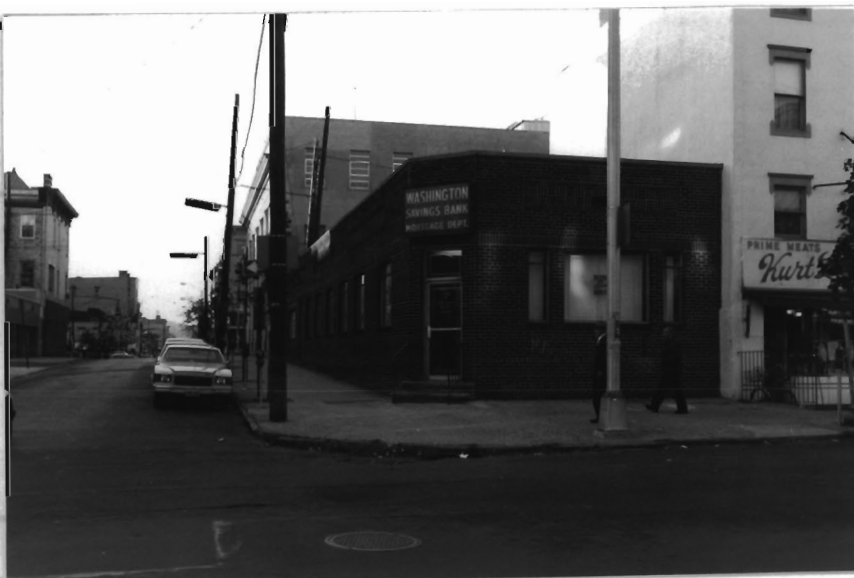
Photo: 10-30-78

HISTORIC NAME:**LOCATION:** 100 Hudson**COMMON NAME:** Washington Savings Bank**BLOCK/LOT:** 212 B/1**MUNICIPALITY:** Hoboken**COUNTY:** Hudson**OWNER/ADDRESS:****ORIGINAL USE:** Comm.**PRESENT USE:** Comm.**USGS QUAD:****DESCRIPTION****Construction Date:** C 1930 ?**Source of Date:****Architect:****Builder:****Style:****Number of Stories:****Foundation:****Form/Plan Type:****Structural System:** steel frame (?)**Exterior Wall Fabric:** Brown Brick**Fenestration:** Fixed Windows**Entrance Location:** Corner**Roof/Chimneys:** Flat**Additional Architectural Description:** Utterly plain with bevelled entry and parapet.

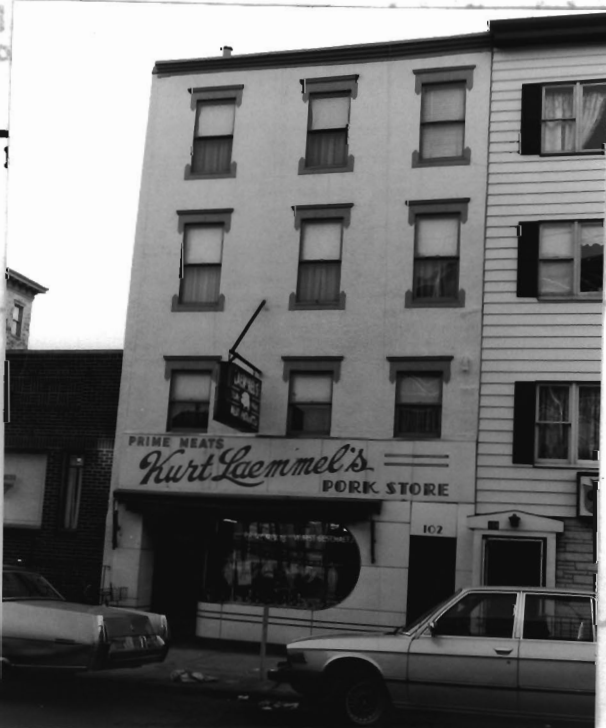
photo: 10-30-78

Drip moulding lintels that are pointed at ends and reversed (point upward) in sills.

Curved glass in storefront where sheathing is enamelled metal panels.

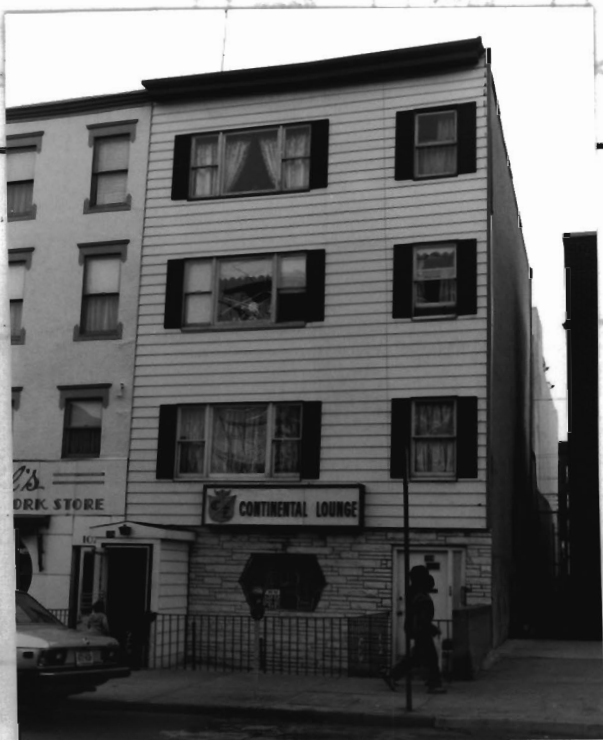
photo: 10:30-78

six-sided window in 1st story.

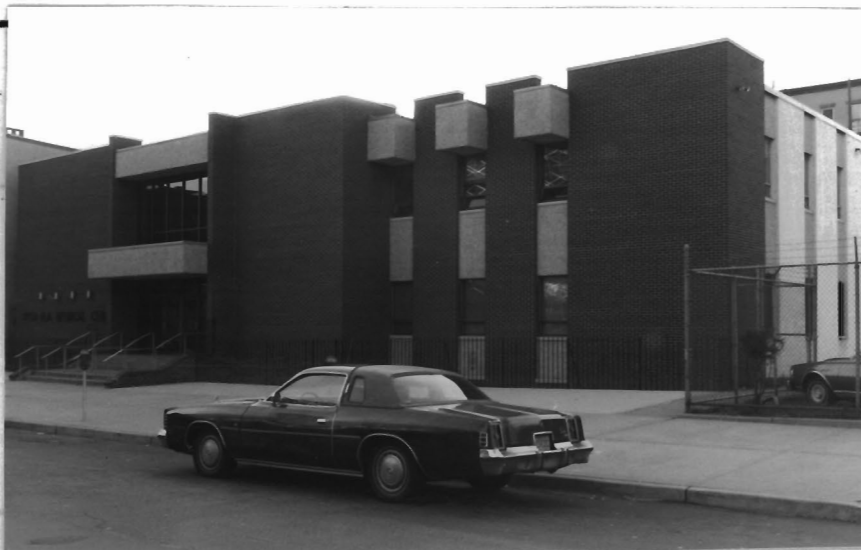
photo: 10-30-78

Additional Architectural Description: Protruding overhangs at entry and over 2nd story windows at right.

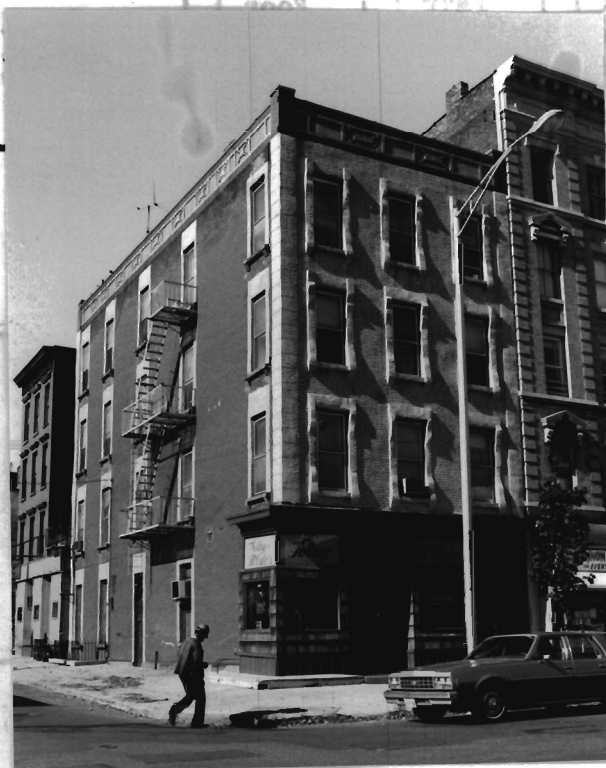
photo: 10-24-78

HISTORIC NAME:**LOCATION:** 200 Hudson**COMMON NAME:** Foley and McCabe's Bar**BLOCK/LOT:** 213 A/1**MUNICIPALITY:** Hoboken**COUNTY:** Hudson**OWNER/ADDRESS:****ORIGINAL USE:** Comm./Res.**PRESENT USE:** C/R**USGS QUAD:****DESCRIPTION****Construction Date:****Source of Date:****Architect:****Builder:****Style:** Altered**Number of Stories:****Foundation:****Form/Plan Type:****Structural System:****Exterior Wall Fabric:** Brick (side wall) and applied false brick (on front and around side windows) w/stuccoed front window surrounds and corner quoins.**Fenestration:** 3 Bays - Metal double-hung**Entrance Location:****Roof/Chimneys:****Additional Architectural Description:** Storefront altered with shingles but cornice and transoms are intact.

Art deco detailing in band at top of building which is done in lighter (yellow) brick.

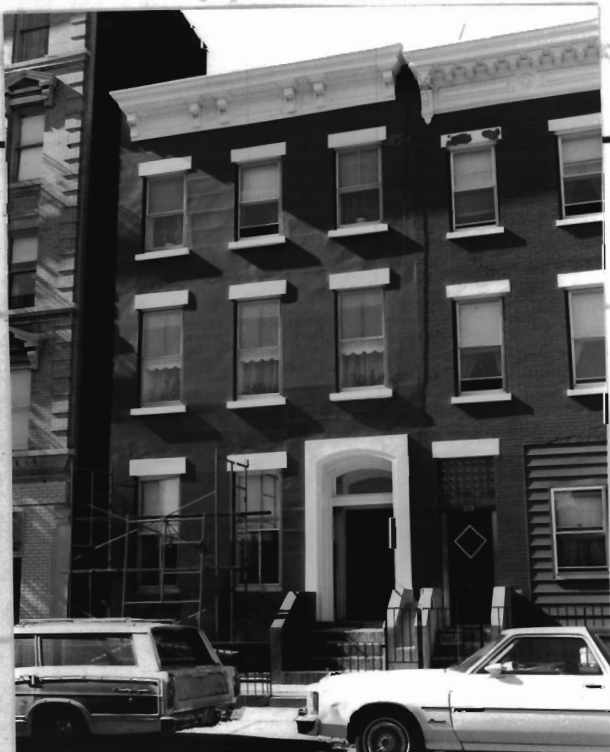
photo: 10-24-78

Additional Architectural Description: All detailing trimmed flush.
Entry has 2 intact transoms.
Intact (wood?) cornice.

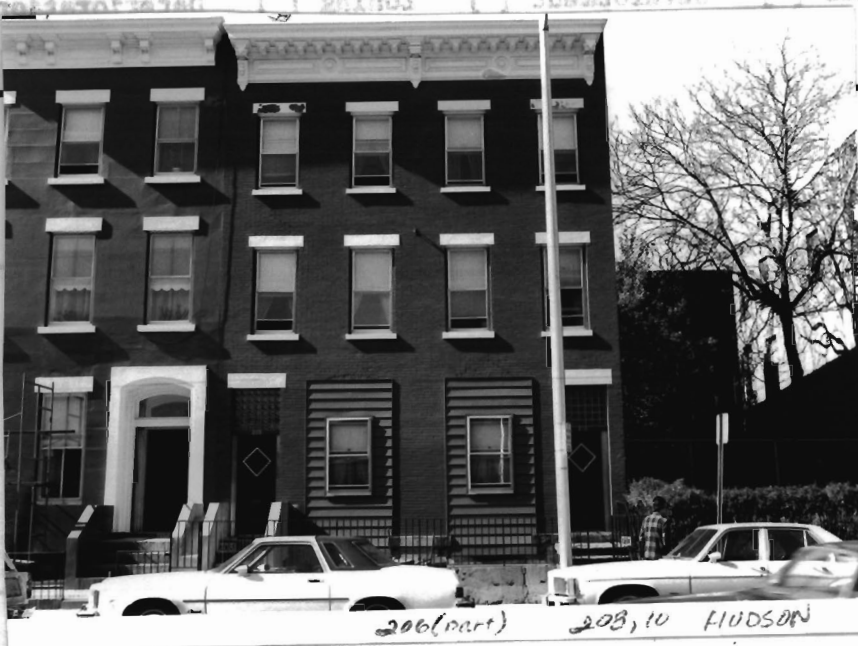
208(part) 208, 10 HUDSON

Additional Architectural Description: 2 Units - 2 bays each - share intact 1st story fenestration altered w/horizontal siding - water line brownstone causing broken at sections wunder window. Top of brick arch visible behind the new siding (see references - other side).

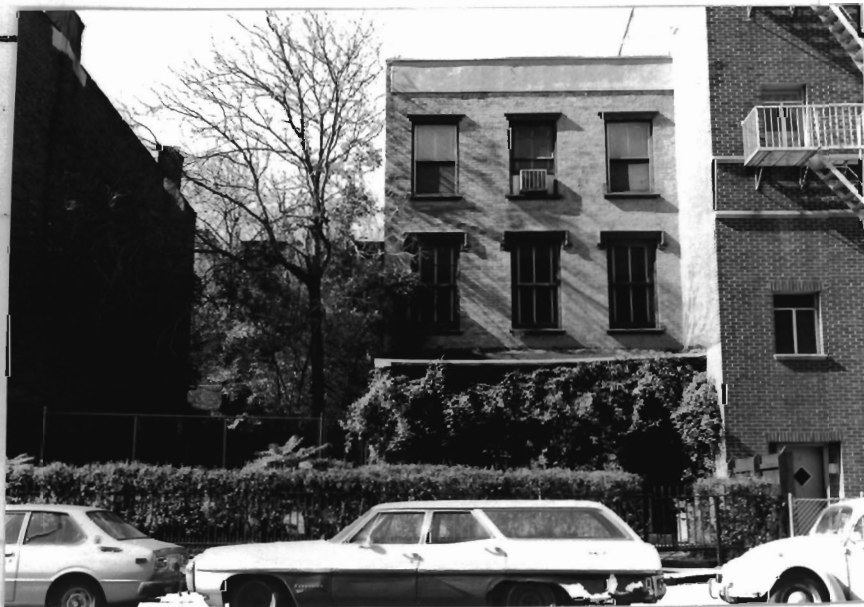
photo: 10-24-78

Intact fence may be original.

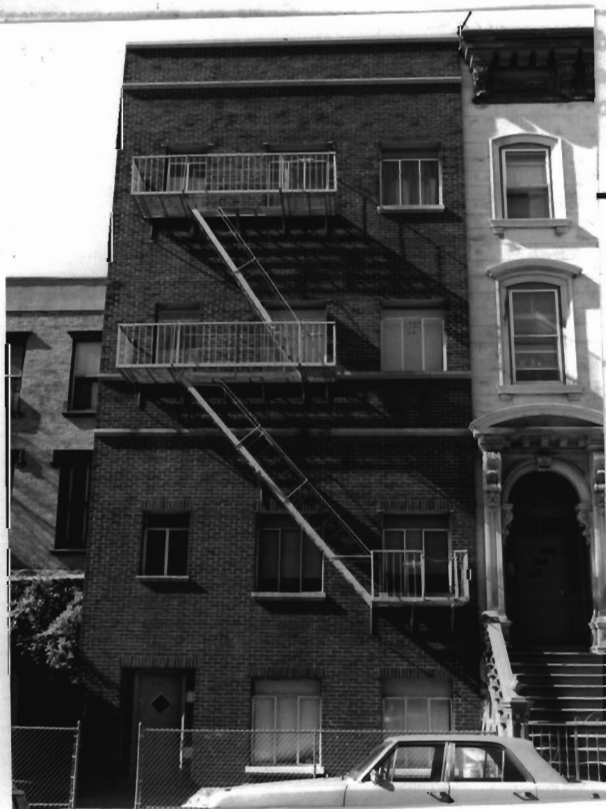
Additional Architectural Description: Completely altered fire escape.

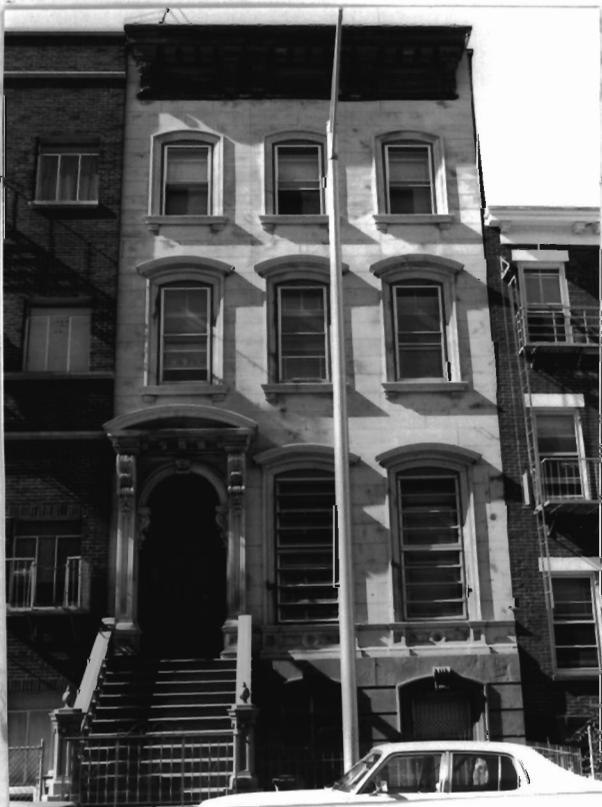
photo: 10-24-78

Additional Architectural Description: Fine intact baluster on front steps consoles over basement windows, massive console bracketed segmental arch pediment over entry (door altered). Full window surround w/seg. arch lintels. Intact cornice in deteriorated condition.

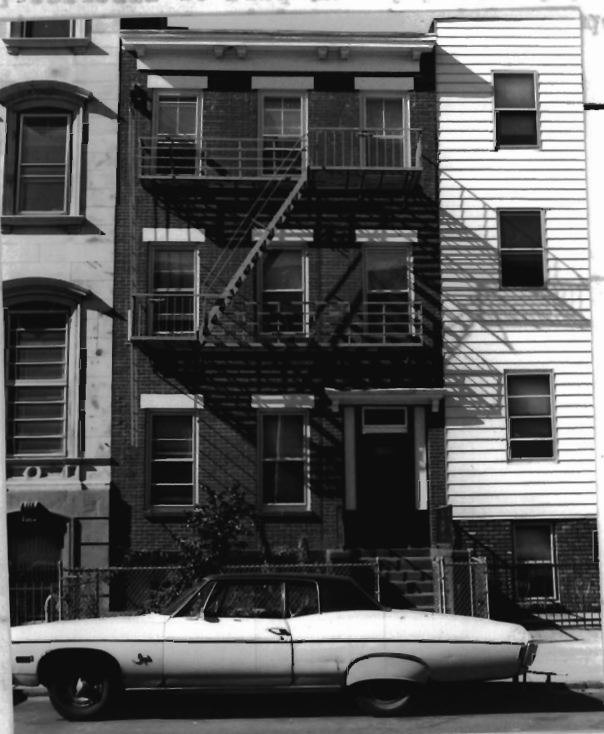
photo: 10-24-78

USGS QUAD:**DESCRIPTION****Construction Date:****Source of Date:****Architect:****Builder:****Style:** Italianate**Number of Stories:** 3**Foundation:****Form/Plan Type:****Structural System:****Exterior Wall Fabric:** Brick**Fenestration:** 3 Bays, metal double hung sash - 2 over 2 wood behind metal storm in 3rd).**Entrance Location:****Roof/Chimneys:****Additional Architectural Description:** Only intact lintel is over entry
Fire escape
Intact wood cornice**MAP (Indicate North).**

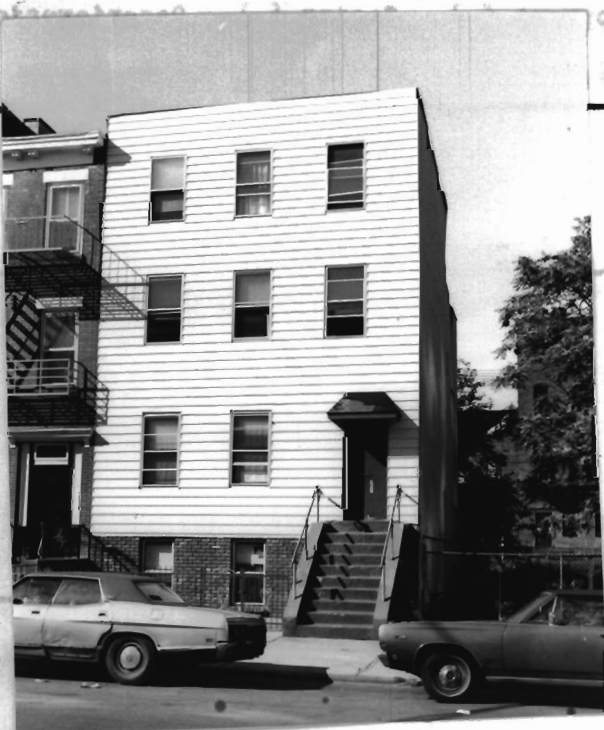
photo: 10-24-78

Additional Architectural Description: Applied false brick in basement

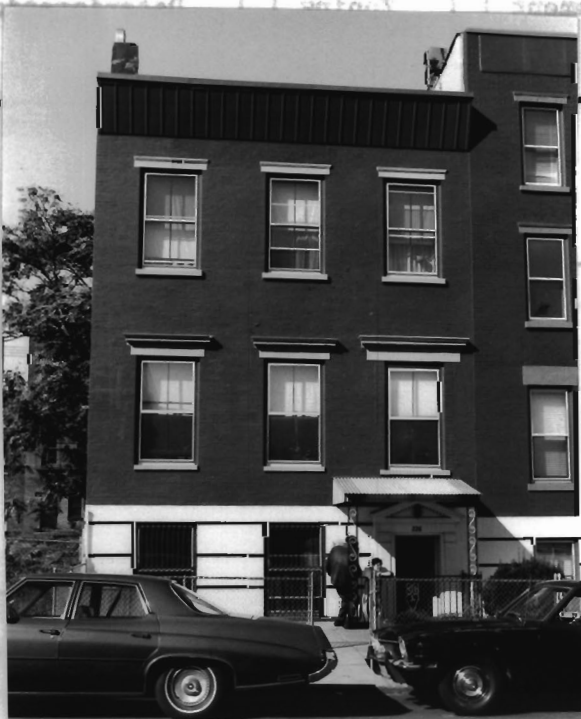
photo: 10-24-78

USGS QUAD:**DESCRIPTION****Construction Date:****Source of Date:****Architect:****Builder:****Style:** Altered Italianate**Number of Stories:** 2 W/Basement**Foundation:****Form/Plan Type:****Structural System:****Exterior Wall Fabric:** Brick**Fenestration:** 3 Bays, 2 wood double-hung window intact behind metal windows**Entrance Location:** In Basement (Altered)**Roof/Chimneys:****Additional Architectural Description:**Mock-colonial enframement in basement
Covered cornice (verticle metal sheathing)

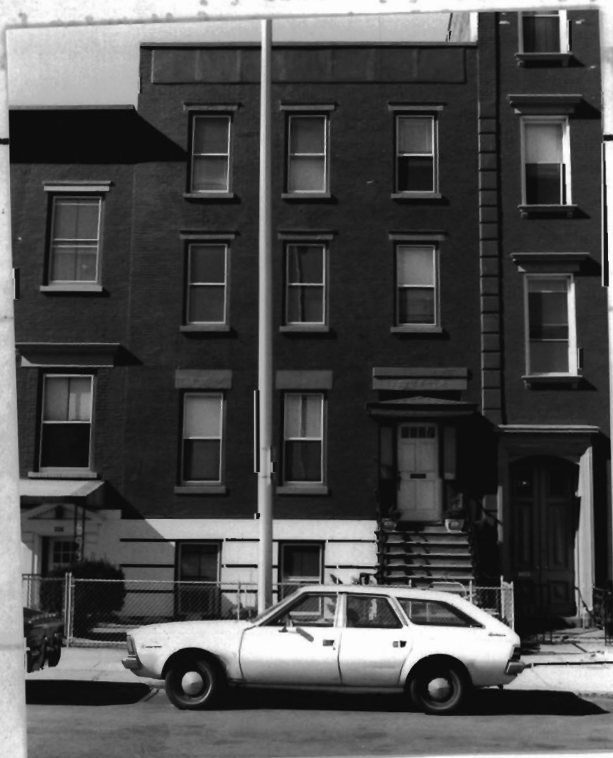
photo: 10-24-78

Additional Architectural Description: Doorway altered with pagoda - shaded hood
Flat lintels trimmed flush in 1st story,
intact in 2nd and 3rd.
Cornice removed.

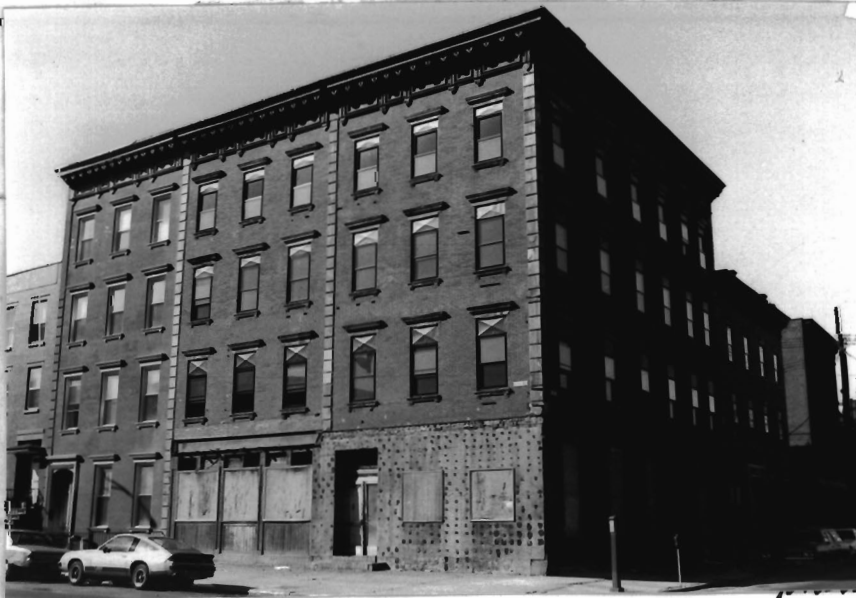
10-24-78

232-32 First story stripped w/wood around window intact at 232 - Recently (1978) steam-cleaned. All cornices intact (wood). Quoins at ends of and between units. Building of 3 stories on 3rd behind 234 also steamcleaned at same time.

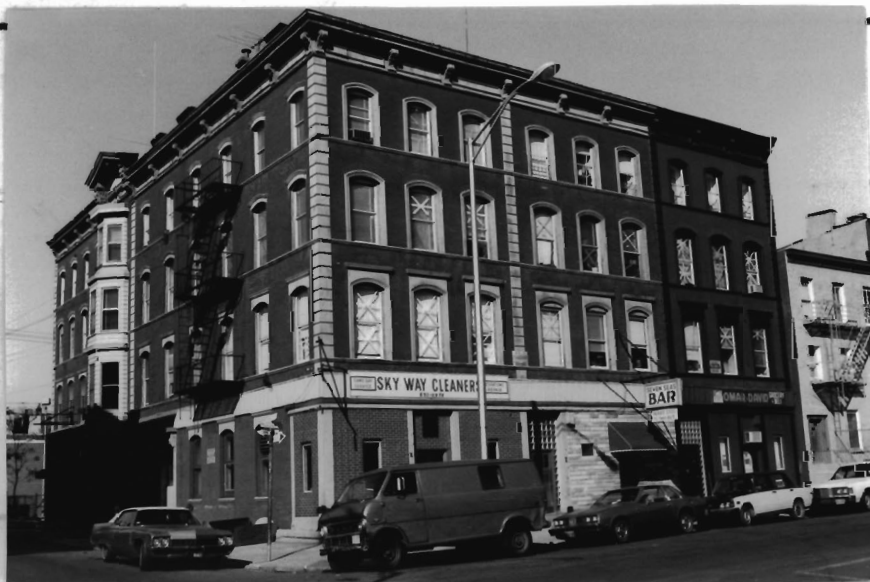
photo: 10-20-78

Additional Architectural Description: First story altered along Hudson St. with brick. At 300 & 304 and perma stone at 302 very fine intact detail on 3rd Street 1st story. Storefront cornices have been removed, but cast iron pillars are intact and visible. Quoins separate the three units and also at corners. Intact cornices (metal). Trim painted gray at 300,02 and brown at 304. Refaced (horizontal siding) over on 3rd street side with pediment overhead over cornice. Major alterations to brick portion of first story along 3rd St.

Very fine example of Italianate that is in good to excellent condition above 1st story. The fact that it matches 230,32,34 makes for a fine unified streetscape on the west side of Hudson St. at 3rd Street.

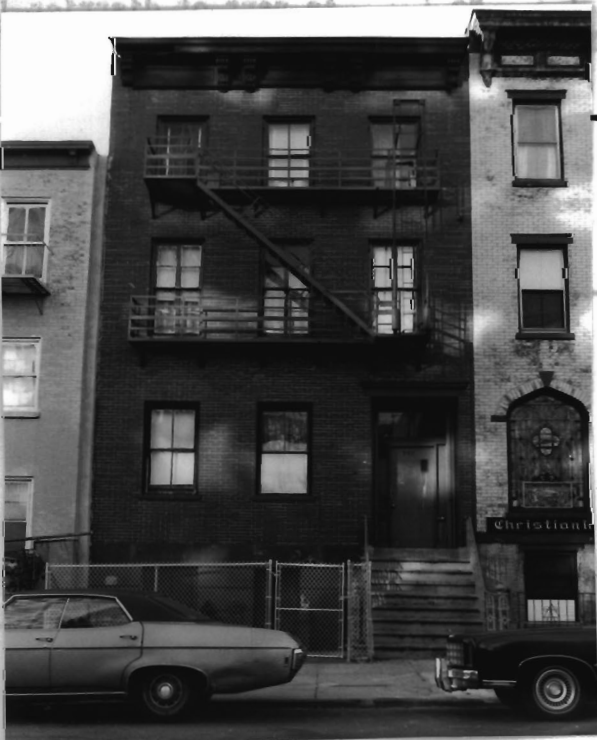
photo: 10-20-78

HISTORIC NAME:**LOCATION:** 308 Hudson St.**COMMON NAME:****BLOCK/LOT:** 214 A/31**MUNICIPALITY:** Hoboken**COUNTY:** Hudson**OWNER/ADDRESS:****ORIGINAL USE:** Res.**PRESENT USE:** Res.**USGS QUAD:****DESCRIPTION****Construction Date:****Source of Date:****Architect:****Builder:****Style:** Italianate**Number of Stories:** 3**Foundation:****Form/Plan Type:****Structural System:****Exterior Wall Fabric:** Brick**Fenestration:** 2 over 2 wood double hung - those in 2nd story have heavy mullions that make windows look like casements.**Entrance Location:****Roof/Chimneys:****Additional Architectural Description:** Intact entry but new door
Fire escape
Intact, bracketed cornice**MAP (Indicate North)**

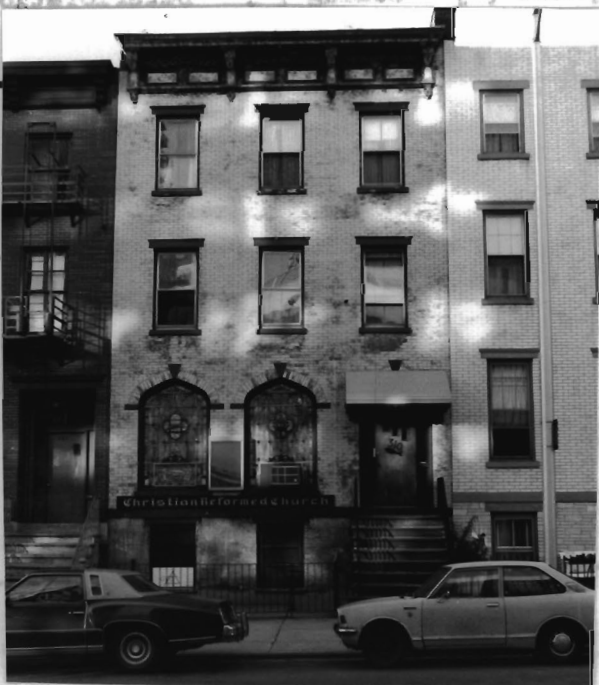
photo: 10-20-78

HISTORIC NAME:**LOCATION:** 310 Hudson**COMMON NAME:** Christian Reformed Church**BLOCK/LOT:** 214 A/30**MUNICIPALITY:** Hoboken**COUNTY:** Hudson**OWNER/ADDRESS:****ORIGINAL USE:** Res.**PRESENT USE:** Shurch**USGS QUAD:****DESCRIPTION****Construction Date:****Source of Date:****Architect:****Builder:****Style:****Number of Stories:****Foundation:****Form/Plan Type:****Structural System:****Exterior Wall Fabric:****Fenestration:** 2 over 2 wood, double hung in 2nd & 3rd stories, stained glass in pointed arched opening in 1st & 2nd story**Entrance Location:****Roof/Chimneys:****Additional Architectural Description:** Altered door & sidelights, (pointed).
Arched transom.
Intact, peeling metal cornice.

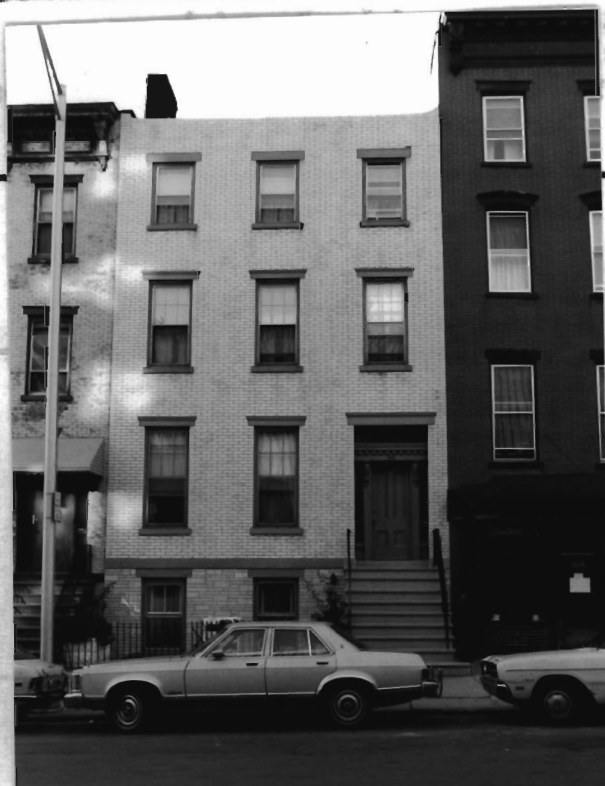
photo: 10-20-78

USGS QUAD:**DESCRIPTION****Construction Date:****Source of Date:****Architect:****Builder:****Style:** Altered (Greek Revival)**Number of Stories:** 3 W/high basement**Foundation:****Form/Plan Type:****Structural System:****Exterior Wall Fabric:** PermaStone in Basement, applied false brick above**Fenestration:** 6 over 6 wood frame w/intact flat lintels in 1st & 2nd stories**Entrance Location:****Roof/Chimneys:****Additional Architectural Description:** Elaborate entry w/sidelights & tansom as well as consoles and dentils.

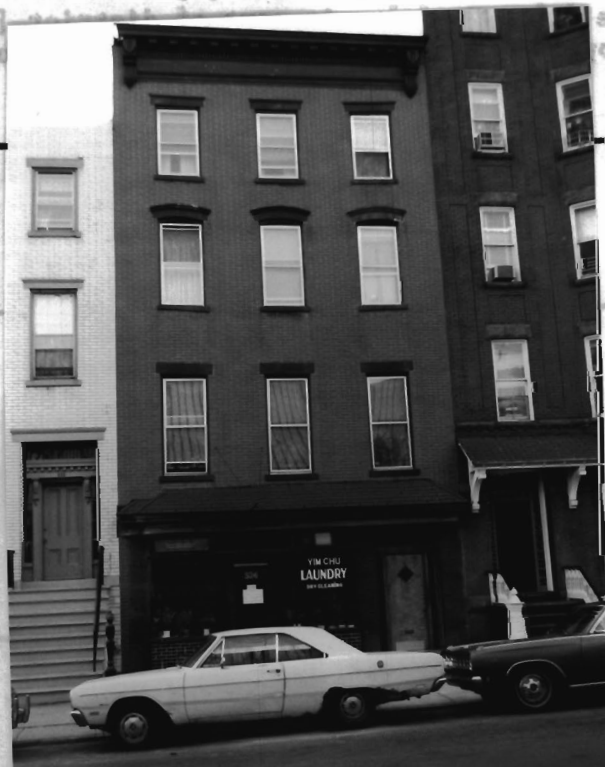
photo: 10-20-78

Segmental arch lintels (intact) in 2nd.

Intact metal cornice with modillions and dentils.

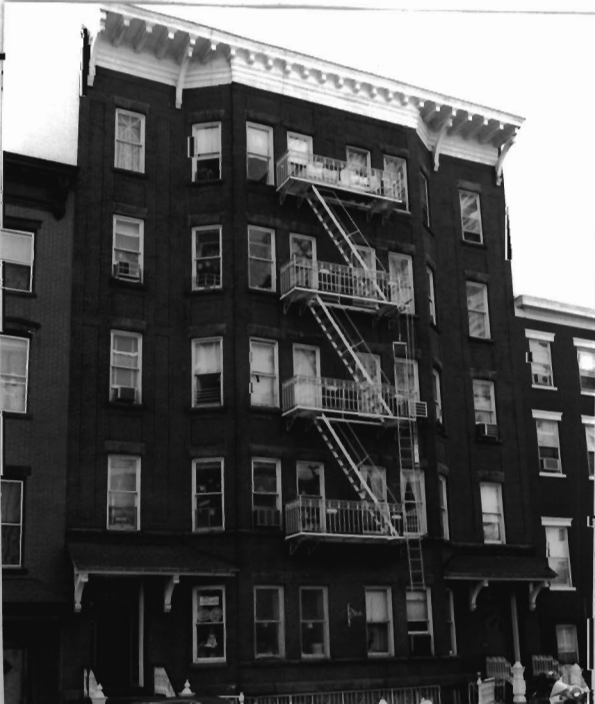
photo: 10-20-78

Additional Architectural Description: Entries to this double apartment house are at each end with bracketed shed hoods. Intact stair rails along with portions of fencing and (possibly) the fire-escape. Facade is eight windows across with six in the central bay that the 2 units share. Impressive bracketed cornice at top. A brownstone course runs along at sill level in the second story. Glass block surrounds doors.

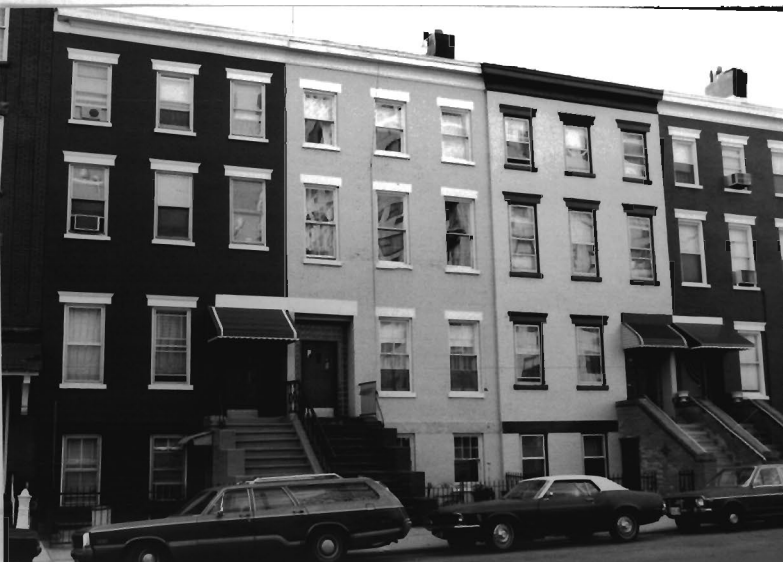
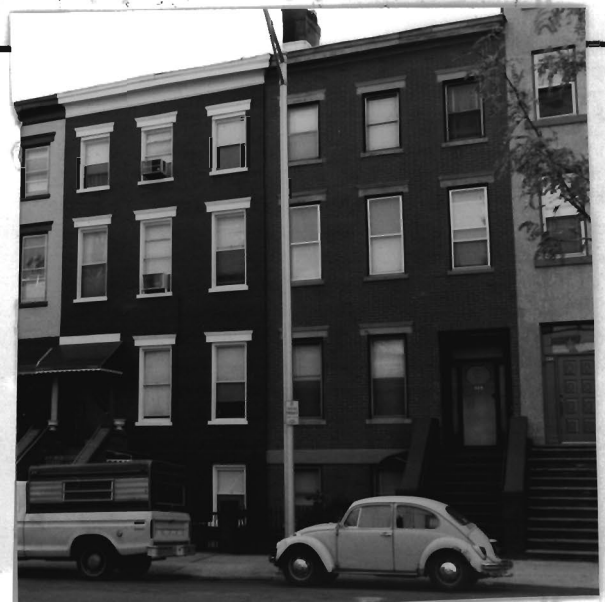
photos: 10-20-78

Additional Architectural Description: 5 3 x 3 rowhouses. All door lintels shaved. Stair partially intact at 320, 22, 28. Portion of cast iron stair rail intact at 320-22. All windows lintels intact except at 322. Simple wood cornices, w/friezes that are simply. Painted brick w/wood strip at bottom. No intact doors - 332, 34, 36 have glass block.

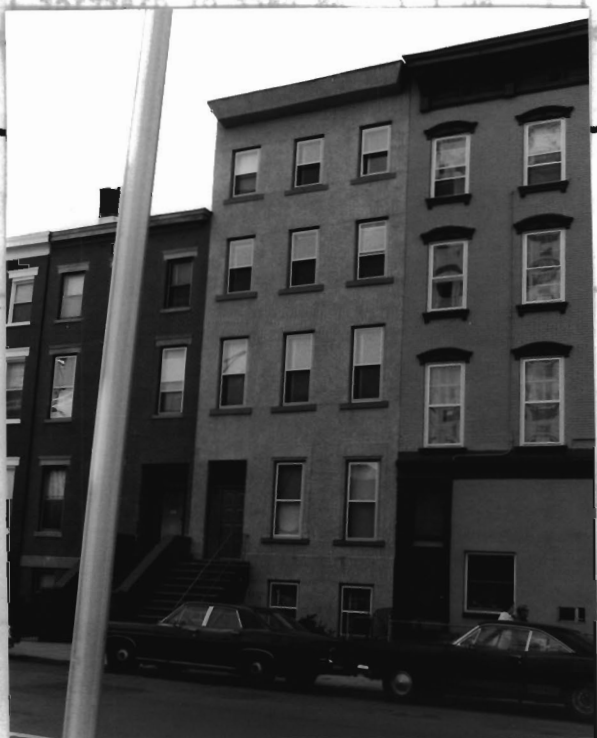
photo: 10-20-78

Additional Architectural Description: Only sills intact (orange)
Cornice covered in stucco w/pebbles.

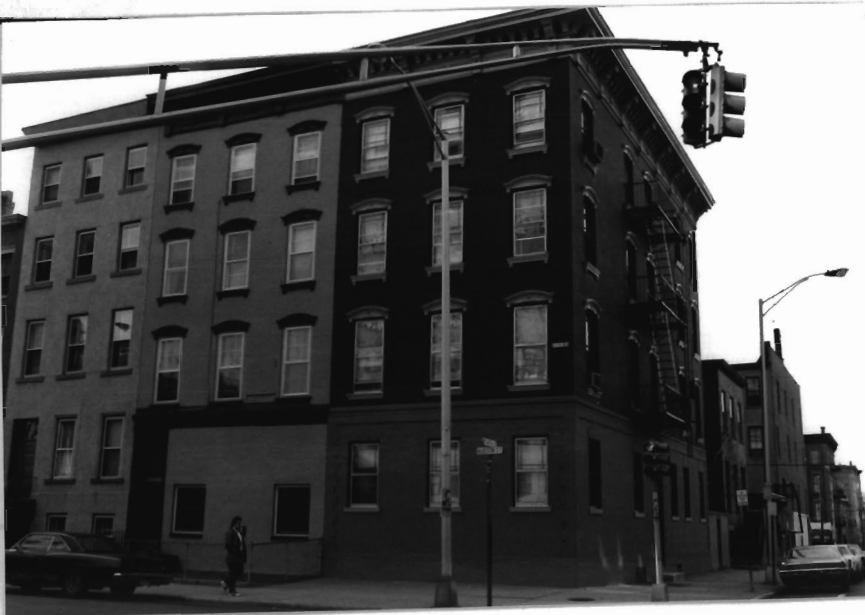
photo = 10-20-78

Additional Architectural Description: 2 matching facades, both altered in 1st story.
Doorway at 332, remains intact.
Large bracketed and modillions cornices.
334 has applied quoin and voussoir details in 1st story.

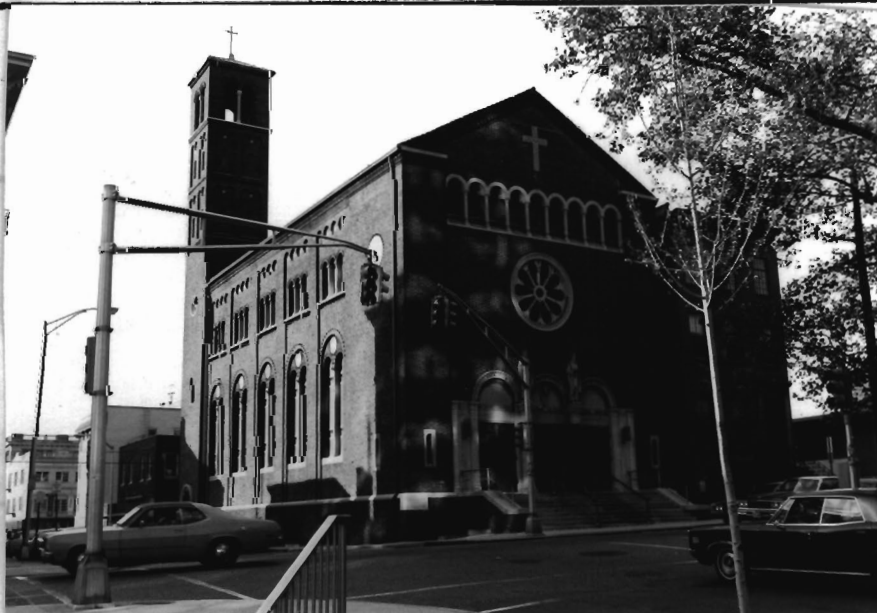
SS. PETER & PAUL Church (R.C.)

2 Columns flank center of 3 entries and have statutes of Saints on each.
 Blind arcade over doors
 Rose window in 2nd Story
 Arcade with arches beneath eave returns in cable end
 Bronze stair rails and lamps
 Tower at left rear

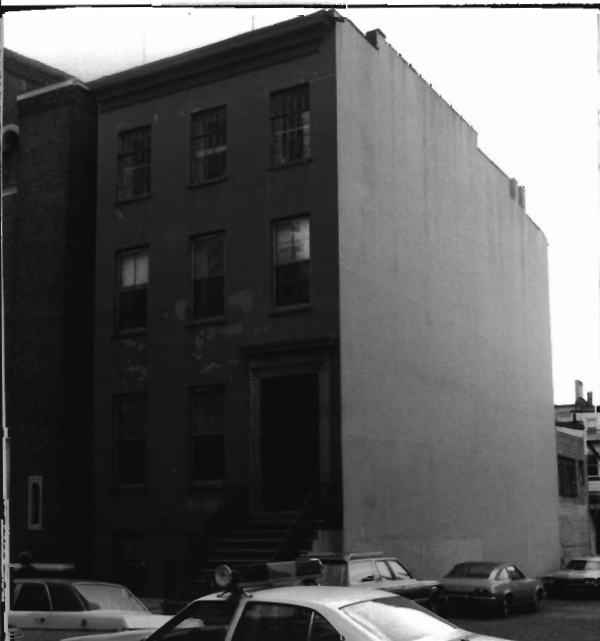
During the summer of 1980, the spalling brownstone of the entry was covered over with brown brick, the front steps were resurfaced with slate, and the cast-iron railing was removed and replaced with a simple, modern railing; the door's entablature remains intact, as does the brownstone door enframement, although both are largely obscured by the alteration.

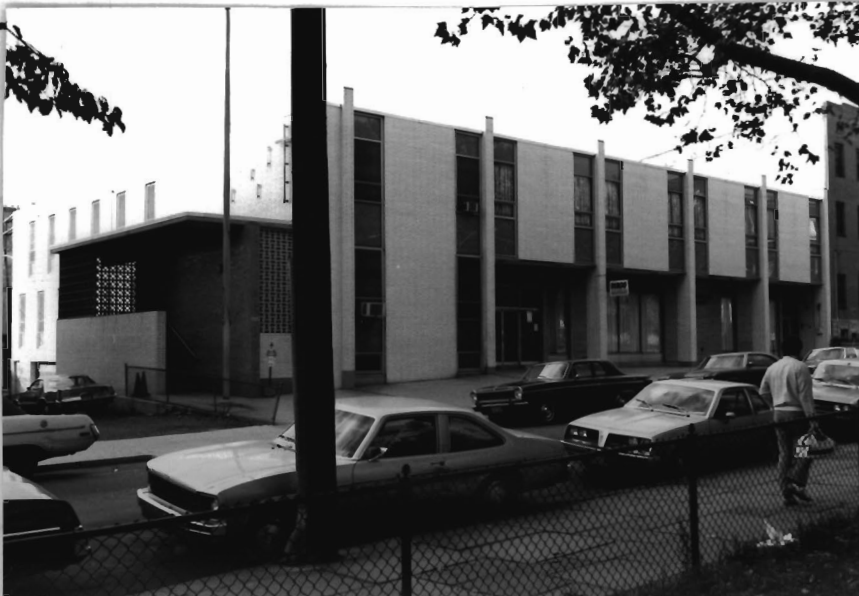
photo: 10-20-78

2 color brick and glass block, 1 story extension.

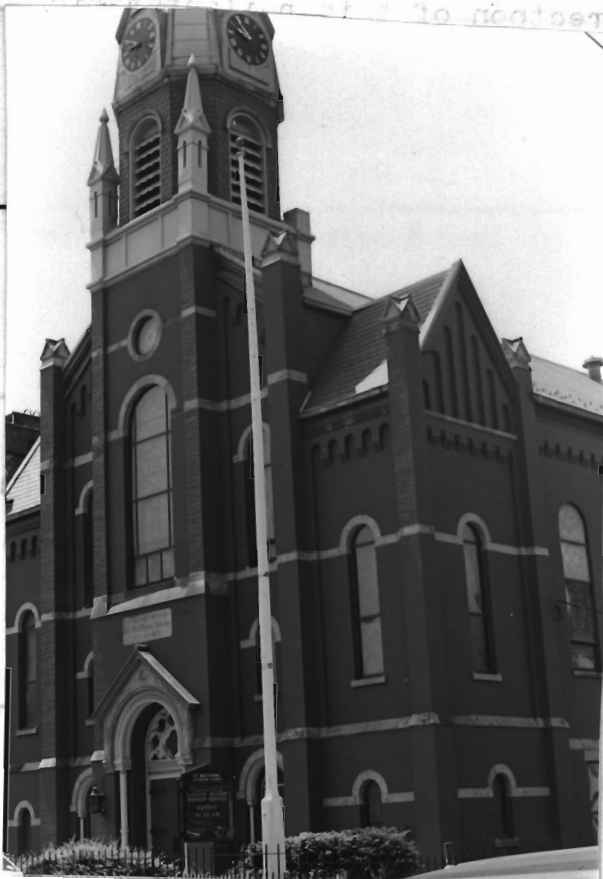
tall, arched windows and gable ends
give a sense of verticality to the
building; further emphasized by the
limestone finials in the shape of
steeples which top the corner pilasters
and balcony of the steeple itself.

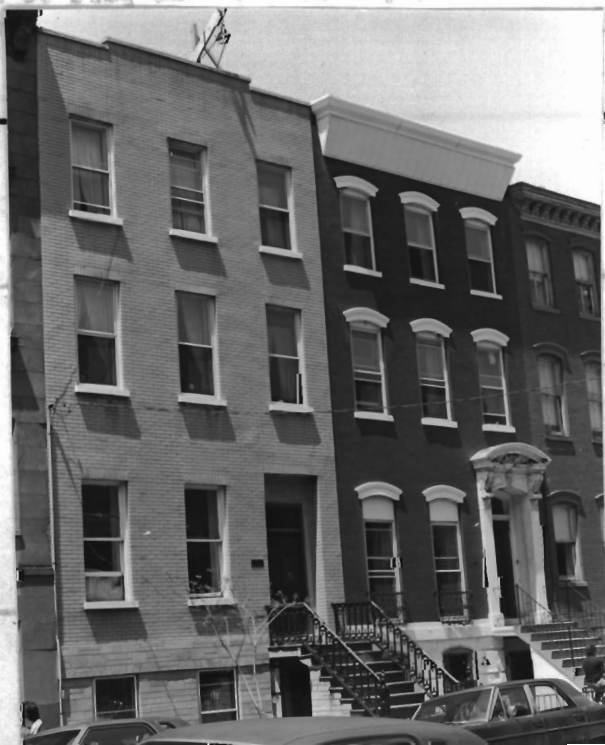
PHOTO:

cornice, all detail stripped or covered with yellow brick
original cast iron balister

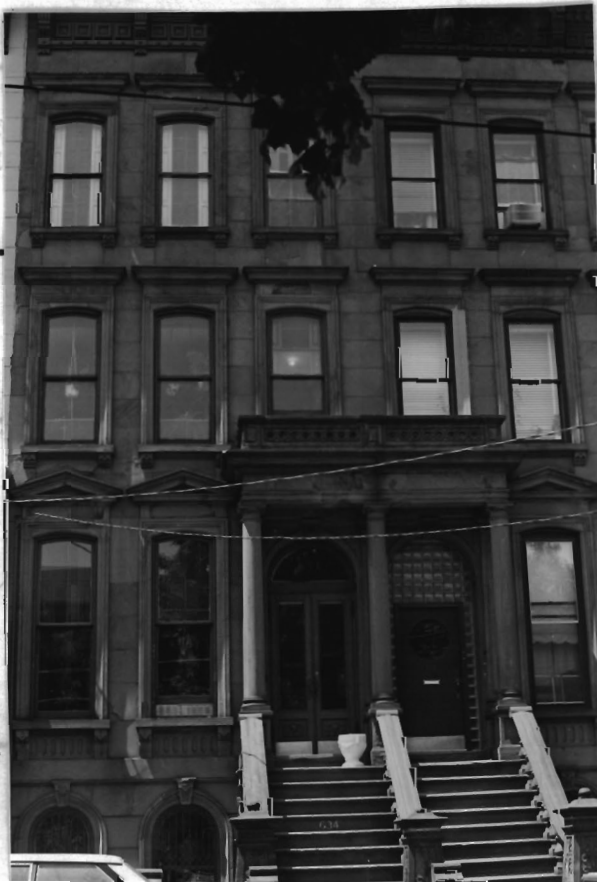
Additional Architectural Description: intact metal cornices; corner unit (638) has fourth story mansard addition; red brick on side facing Seventh Street. (Italianate remodelled during fad for Fr. 2nd empire)

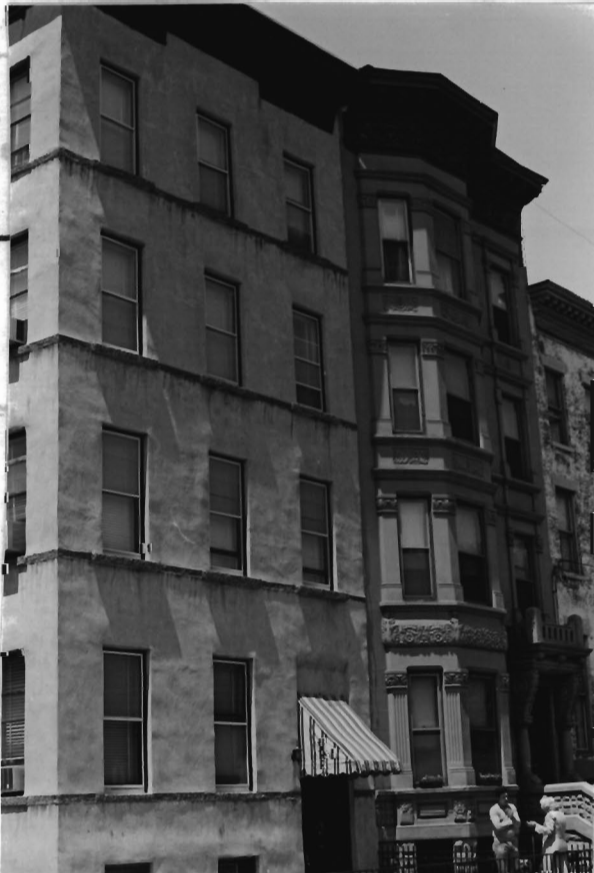
700, 702 Hudson Street

totally altered, exterior details removed and stuccoed

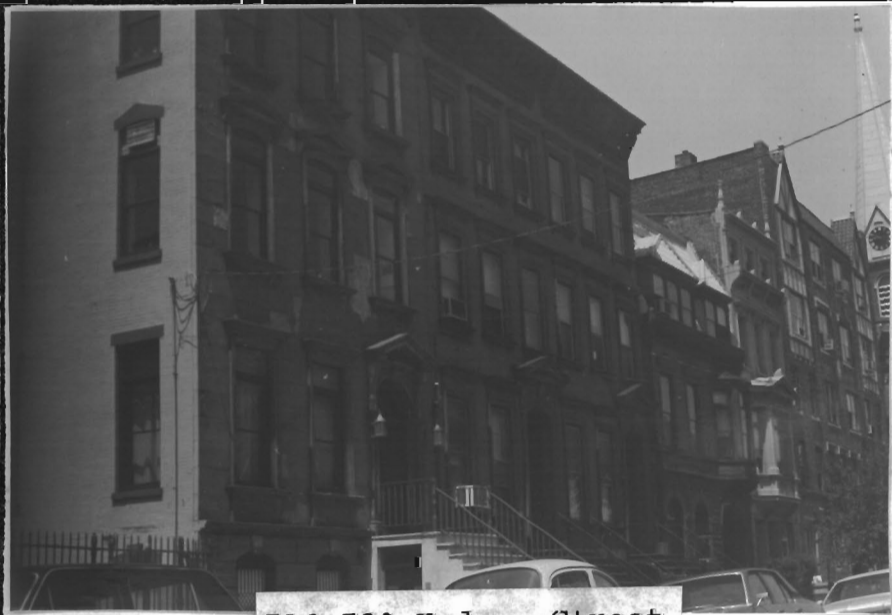
716-730 Hudson Street

segmental pedimented wood cornice
semi-circular transom over fine Italianate surround
