Located on Hudson Street

NEW JERSEY OFFICE OF HISTORIC PRESERVATION HISTORIC SITES INVENTORY # 30-30

INDIVIDUAL STRUCTURE SURVEY FORM

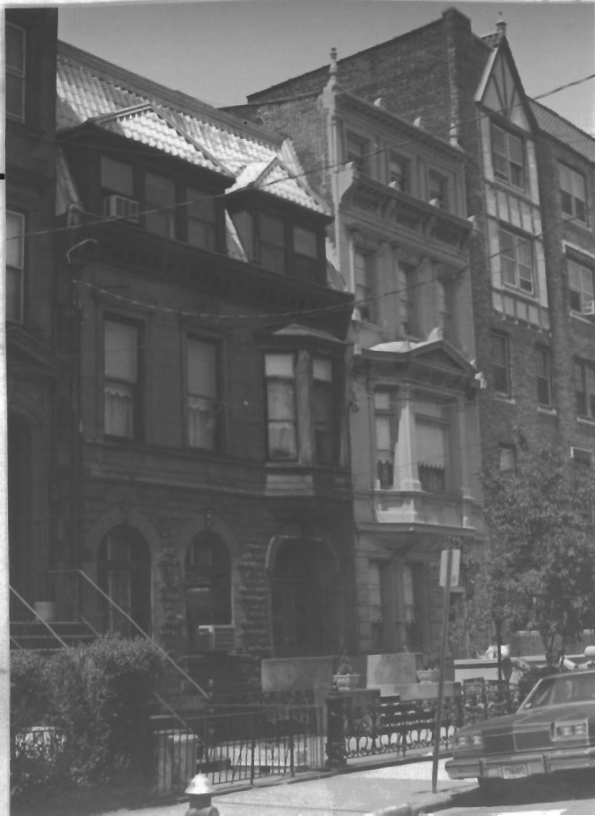
722, 724 Hudson Street

stone stoop and trim, metal cornice, new door
note ornamentation under oriel, peaked roofs over top gables

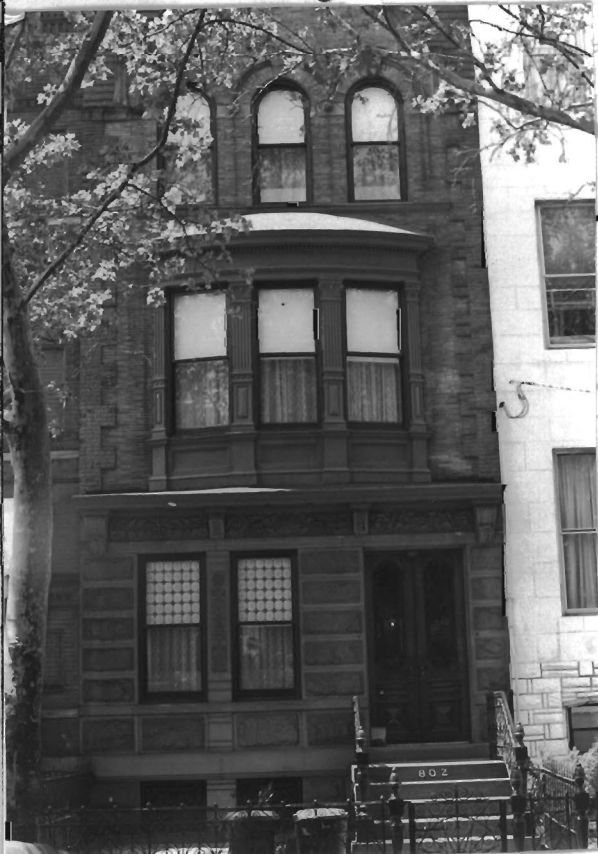
metal cornice over first storey
rusticated stone at basement
and first storey
oreole window at second storey

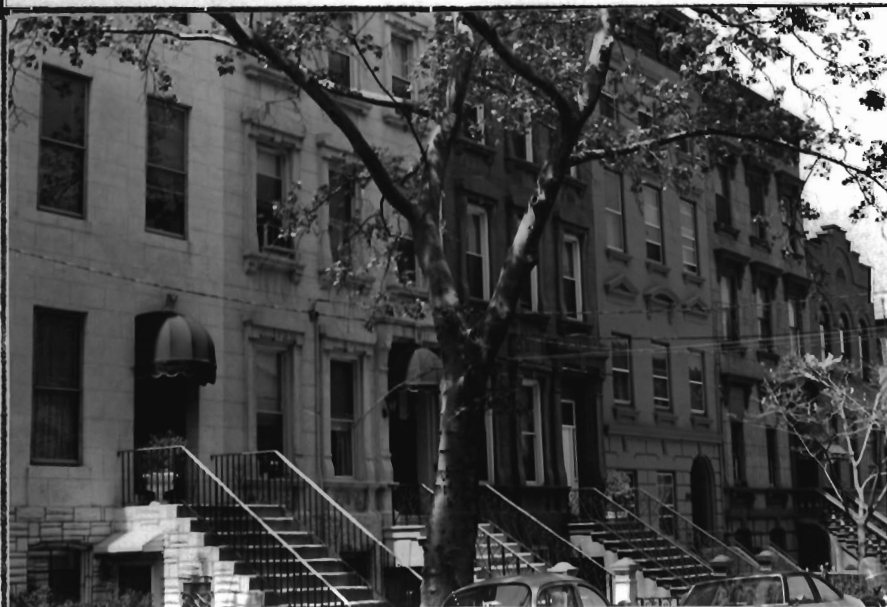
original railings, window surrounds stripped cornices

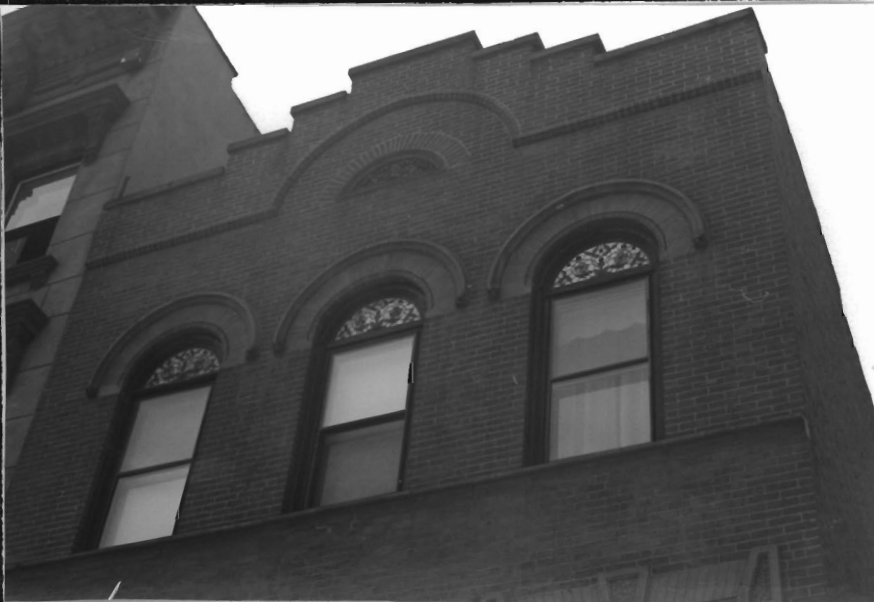
unusual voussiors and keystone-like elements in flat first story lintels. Thin brick arches over flat second story windows.

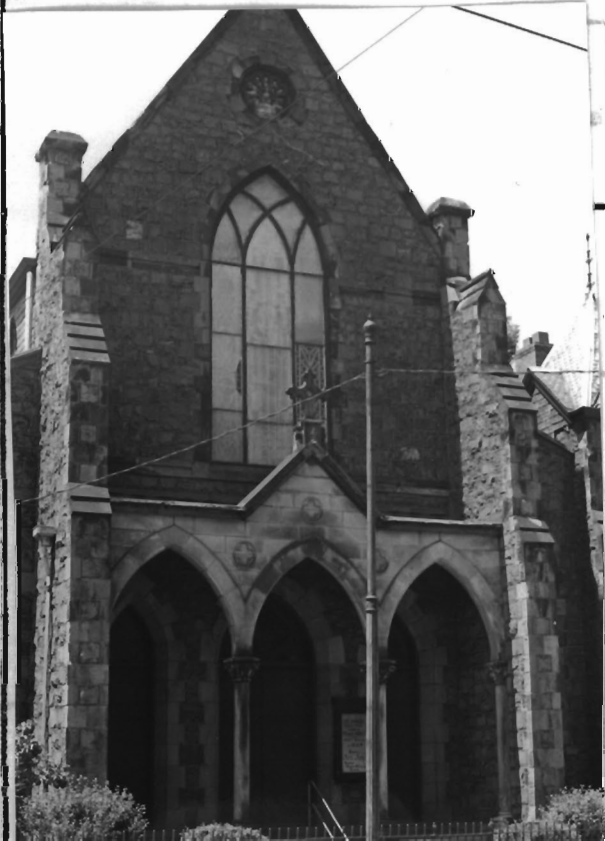
stone trim; wood cornice over entranceway, gothic revival stone; stone columns holding porch

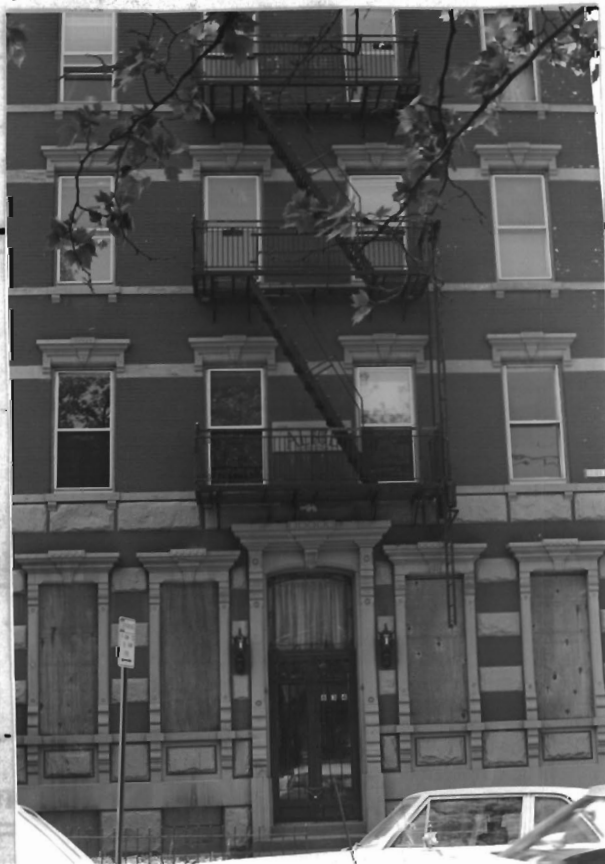
fire escape; both smooth and coarse stone; stone coursing;
heavy Italianate lintels.

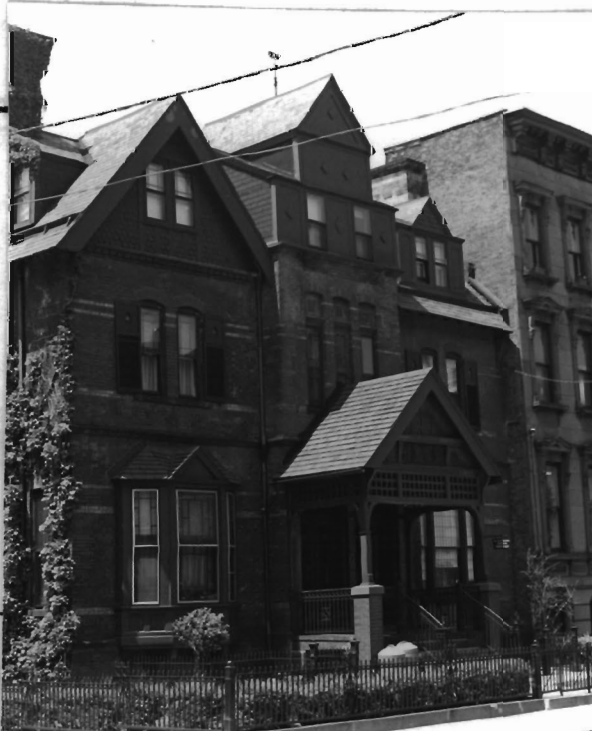
PHOTO:

gabled roofs, note window surrounds and wood detail; entranceway has free; standing columns

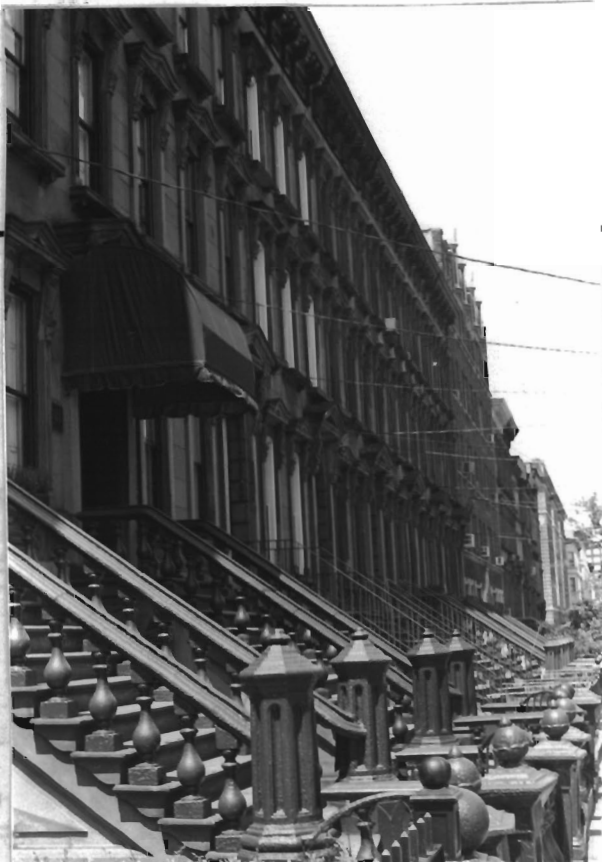
ogee doorway, detailed window glass; stone trim on top parapet.

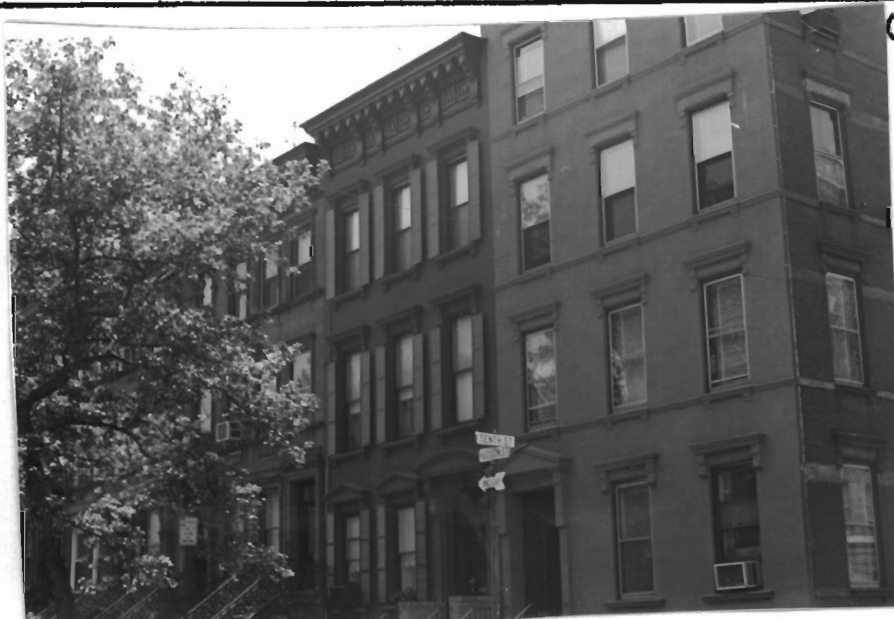
door consuls; metal railings; pedimented lintels; top cornice

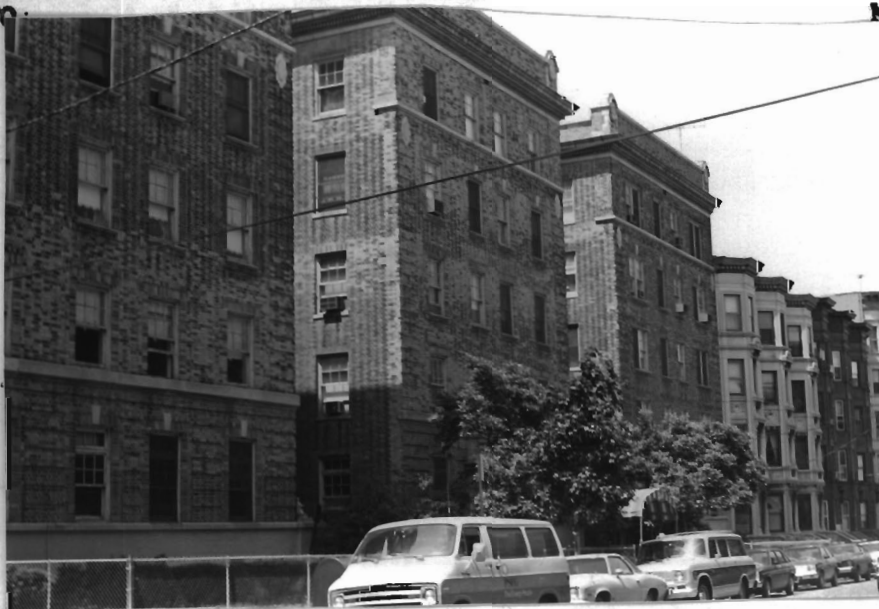
top parapet; stone coursing below fifth story and second story;
keystone lintels in first and fourth story.
