NEW JERSEY OFFICE OF HISTORIC PRESERVATION HISTORIC SITES INVENTORY # 17-13
INDIVIDUAL STRUCTURE SURVEY FORMHISTORIC NAME: St. Joseph's School
LOCATION: 73 (73-77) Jackson St.COMMON NAME: Same
BLOCK/LOT 15/5MUNICIPALITY: Hoboken
USGS QUAD:
OWNER/ADDRESS:COUNTY: Hudson
UTM REFERENCES:
Zone/Northing/Easting

NEW JERSEY OFFICE OF HISTORIC PRESERVATION HISTORIC SITES INVENTORY # 17-14
INDIVIDUAL STRUCTURE SURVEY FORMHISTORIC NAME: St. Joseph's convent
LOCATION: 69 (69-71) JacksonCOMMON NAME: Same
BLOCK/LOT 15/5MUNICIPALITY: Hoboken
USGS QUAD:
OWNER/ADDRESS:COUNTY: Hudson
UTM REFERENCES:
Zone/Northing/Easting

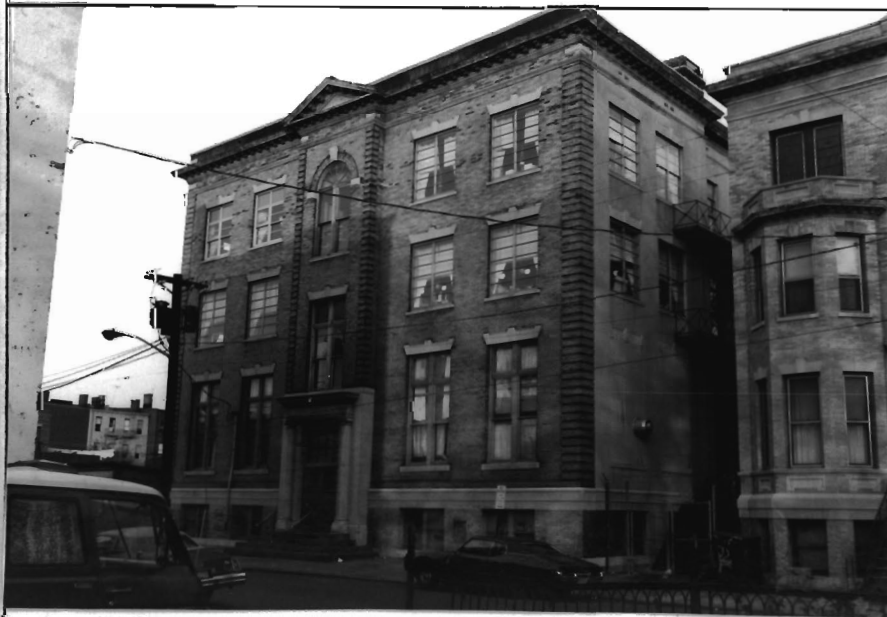
photo date: 11-2-78

Fenestration: 5 bays, paired wood double hung with elaborate mullions and transoms in 1st story. Jalousies in 2 top stories (except center Roof/Chimneys: bay which has arched transom in 2nd story).

Ionic capitals of columns flanking entry voussoirs in lintels. Center bay protrudes with pediment in metal cornice. Brick "Quoins" on center bay and corners.

PHYSICAL CONDITION: Excellent ☐ Good ☒

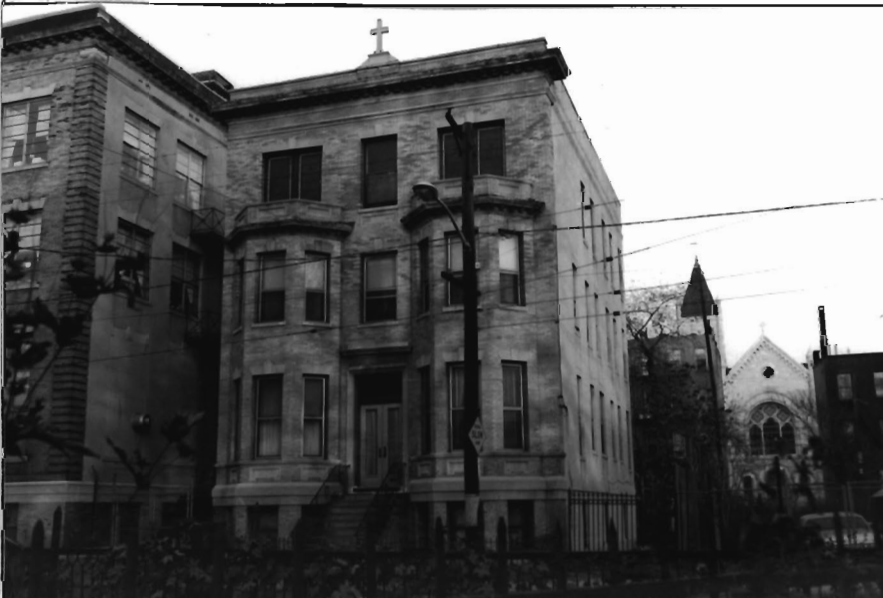
Photo date: 11-2-78

Exterior Wall Fabric: Orange brick

Fenestration: 3 bays. Double hung aluminum, stained glass top story
2 story protruding bays either side of entry.

Much (false?) stone used - especially over windows with false key-stones in lintels. Rusting cornice but otherwise good condition.

PHYSICAL CONDITION: Excellent ☐ Good ☒
