NEW JERSEY OFFICE OF HISTORIC PRESERVATION HISTORIC SITES INVENTORY #
STREETSCAPE SURVEY FORM

STREET NAME: Monroe
MUNICIPALITY: Hoboken

NEW JERSEY OFFICE OF HISTORIC PRESERVATION HISTORIC SITES INVENTORY #
INDIVIDUAL STRUCTURE SURVEY FORM

HISTORIC NAME: St. Joseph Rectory
LOCATION: 61-63 MonroeCOMMON NAME: Same
BLOCK/LOT 16/4MUNICIPALITY: Hoboken
USGS QUAD:
OWNER/ADDRESS:COUNTY: Hudson
UTM REFERENCES:
Zone/Northing/Easting

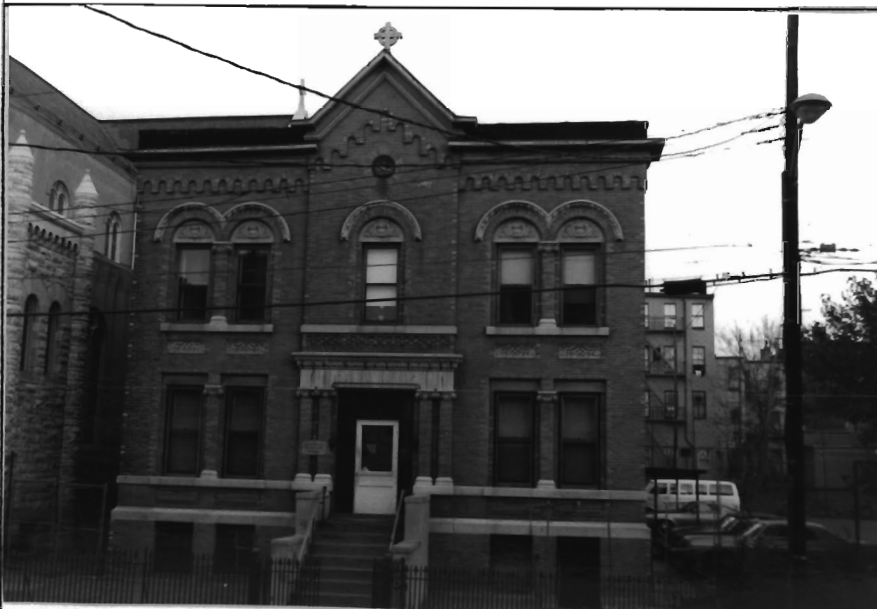
Exterior Wall Fabric: Beige brick with stone trim

Fenestration: 3 bays, double-hung wood, paired windows in end bays

Blind arch panels over 2nd story windows with thin carved arched
"brows".

Center bay protrudes slightly with peaked cornice.

Next to St. Joseph Church. Later period but complements style of church.

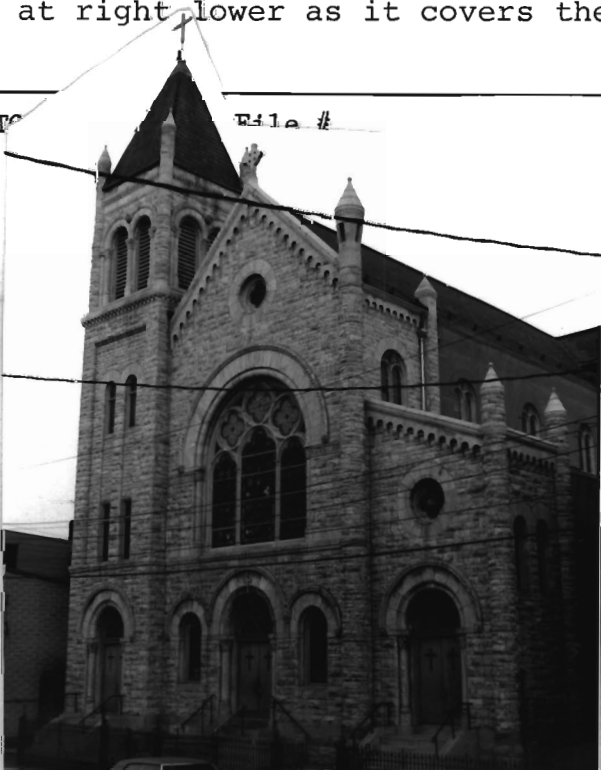
Exterior Wall Fabric: Limestone front facade, stucco on sides and rear

Fenestration: All windows are round arched and stained

Roof/Chimneys: Black slate roof shingles

3 pair window in large 2nd story arch have bounded quatrefoils.

Tower at left has arches over louvers.

Small corner towers add interest.

Fine stone work.

Bay at right lower as it covers the aisle (lower) portion of church.

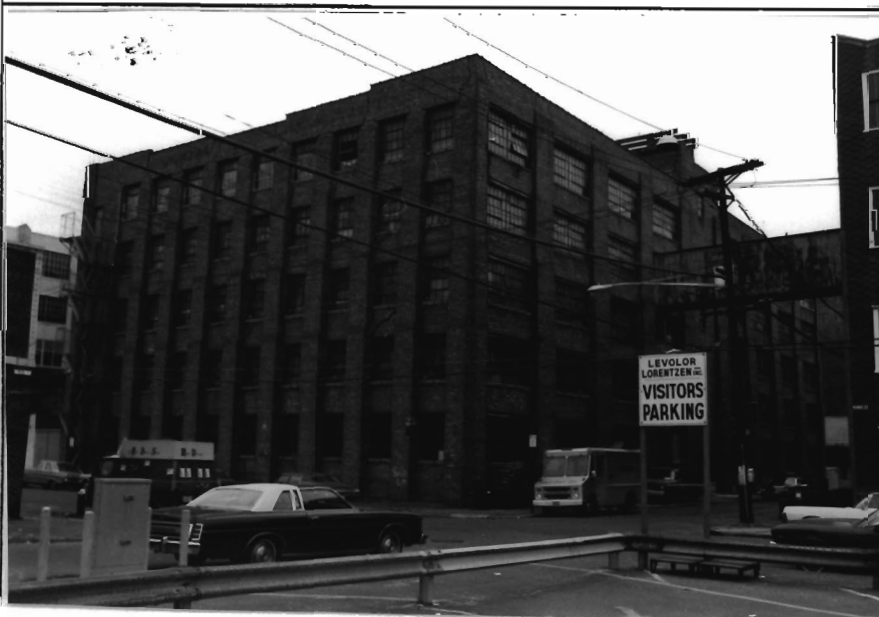
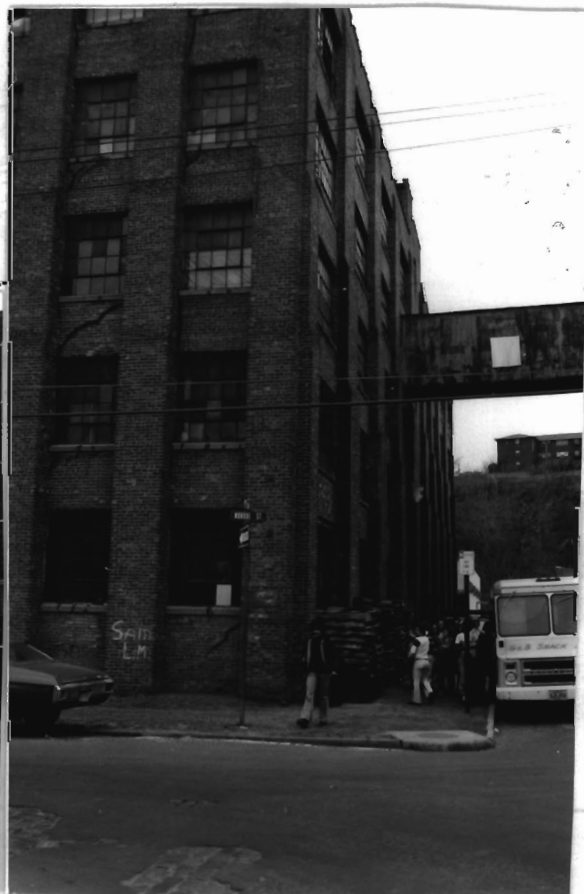
Exterior Wall Fabric: Brick

Fenestration: Factory sash - squarish bays on east facade, horizontally
rectangular bays on north facade.

Buttress-like piers between windows step in at each story.

Some cracks along mortar joints are visibel.

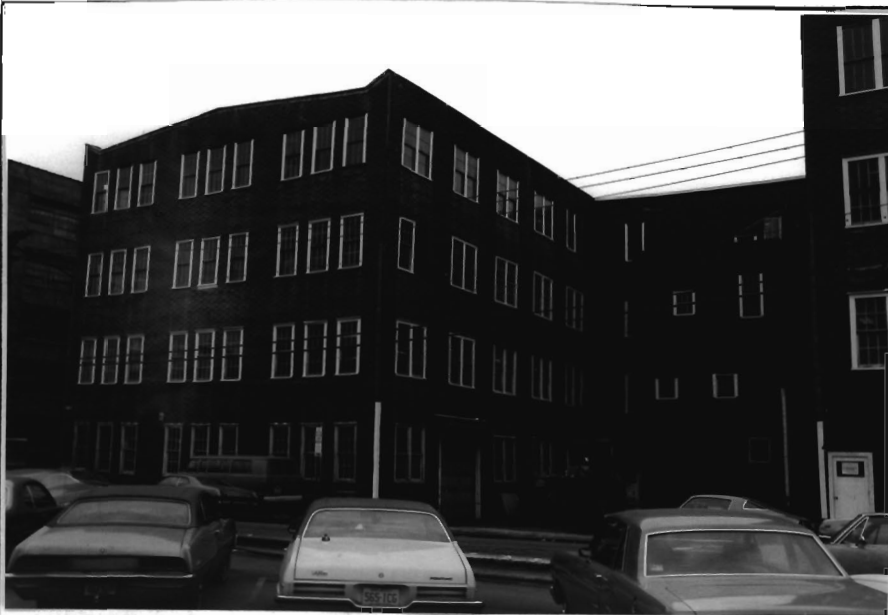
Structural System: Wood frame, some parts are fireproof (Sanborn Map)

Exterior Wall Fabric: Asphalt shingles over wood slats

Fenestration: Paired double hung sash

Actually several connected buildings with identical sheathing. Large frame structures and some set backs provide the interest here.

Some obviously uneven settling in facade on Monroe side.

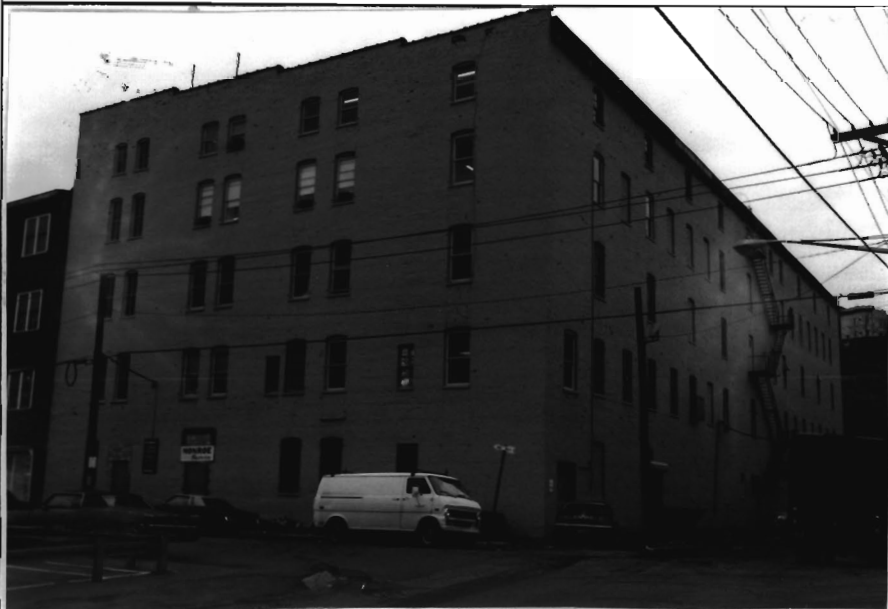
Structural System: Loft mill construction

Fenestration: Segmental arch openings

Eave brackets on North side.

Cracks in back wall (Palisade, on West Side.
