# NEW JERSEY OFFICE OF HISTORIC PRESERVATION HISTORIC SITES INVENTORY # 1-1A

## INDIVIDUAL STRUCTURE SURVEY FORM

**HISTORIC NAME:****LOCATION:** 110 Observer Highway**COMMON NAME:** Alpine Cap**BLOCK/LOT:** 198/1A**MUNICIPALITY:** Hoboken**COUNTY:** Hudson**OWNER/ADDRESS:** Applied Housing Assoc.,

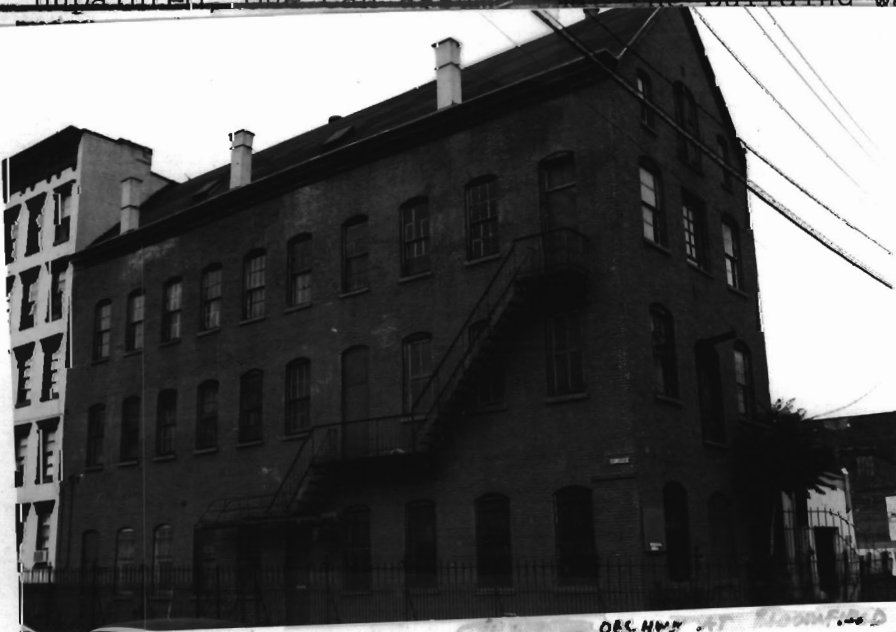
**Number of Stories:** 3, w. attic storey**Foundation:** brick foundation wall**Form/Plan Type:** rectangular**Structural System:** wood framed bldg. with brick piers; rafters, tendon joints into girders**Exterior Wall Fabric:** red brick**Fenestration:** 10 bays wide on longer side; three bays on shorter side  
windows all have arched lintels and slightly projecting sills.**Entrance Location:** on Bloomfield Street**Roof/Chimneys:** pitched roof with three chimneys on longer side st.**Additional Architectural Description:**

The building is painted a brick-colored red, and has a wooden cornice which is classically derived, but simple and unornamented, typical of the Greek Revival mill buildings that appear classic more because of proportion and massing than because of elaborate detailing. On the Observer Highway side, the middle bay is the location of two hoistways, at the attic and 2nd floor levels. The counterweight for one of these is said to have been in the shape of a beaver hat. The windows on its eastern side were bricked up at a later date. Because the wall on this side is unpainted, one can assume that the building was originally unpainted.

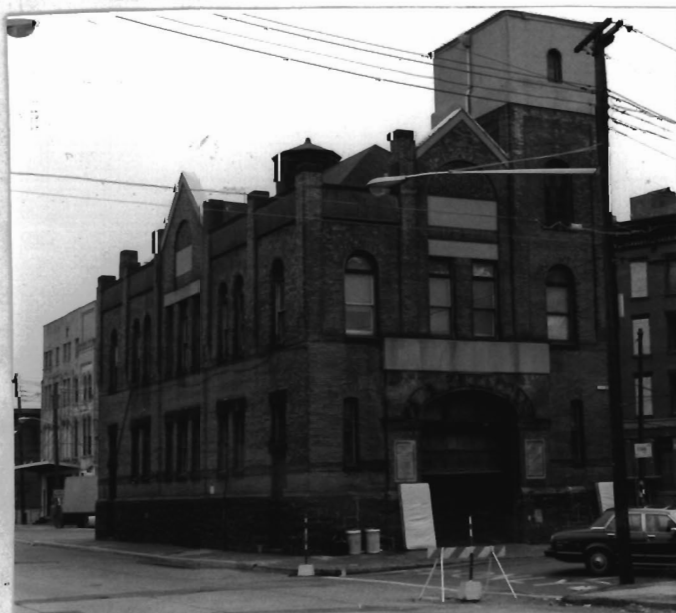
PHOTO Negative File #

Facade has tower at right which has been altered at the top. The facade also contains lancet windows.

At sill levels are continuous bands of raised brick.

Sides contain round arch windows with rusticated sandstone arches.

Arches above fire engine doors has brick voussoir and foliage capitals.

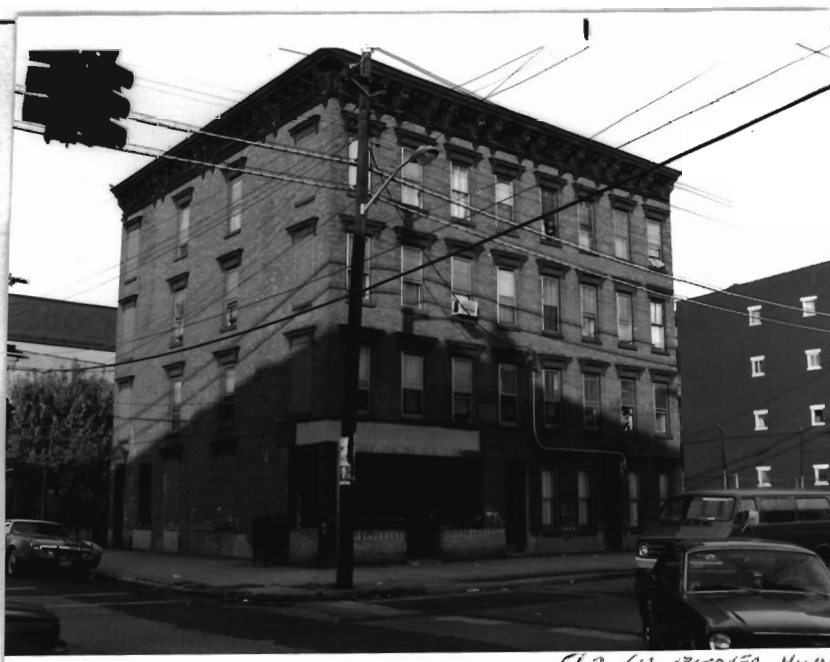
562, 64 OBSERVER HWY

Fenestration: 8 bays (2 entries), aluminum double-hung sash

Additional Architectural Description: Heavy cast iron lintels w/brackets and raised patterns. Pedimented lintel over door at 562. Deteriorating wood cornice with paired onconsole brackets.

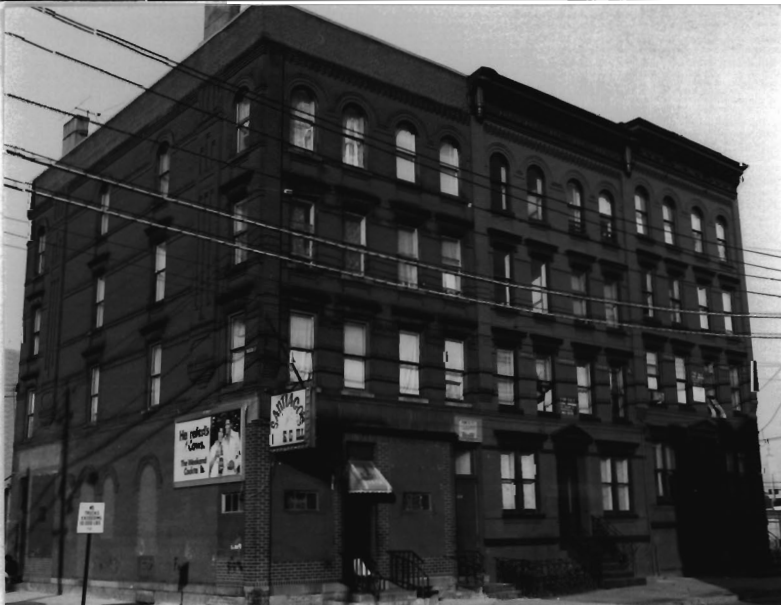
510, 512, 514. OBSERVER Hwy

Exterior Wall Fabric: Brick with cast iron lintels and cornices

Fenestration: 4 bays each, wood double-hung with round arched windows  
in 1st story.

- 1) Pedimented lintel over doors at 510, 12
- 2) Paired windows, flank center entries at 510,12
- 3) Intact door at 510  
Corbelling below cornices (514 Parapet)
- 4) 510 slightly taller and has different cornice (with four console brackets) than 512.
- 5) Altered storefront, stripped cornice at 514

Demolition a threat although buildings look exceptionally  
sound.

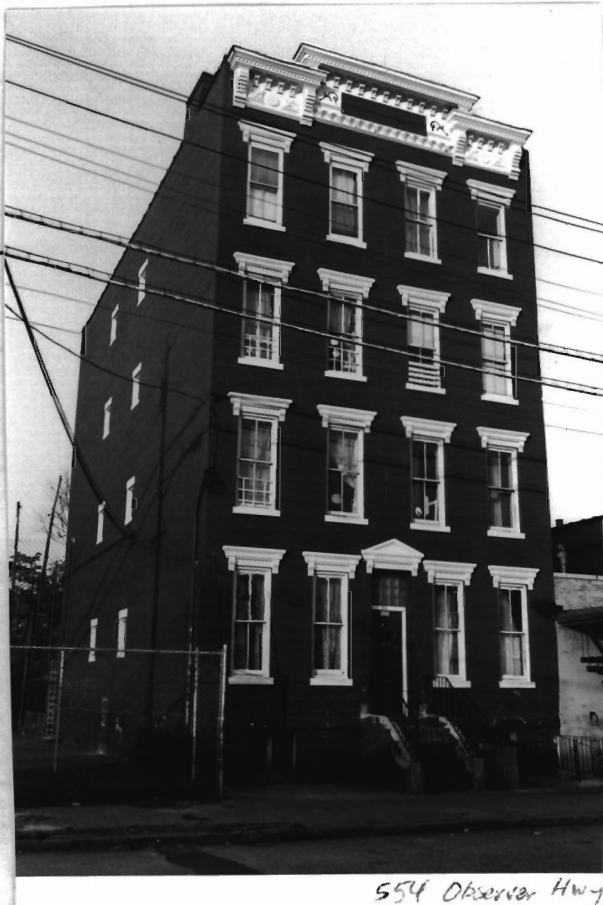
photo: 11-2-78

Fenestration: 4 bays, 2 over 2 wood double-hung

Additional Architectural Description: Elaborate cast-iron lintels, pediment at entry. Fanciful cornice of two levels with brackets, modillions etc.
