LOCATION: 52-56 Washington St.

COMMON NAME: La Carreta, Betty's Lunch BLOCK/LOT: 198/23

MUNICIPALITY: Hoboken

ORGANIZATION: Hoboken Community Development Agency

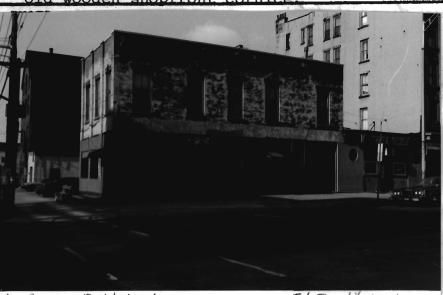
La Carreta, Betty's funda 511-56 Bleshington

The ground floor of this building has been greatly altered, and the only remaining old features, although they may date from a period later than the original construction date, are cast iron piers on the Washington Street side. The Observer Highway side has brick piers which suggest pilasters, and which are capped by limestone The windows have brownstone lintels which are somewhat ornamented but in a state of decay. The one-storey luncheonette has an old wooden shopfront cornice

On its western wall, this building bears the trace of an earlier building which may predate the others on the block. In its present condition, however, the building seems to be too altered to have any real significance to the area.

PHYSICAL CONDITION: Excellent [] Good [] Fair [] Poor [X]
REGISTER ELIGIBILITY: Yes [] Possible [] No [X] As part of district []
'THREATS TO STRUCTURE: Roads [] Development [] Zoning [] Deterioration [X]
No Threat [] Other []
COMMENTS:

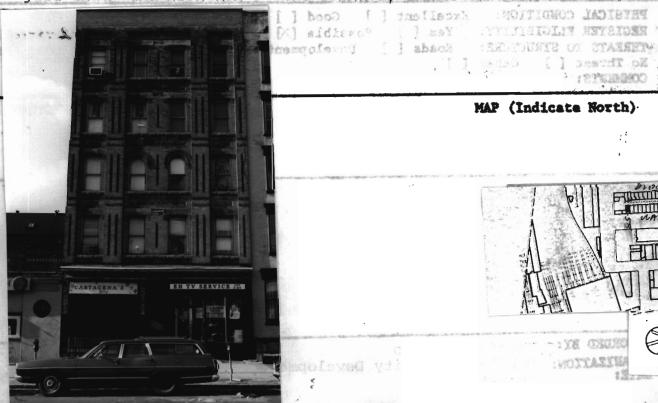
Windows have brownstone lintels and red terracotta sills; ground floor has shopfront cornice with moditlions, in wood, Decorative brick coursing in bands along the vertical piers on the facade, and just under the location of the cornice, which has been removed,

Is one of the few vernacular Romanesque-styled buildings in this area of Hoboken; represents a high level of craftsmanship, evident even in its present run-down condition. Structural Syacani

Excellent [] Fair [x] Poor [] PHYSICAL CONDITION: Good [] No [] As part of district [X] REGISTER ELIGIBILITY: Yes [] Possible [X] THREATS TO STRUCTURE: Roads [] Development [] Zoning [] Deterioration [] No Threat [X] Other [] COMMENTS:

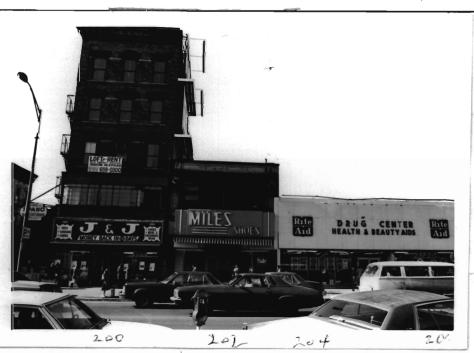
Notable lintels in upper stories, brick quoins, top cornice intact (wood),

storefront heavily altered.

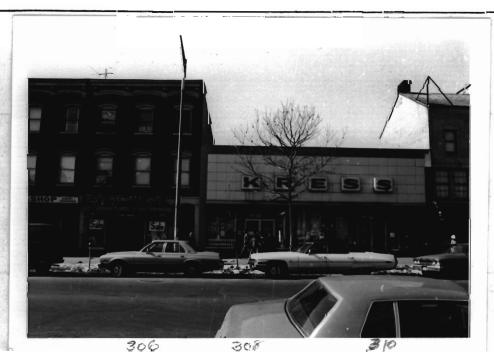
Handsome, intact matching buildings with bracketted cornices and arched, denticulated window lintels. Changes have occurred in the storefronts, but the residential entries, with their classical pilasters and archways, and rope moldings survive, as does the stone fiscia between the first and second stories.

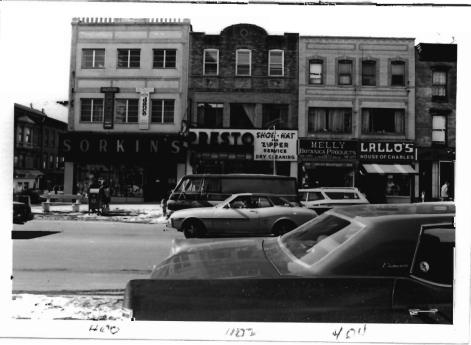
Altered ground floor facade and windows.

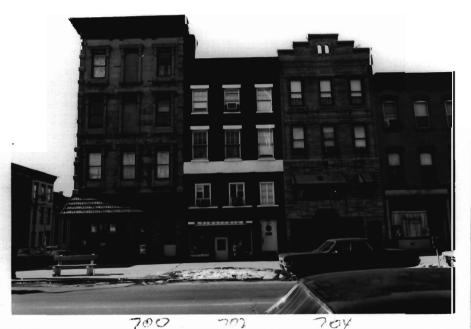
Storefront altered, center 3rd & 4th story windows bricked shut, heavy lintels and window surrounds.

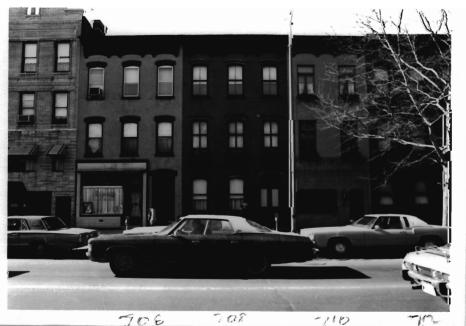
Storefront altered, lintels trimmed flush with facade, intact cornice

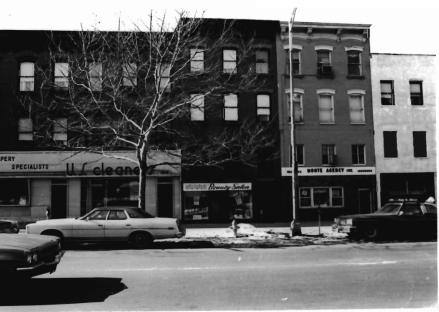
720

Storefront altered, enamelled metal tiles. Intact lintels and cornice.

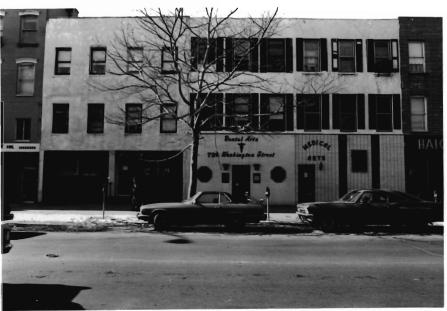
All cornices, lintels and ornamentation removed, with entire facade (except storefront) stuccoed. Storefront has brick infill and small window.

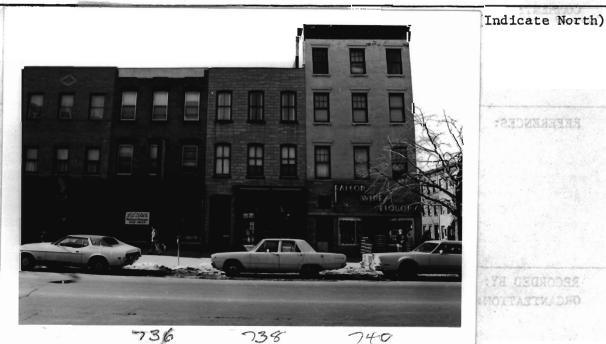
Original storefront intact. Top cornice removed, intact lintels.

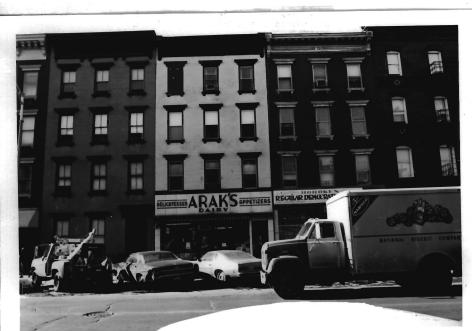
Intact lintels, and particularly heavy lintels over doors. 822,24 wrought iron fence work in excellent condition 826 - original residential entrance intact, in excellent condition.

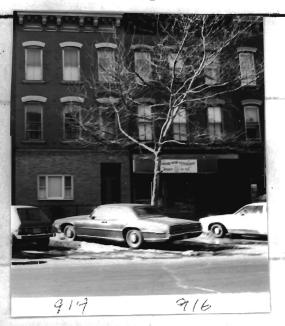
916-original storefront slightly altered; 914,18-36-storefronts altered to brick veneer; 922,34,36-topmost cornices removed, all others intact with identical details; 922-altered to permastone (first story) and

white applied false brick. 936-permastone.
All intact cornices have modillions and six brackets (those toward middle are paired). Stone segmental arch lintels have been shaved flush except for those at 918,920,930 and 932, which remain substantially intact. Intact residential doors at 924 and 932.

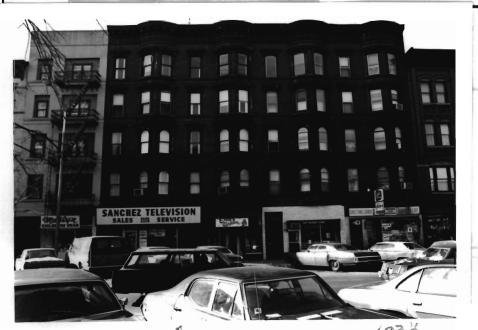
second and third story oriel windows are round arched

-1034 recently repainted

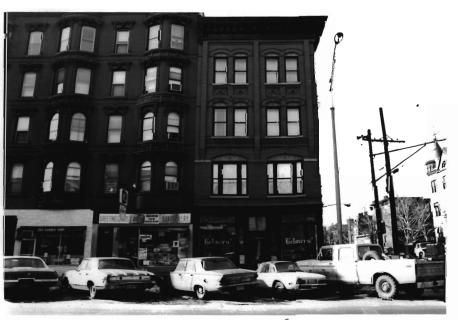
Additional Architectural Description:
Excellent, appropriate renovation of storefront; caste iron columns exposed brown brick veneer in window base panel, large glass pane display windows, ornamental glass transoms. All suggest original appearance. bracketed cornice with dentils. Elaborate brickwork on entire facade: segmental arches above second story combination windows, stilted segmental arches above third and fourth story windows. Three pilasters corbelled out from second story lintel line and extending to top cornice. Brick dentils above fourth story windows; overlapping triangular pattern frieze in brick between third and fourth story windows. Patterns follow to Eleventh Street facade.

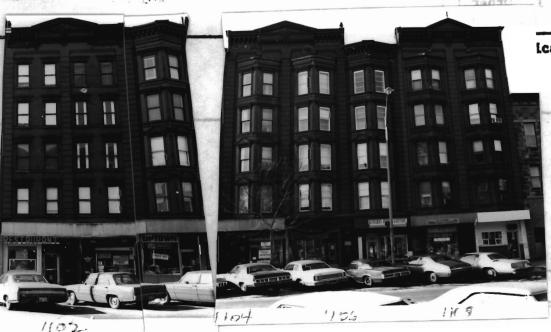
quoins between bays, res. doors, transoms, other details remain in storefronts; cornice intact at 1106, may be intact unter others; top cornices slightly different, as are dtails on oriels.

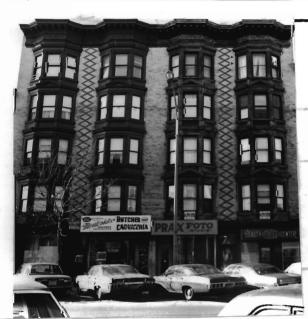
copper bays, classical pilasters, patterned brick, festoons on lowest top cornice panel; cornice intace, heavy brackets, intact res. doors on both bldgs.

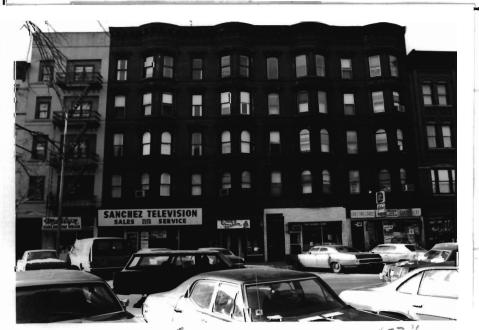
second and third story oriel windows are round arched

-1034 recently repainted

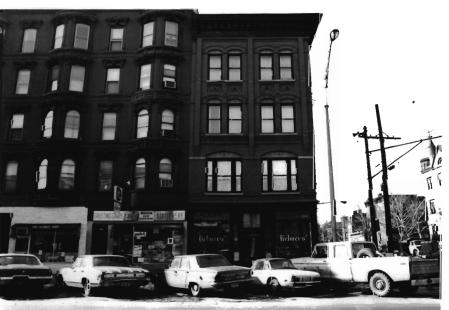
Additional Architectural Description:
Excellent, appropriate renovation of storefront; caste iron columns exposed brown brick veneer in window base panel, large glass pane display windows, ornamental glass transoms. All suggest original appearance. bracketed cornice with dentils. Elaborate brickwork on entire facade: arches above second story combination windows, stilted segmental arches above third and fourth story windows. Three pilasters corbelled out from second story lintel line and extending to top cornice. Brick dentils above fourth story windows; overlapping triangular pattern frieze in brick between third and fourth story windows. Patterns follow to Eleventh Street facade.

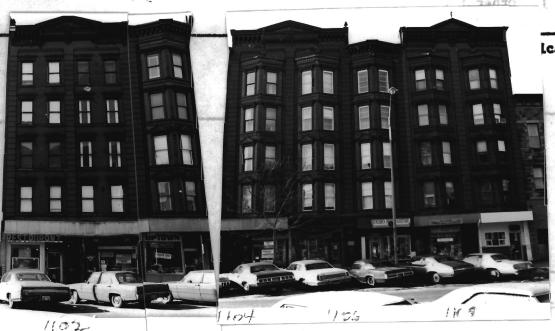
quoins between bays, res. doors, transoms, other details remain in storefronts; cornice intact at 1106, may be intact unter others; top cornices slightly different, as are dtails on oriels.
