NEW JERSEY OFFICE OF HISTORIC PRESERVATION HISTORIC SITES INVENTORY #
STREETSCAPE SURVEY FORM

STREET NAME: Adams
MUNICIPALITY: Hoboken

CROSS STREETS: Newark, First
COUNTY: Hudson

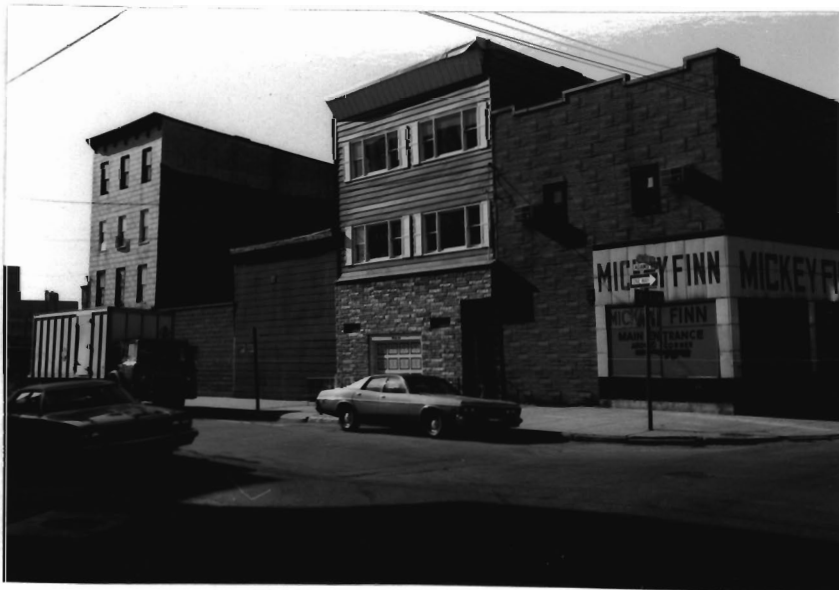
90,92,94,96,98 Adams St.
36-33

93-95 - 2 4 x 3 italianates. 93 has partial stucco alteration of first story. Foliate patterns on lintels, stone coursings at sill and lintel level.
