STREET NAME: Bloomfield Street

MUNICIPALITY: Hoboken

Bloomfield Street, between Observer Highway & Newark Street, East Side #'s running north--south

## NEW JERSEY OFFICE OF HISTORIC PRESERVATION HISTORIC SITES INVENTORY # STREETSCAPE SURVEY FORM

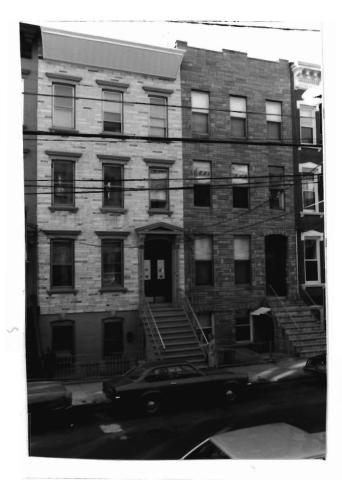
1028,1030 Bloomfield St. neg. # 18-29

1024-28 - Three brownstone rowhouses, one of which (1028) has been refaced with permastone and a covering over its cornice. 1024 is most nearly intact (only the fence and rails are lacking) with panels (these may be altered and those at 1026 may be original) under the first story windows, lintels that are thick with projecting top halves, a pediment over the door, and a console bracketed cornice. 1026 has decaying lintels, pediment and a cornice whose details have been simplified. Lintels and pediment are intact at 1028.

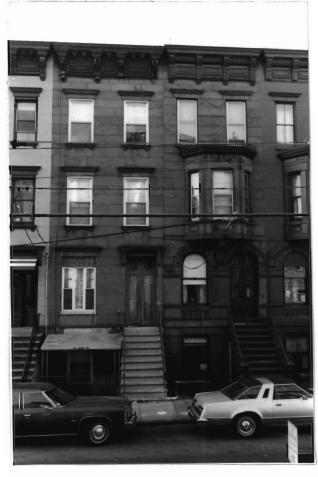
1036,1038 Bloomfield St. neg. # 18-23

1034-36 - Two 3 story brownstone rowhouses. 1034 is three bays wide; 1036 has 2 bays. These are quite similar to 1024-28 although the windows are slightly narrower. Rails and fences are not intact. The console brackets at 1036 are decaying.

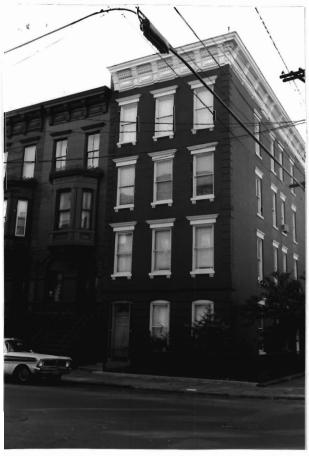
1040,1042 Bloomfield St. neg. # 18-33

There are panels under the three windows and a cornice with a metal grill around the top of the oriel. The third story windows match those at 1024-28, 1034-36, etc., and the cornices are intact (except for the pendants at 1040). There is some spalling of the wall surface at 1038, repairs have been done at 1040. Both are basically well-maintained, handsome and unusual.

1042 - 4X3. Corner quoins echo 1000 in this brownstone faced building (painted with brick on the north side). Lintels match those atop 1038-40 and the cornice is nearly identical to those units as well.

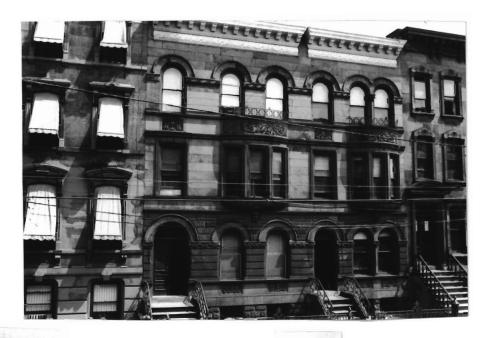
1039-1037 Bloomfield St. neg. # 5-15

1037-39 - A pair of three story brownstone rowhouses. Both have relatively low basements, arched window and door openings with thin brow-like lintels, and single and tripartite windows in the second stories. 1037 is narrower and the two right windows are separated by colonettes in the first and third stories, whereas the corresponding windows in 1039 are separated by thicker panels that act as pilasters. The brownstone goes from rough to rusticated to smooth surface through the basement, first and two top stories, respectively. A band set off by raised courses between the second and third stories contains terra cotta panels over the single and oriel bay windows. Metal cornices have modillions and are intact.

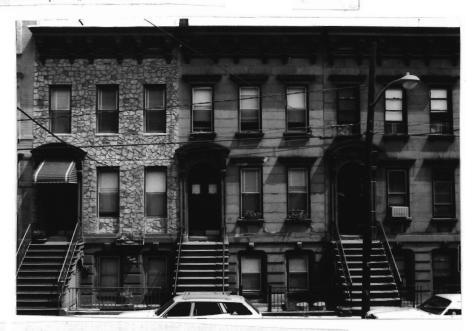
1021,1019.1017 Bloomfield St. neg. # 5-10

1017-21 - Three 2X3 brownstones with high basement stories that have horizontal rustication. Massive door lintels have segmental arch pediments that are broken in bottom entablature and which are intact in all units. 1021 is refaced in green fieldstone pattern permastone with pink paint on trim and on the basement brownstone. Intact bracketed sills and protruding lintels at 1017 and 1019. All three console bracketed cornice with pendants are intact.

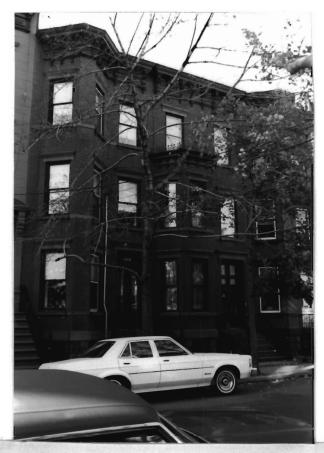
1108,1110,1112 Bloomfield St. neg. # 19=2

1108-12 - Three 3 story brick rowhouses that form a set. Completely intact with wrought iron rails, newels, fences, double doors and 1102 type lintels. A few pendants are missing in cornices which match 1106 style. All are essentially two bays. Left bay in each is a projecting bay window, each being three sides. 1108 and 1112 have two windows in three story bays; the front panel is narrow and blind. 1110 has three narrower window in a tripartite two story bay which has ironwork over a small cornice which echoes the top cornice design. The top cornices are structly separate but the unit acts as one, and is especially exciting because of the projections in such a small scale range.

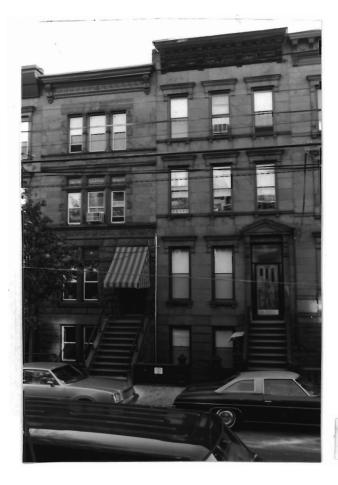
1134,1136 Bloomfield St. neg. # 19-7

- 1134 Three story brownstone with rough-faced blocks in basement and first stories. Smooth above with rough lintels and jagged, guoin-like surrounds. The basement and first story windows are paired, those above are trippled. First and second story windows have stained glass transoms. Double courses above first and second stories have running, raised foliate relief. Top cornice has two brackets and foliate raised relief in frieze.

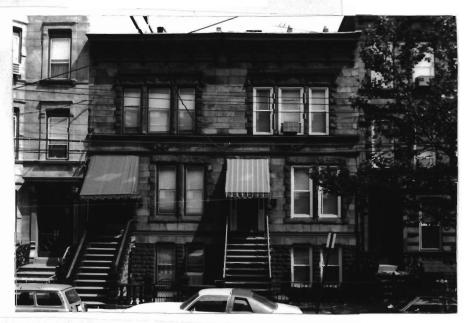
1133,1131 Bloomfield St. neg. # 5-22

PHYSICAL CONDITION OF SITES: Excellent 1131-33 - Two 2 story brownstones with rough finish rusticated blocks in high basement. Intact balusters in fence and railing at 1133. Rough finish stone is also used in surrounds and lintels of paired first story windows, of tripple third story window grouping and of doorway. Continuous courses across both facades above first story lintels and at second story sill level have palm leaf stone relief ornament. Intact cornices.

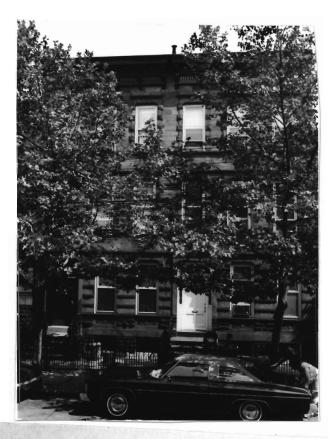
1129,1127 Bloomfield St. neg. # 5-21

1127-29 - Two 3X3 brownstone rowhouses with rough-finish used in the basement, in band courses in the first story, and in quoin-like members in sec4nd and third story window surrounds. Courses at all lintel levels and two upper sill levels. Cornices are in excellent condition.

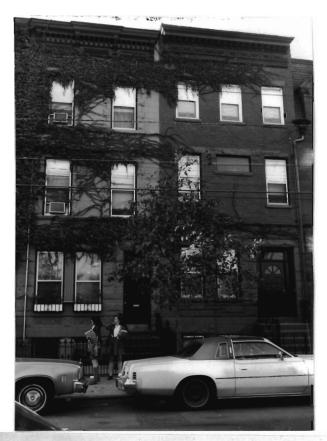
1216,1218,1220,1222 Bloomfield St. neg. # 19-14

1218-20 - Two brownstones. Intact balasters in both stair rails and in fence at 1218. Full first story window and door surrounds. Thick lintels with projecting top half. Console brackets are deteriorating, particularly at 1218.

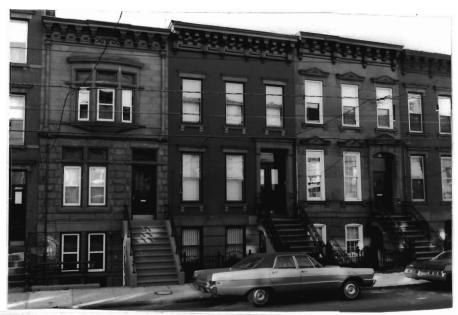
1230,1232,1234,1236 Bloomfield St. neg. # 19-16

1230 - 3X3 with brownstone basement, brick above. Grills at basement windows in addition to intact fences, rails, grill at basement entry. Intact door lintels similar to 1228, but pediment cappings are replaced by small incised triangles in brownstone. Some deterioration of cornice.

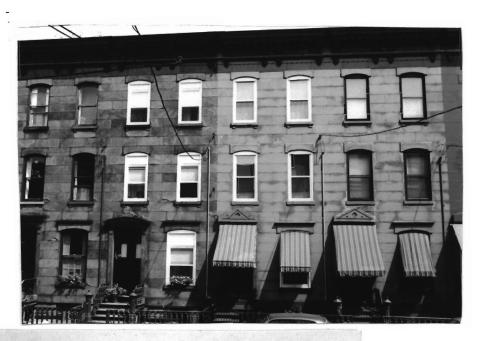
1221,1219,1217,1215 Bloomfield St. neg. # 5-28

The intact brownstone facades are in various states of repair. Some are painted, some are patched with brown concrete, while some are free of coatings. 1313 and 15 have quite a bit of patching. 1217 & 19 are spalling badly. Areaways have steps down to basement entries under stoops.

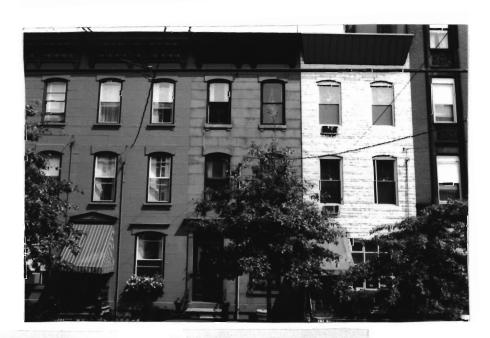
1201 Bloomfield St. neg. # 5-24 detail, 1201, neg. # 5-25

1201 - 5X3 red brick apartment house with brownstone on front side of first story. It may be entirely intact, including fence around building on two sides, although the original windows have been replaced with smaller aluminum sash with the extra space being filled with white plastic panels. The second through fourth story bays are vertically emphasized with continuous brownstone surrounds and dark terracotta between the stories. Transons are over the tripartite first-story windows. The fifth story windows are roundarched with full brownstone surrounds. Heavy lintels are over windows on the Twelfth Street facade, which has a tripartite projecting bay at rear. The cornice has particularly elongated consoles. ("Dragon" newels on steps recall similar items this surveyor has seen in Park Slope Brooklyn.)
