CHURCHES  
LOCATED ON JEFFERSON STREET

# NEW JERSEY OFFICE OF HISTORIC PRESERVATION HISTORIC SITES INVENTORY # INDIVIDUAL STRUCTURE SURVEY FORM

HISTORIC NAME: Engine Co. #3  
LOCATION: 201 Jefferson Street

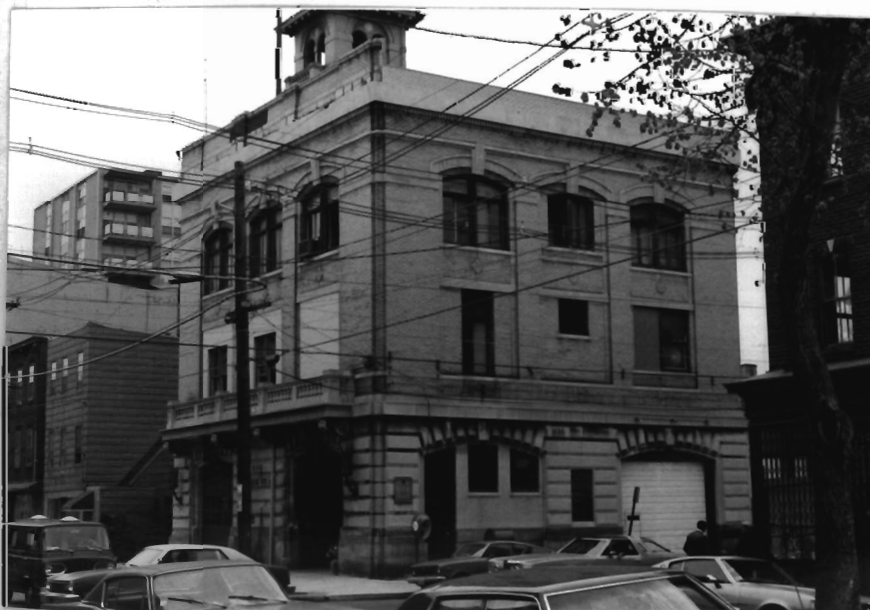
PHOTO Negative File #

Center double fire engine doors made of wood, (panelled).  
Above base is a limestone balcony with balustrade which is held by elaborate limestone brackets.  
Limestone coping and band at roof line.  
Segmental arched windows below which are limestone panels and decorative brick work. Third floor transom windows.  
Cornice is dentiled. Modillion cornice on tower.

Situated on a corner lot the structure dominates over the smaller surrounding row houses.

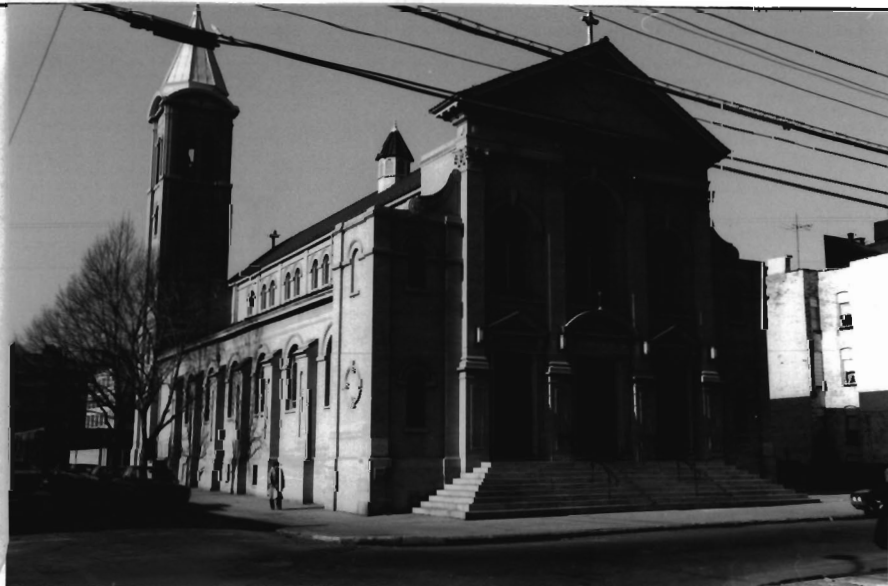
St. Anne Italian R.C. Church

The building is reminiscent of such churches as Il Gesu in Rome with its attached columns supporting a pediment and curved sections which accomplish the transition from the wave eaves to the aisles roofs. The front steps elevate the entry.

One of the most impressive churches in Hoboken, though on a relatively small scale.
