NEW JERSEY OFFICE OF HISTORIC PRESERVATION HISTORIC SITES INVENTORY #  
INDIVIDUAL STRUCTURE SURVEY FORM

**HISTORIC NAME:**  
**LOCATION:** 76, 78, 80, 82 River Street

**COMMON NAME:** American Hotel  
**BLOCK/LOT:** 222/9,8,7,6

**MUNICIPALITY:** Hoboken

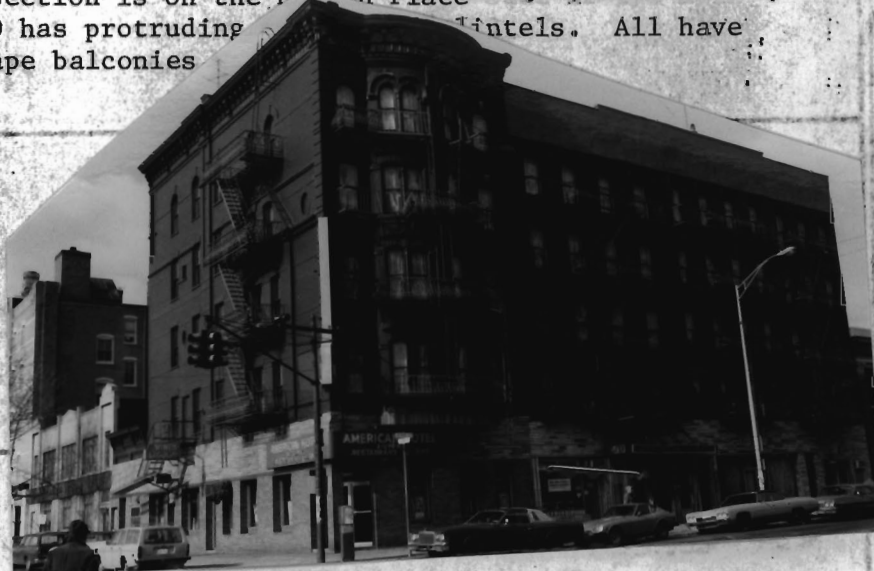
40-8

Four separate facades although 78 and 82 have identical cast-iron segmental arch lintels with upturned ends. 78 has four bays; 82 has three.

The first stories of all the buildings are permastone sheathed. The cornices are removed at 78, 80 and 82.

76 is the most elaborate design with paired windows under cast iron lintels in the two bays of a bow-fronted oriel that is in the second through fifth stories. The flanking single windows have brick stilted segmental arch lintels. The top story windows all have round arched heads. Brick quoin-like detailing is at the building corners and the metal cornice is intact. A large cornice is on a one story storefront at the rear and facing Hudson Place (38 Hudson Place). A slightly

**PHOTO:** projecting gable-like section is on the Hudson Place side of the main building. 80 has protruding curved, wrought-iron fire escape balconies

**PHYSICAL CONDITION:** Excellent ☐ Good ☒ Fair ☒ Poor ☐  
**REGISTER ELIGIBILITY:** Yes ☐ Possible ☒ No ☐ As part of district ☒  
**THREATS TO STRUCTURE:** Roads ☐ Development ☐ Zoning ☐ Deterioration ☐  
No Threat ☐ Other ☐

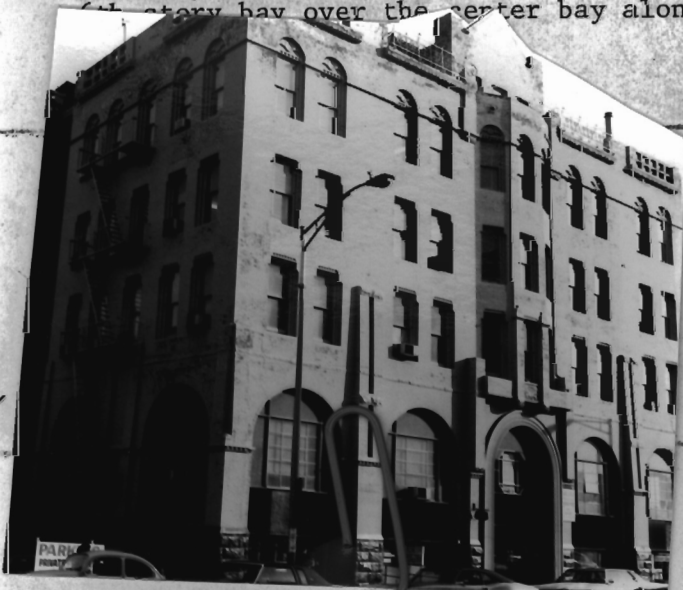
24-13

Penetration: Wood frame double-hung windows are in the third through fifth stories.  
Metal frame sash with black Cararra glass panels fill the arched opening

**Additional Architectural Description:** From foundation to the 1st floor, walls battered (i.e. slightly inclined) & five round arched bays are separated by pillars. Rough block buses and enclosed windows of semi-basement first story and second story along River Street. There are two of these bays on the end facades with five bays in the upper three stories. The River Street side has two windows above each archway, except at the center, entrance bay where there is a projecting bay in the third through the fifth stories. The first and second story windows have been altered and have structural glass panels. The third and fourth story lintels have drops that edge into the top covers of the window openings. The 5th story windows are rectangular with half circle panels under round arch opening. They have what seems to be an Egyptian sun motif and the insit arched panels above lintels. Parapets with brick

**PHOTO:** walls and wrought iron fences flank a gable-ended  
6th story bay over the center bay along River Street. **MAP (Indicate North)**

**PHYSICAL CONDITION:** Excellent ☐ Good ☒ Fair ☐ Poor ☐  
**REGISTER ELIGIBILITY:** Yes ☒ Possible ☐ No ☐ As part of district ☒  
**THREATS TO STRUCTURE:** Roads ☐ Development ☐ Zoning ☐ Deterioration ☒  
No Threat ☐ Other ☐

In early photos, building was unpainted and had larger awnings in the wide window portals. Contrasting stone trim is evident in such early views. (2)

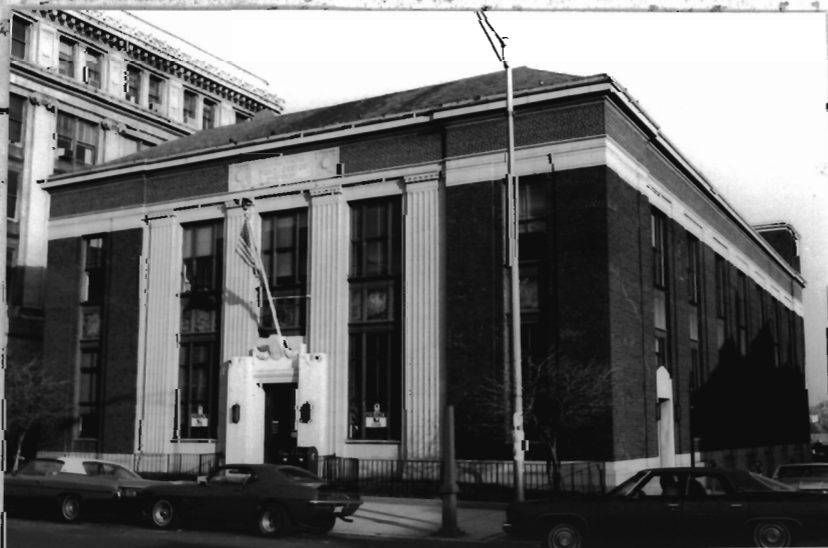
24-10

Four fluted pilasters flank entry with metal frame window units.  
Marble panels separate windows in the two stories.

**PHYSICAL CONDITION:** Excellent ☒ Good ☐ Fair ☐ Poor ☐  
**REGISTER ELIGIBILITY:** Yes ☐ Possible ☒ No ☐ As part of district ☒  
**THREATS TO STRUCTURE:** Roads ☐ Development ☐ Zoning ☐ Deterioration ☐  
No Threat ☒ Other ☐  
**COMMENTS:**

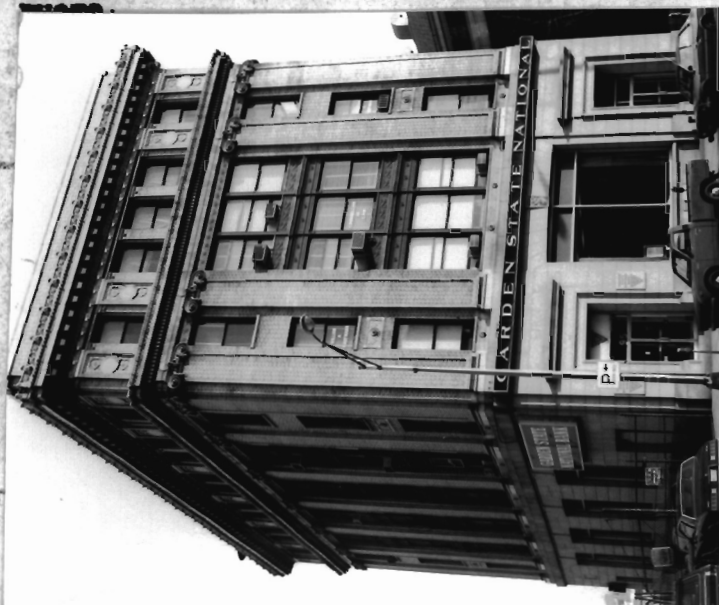
24-9

**Additional Architectural Description:** In the base (first story), shaft (second through fourth stories), capital (fifth story) mode. Virtually flat arches in the wide center bay in front and in the four paired window bays toward the center on the side facades.

The middle bays on all facades have windows in a cast-iron framework, with raised ornament on panels.

Bays are divided by three story pilasters in the middle stories. These have recessed panels so that thin raised portions outline the shafts. The capitals are bold variations on the Ionic.

Panels divide bays in the relatively squat fifth story. The windows sit on a denticulated cornice supported by the Ionic pilasters and are under a modillioned cornice with terra cotta ornament that runs around the attic.

**PHYSICAL CONDITION:** Excellent ☒ Good ☐ Fair ☐ Poor ☐  
**REGISTER ELIGIBILITY:** Yes ☐ Possible ☒ No ☐ As part of district ☐  
**THREATS TO STRUCTURE:** Roads ☐ Development ☒ Zoning ☒ Deterioration ☐  
No Threat ☐ Other ☐

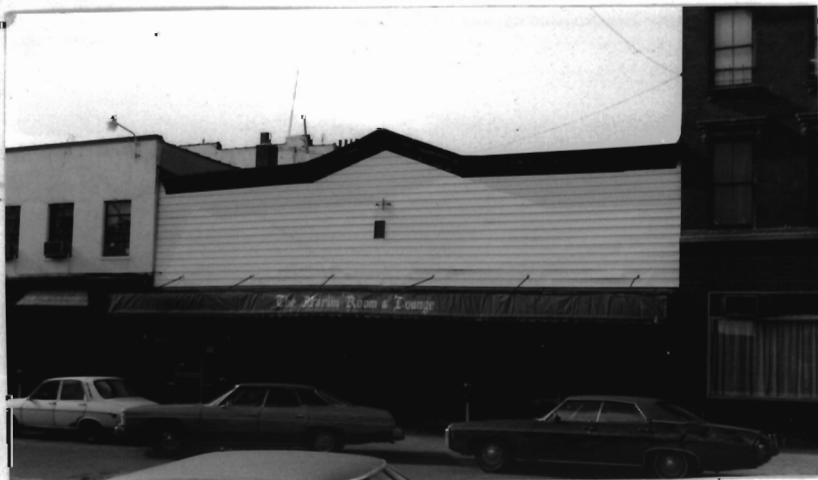
# NEW JERSEY OFFICE OF HISTORIC PRESERVATION HISTORIC SITES INVENTORY # 40-5

altered frame building has peeked cornice

**PHYSICAL CONDITION:** Excellent ☐ Good ☒ Fair ☐ Poor ☐  
**REGISTER ELIGIBILITY:** Yes ☐ Possible ☐ No ☒ As part of district ☐  
**THREATS TO STRUCTURE:** Roads ☐ Development ☐ Zoning ☐ Deterioration ☒  
No Threat ☐ Other ☐  
**COMMENTS:**

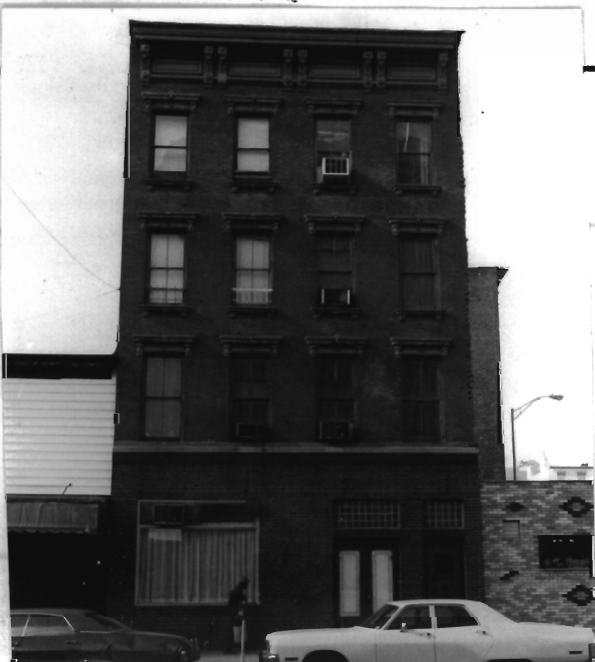
# NEW JERSEY OFFICE OF HISTORIC PRESERVATION HISTORIC SITES INVENTORY # 40-6

storefront altered with brick  
elaborate braquetted, cast-iron lintels are intact above  
sills have raised patterns in braquettes

**PHYSICAL CONDITION:** Excellent ☐ Good ☐ Fair ☒ Poor ☐  
**REGISTER ELIGIBILITY:** Yes ☐ Possible ☒ No ☐ As part of district ☒  
**THREATS TO STRUCTURE:** Roads ☐ Development ☐ Zoning ☐ Deterioration ☒  
No Threat ☐ Other ☐  
**COMMENTS:**

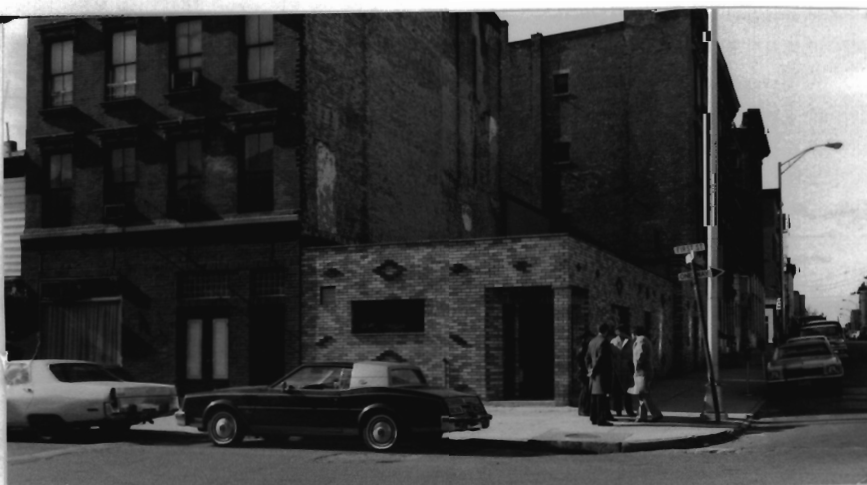
# NEW JERSEY OFFICE OF HISTORIC PRESERVATION HISTORIC SITES INVENTORY # 40-7

an infill building (the building at # 94 has a jagged outline due to the demolition)

**PHYSICAL CONDITION:** Excellent ☐ Good ☒ Fair ☐ Poor ☐  
**REGISTER ELIGIBILITY:** Yes ☐ Possible ☐ No ☒ As part of district ☐  
**THREATS TO STRUCTURE:** Roads ☐ Development ☐ Zoning ☒ Deterioration ☐  
No Threat ☐ Other ☐  
**COMMENTS:**

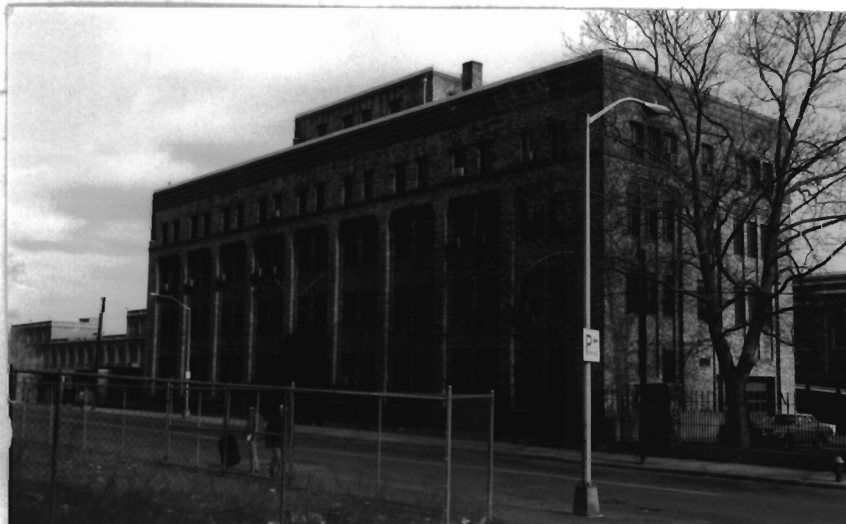
NEW JERSEY OFFICE OF HISTORIC PRESERVATION HISTORIC SITES INVENTORY # 40-13  
INDIVIDUAL STRUCTURE SURVEY FORMHISTORIC NAME: Plant Quarantine Bldg.  
LOCATION: 209 River St.COMMON NAME: same  
BLOCK/LOT 231/

Additional Architectural Description: Pilaster-like piers separate the bays which contain two windows with smaller brick piers between them. Each three storey bay is set back from the facade with a corbelled section. An entry portal of black terracotta enframes the main entry on River St., which have ornamental "morel" metal grilles with medallions in naturalistic scenes. There is a single band of orange terracotta over the third storey and four bands over the fourth storey.

Building is a well-preserved and maintained, functioning center, which is stylistically intact. It is a fine WPA-era building, well-related to its site. Development plans should take into account the planned continued usage of this building.

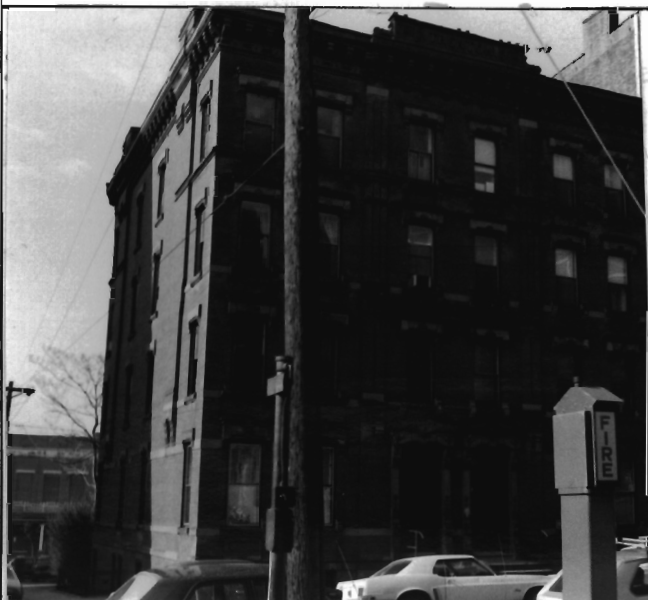
40-16

Fenestration: wood, double-hung sash with heavy brownstone lintels  
having incised ornament and braquettes. Those on the  
Roof/Chimneys: 1st storey are particularly heavy.

Full surrounds and scroll-like incised decoration in surrounds and  
lintels at doors. Doors are intact and double.

Two units act as one with doors in center two bays. The brick  
overhead projects slightly and is outlined with pilaster-like  
sections which split the total of six bays into three sections,

Cronice has sign that reads "Trenton."

**ORIGINAL USE:** res. **PRESENT USE:** dormitory  
**PHYSICAL CONDITION:** Excellent ☐ Good ☒ Fair ☐ Poor ☐  
**REGISTER ELIGIBILITY:** Yes ☐ Possible ☒ No ☐ Part of District ☒  
**THREATS TO SITE:** Roads ☐ Development ☐ Zoning ☐ Deterioration ☒  
 No Threat ☐ Other ☐

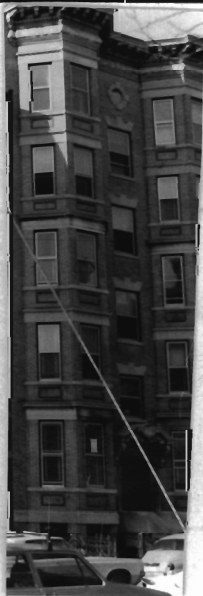
40-17

Two joined buildings have tripartite, projecting bays flanking entries and single windows with center bay. Elaborate consoled swans-neck pediment with shell motif over entries. Doors intact at #606.
