NEW JERSEY OFFICE OF HISTORIC PRESERVATION HISTORIC SITES INVENTORY #
STREETSCAPE SURVEY FORM

STREET NAME: Willow Ave.
MUNICIPALITY: Hoboken

NEW JERSEY OFFICE OF HISTORIC PRESERVATION HISTORIC SITES INVENTORY #
INDIVIDUAL STRUCTURE SURVEY FORM

HISTORIC NAME: Rectory of Our Lady of COMMON NAME: Same
 LOCATION: 410-12 Willow Grace Church BLOCK/LOT 63/1

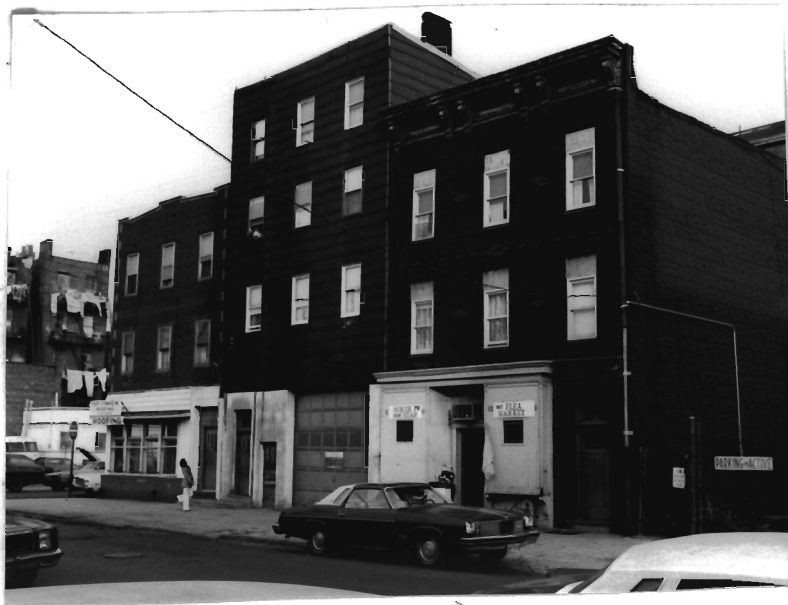
83-81-79 Willow Ave.
neg. #: 20-21

storefront at 79 intact; also top cornice intact
exc. windows boarded up
81 garage
79 2x3
81 3x3
83 2x3
83 storefront altered

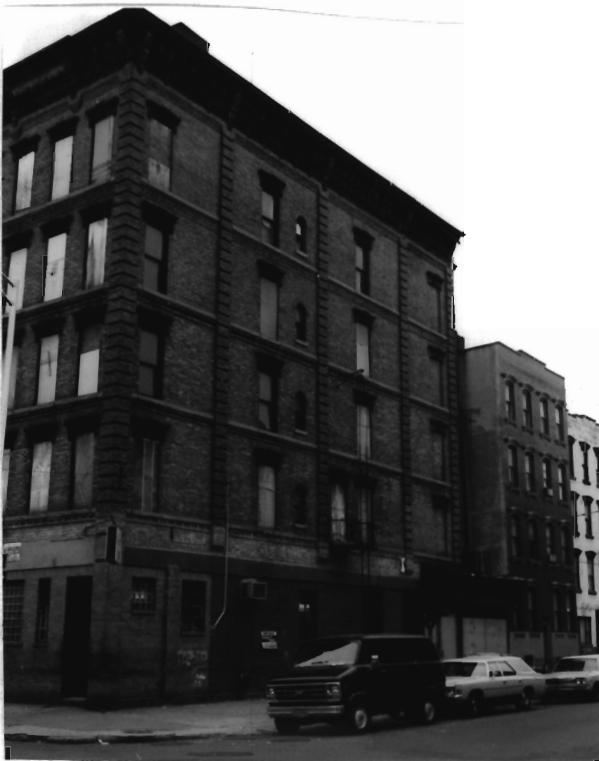
100-4, 106 Willow Ave.
neg. #: 26-14

- /00-4 faces 1st St.
- /06-8 curved lintels; parapets. 6-5x4; 8-4x4.
- /10- cornice--brick veneer
- /12- asphalt palse brick; cornice.
- /14 vacant
- /16-circa 1925 mission style; subt. intact
- /18-aluminum siding, 4x3
- /20 curved lintels, new brick, 4x4
- /22 3x4
- /24-curved lintels, pedimented cornice
- /26, 28 altered s.f.
- /30 s.f. cornice intact
- /32 masonite sheathed 4x3

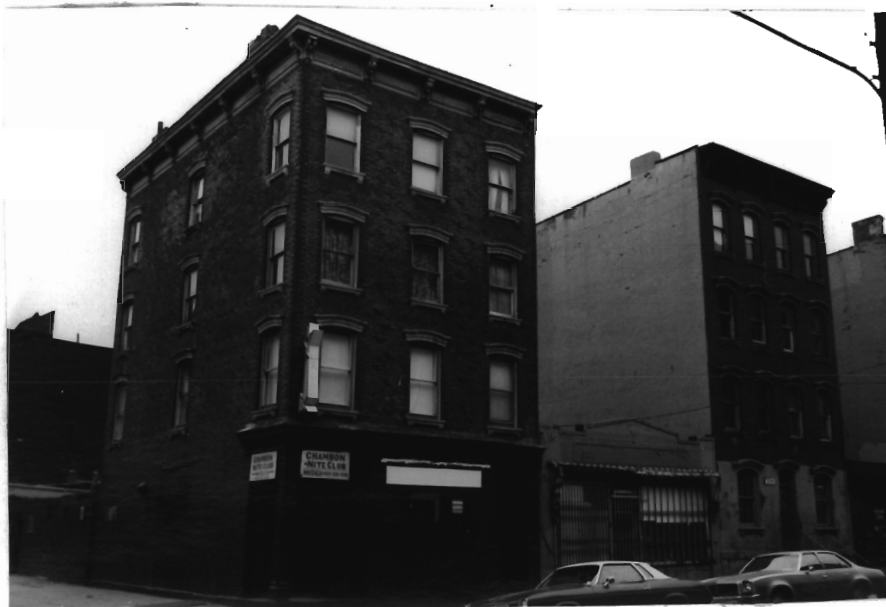
200, 202, 204 Willow Ave.
neg. #: 26-21

- 200-4x3 brick altered storefront with original cornice
- 202 1 storey brick commercial
- 204 4x4 pattern, curved lintels, original cornice
- 206 garage, 2 doors, wood

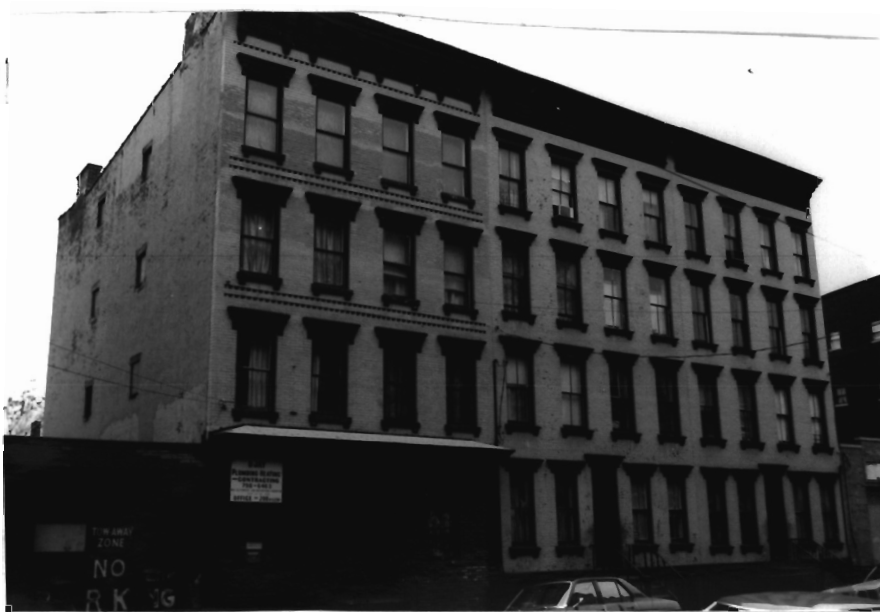
206, 208, 210, 212 Willow Ave.
neg. #: 26-23

- 208 4x4 apartment building, storefront altered with wood
panes and asphalt brick, substantially intact at left original store-
front cornice
- 214, 216 corrugated metal doors on 2 fronts

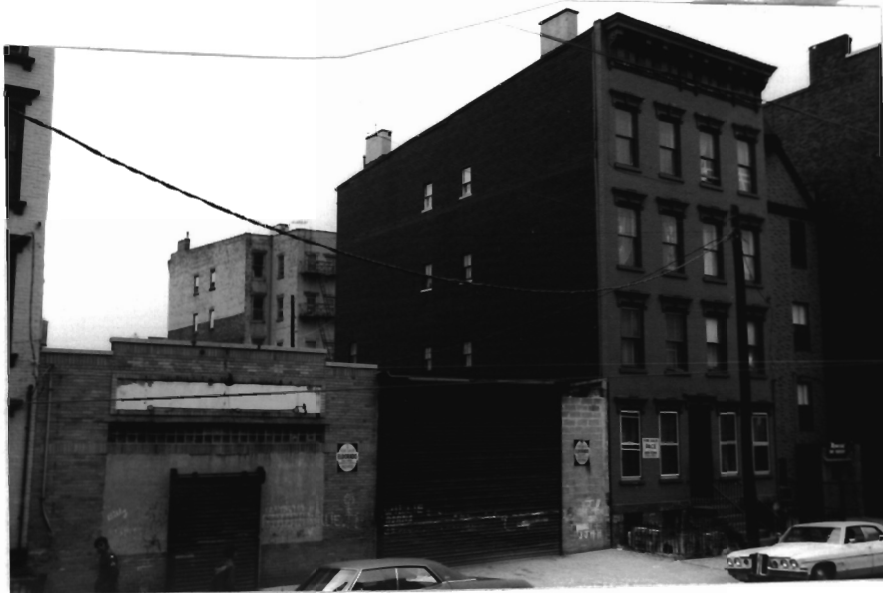
214, 216, 218, 220 Willow Ave.
neg. #: 26-24

- 218 4x4 flower like detail on lintels, door intact
- 220 recessed from unusual facade plan; Memorial Day nursery, altered
windows, asphalt brick. Pedimented gable suggests Greek Revival, top
windows intact with outer row of stained glass

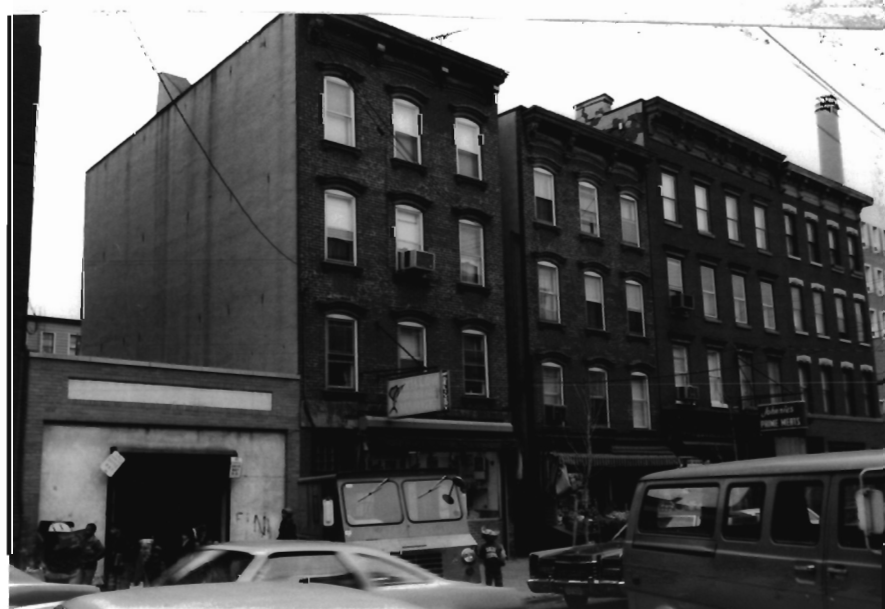
224, 226, 228, 230, 232 Willow Ave.
neg. #: 26-26

- 222 variety of lintel detailing, 5x4 arches in top storey, pediments
over door and in 2nd & 3rd stories, festoon cornice
- 224 1 storey brick, corrugated door

- 226 Willow Fish market; brick altered storefront, 4x3 curved lintels in cornice
- 228 4x3 similar to 26, shorter, storefront cornice intact
- 230 4x4 altered (2) tile & wood intact cast iron pillars
storefront cornices intact

- 232 brick altered storefront, intact residential door, 4x4 unusual lintels
with flowers.

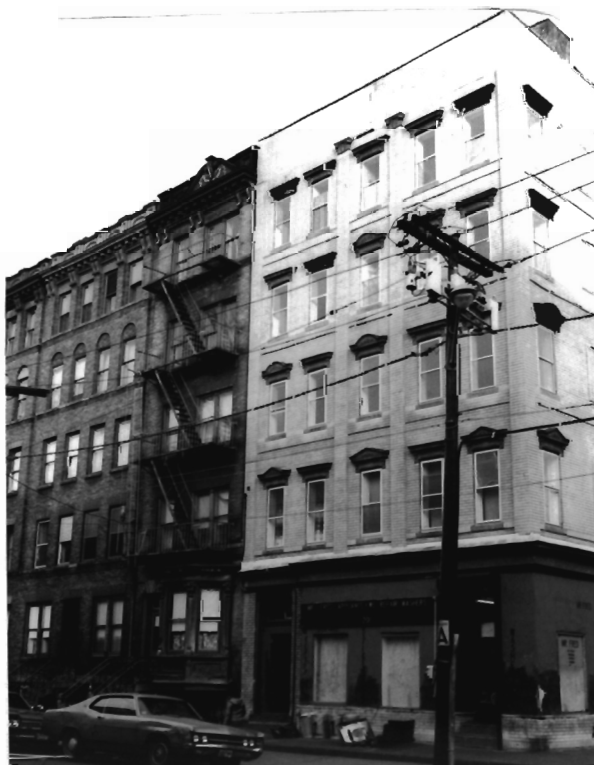
205, 203, 201 Willow Ave.
neg. #: 20-31

- 201-5x5, alternating curved & straight lintels, partially intact s.f.,
no cornice
- 203-5x3 fire escape, oriel in first story with colonettes, asymmetrical
- 205-11 row of 4x5 buildings-Romanesque arches over 4th storey windows,
- 207 altered window detail at 4th storey, cornice unusually tall, with
parapet-like extension, similar to 203
- 213 & 215 5x4 dentils in lintels, Queen Anne type pediments in cornice
- 217 4x3 intact storefront, soncole over residential entry. The rods with
stars, scroll work in cornice
- 219 1-storey red brown brick with garage
- 221 boarded up but partially intact store front-curved lintels echo
bottom edge of cornice 4x4
- 223, 225 auto repairs
- 227-4x4, brick altered storefront, fenestration altered, some shaved sills
- 229-233 - Italianate, 233 is 3x3, 229 almost intact storefront,
- 231 only original brick facade.

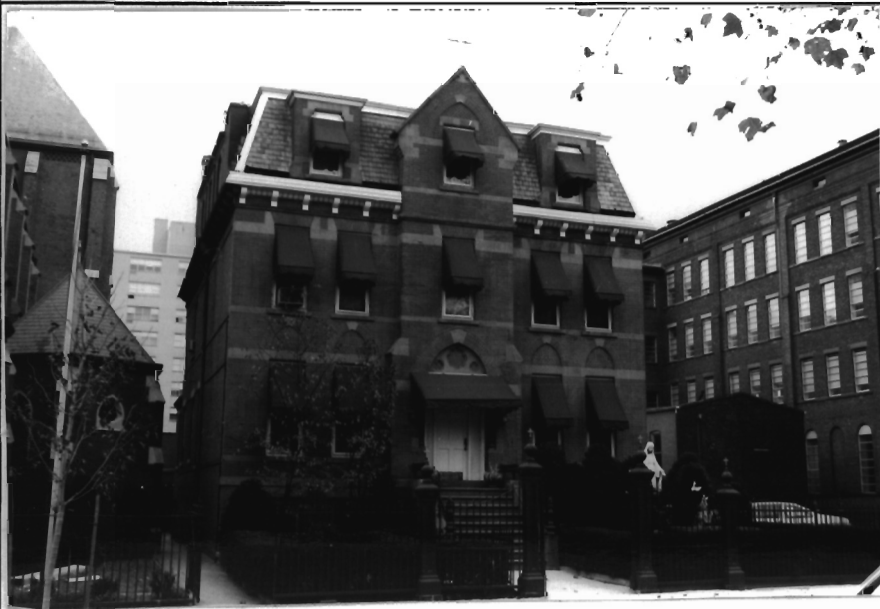
21-14

Style: French 2nd Empire with Gothic Form/Plan Type:
 Arches in 1st story

Exterior Wall Fabric: Red brick, stone

Fenestration: 2 windows on both sides flank central protruding
 entrance bay.

Roof/Chimneys: Mansard roof with grey slate.

Central bay culminates in a gable end

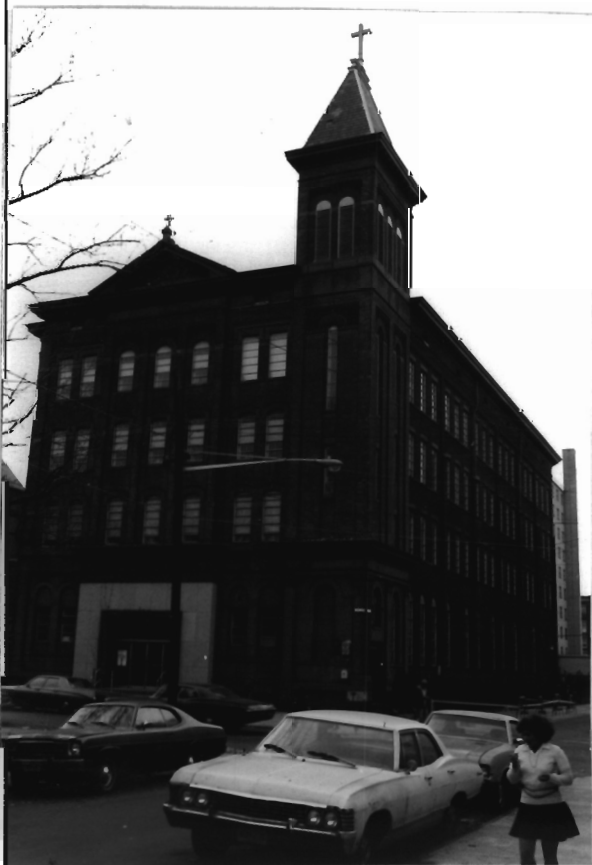
21-15

Style: Italianate w/ Romanesque Arches
in 1st story

Exterior Wall Fabric: Red-brown brick

Fenestration: 7 windows across front bay with segmental arches in
2nd, 3rd stories.

Granite slabs. Frame altered entrance bay; tower at corner with
mansard roof; 3 windows in center protrude over entry with pedi-
ment over them in the cornice.

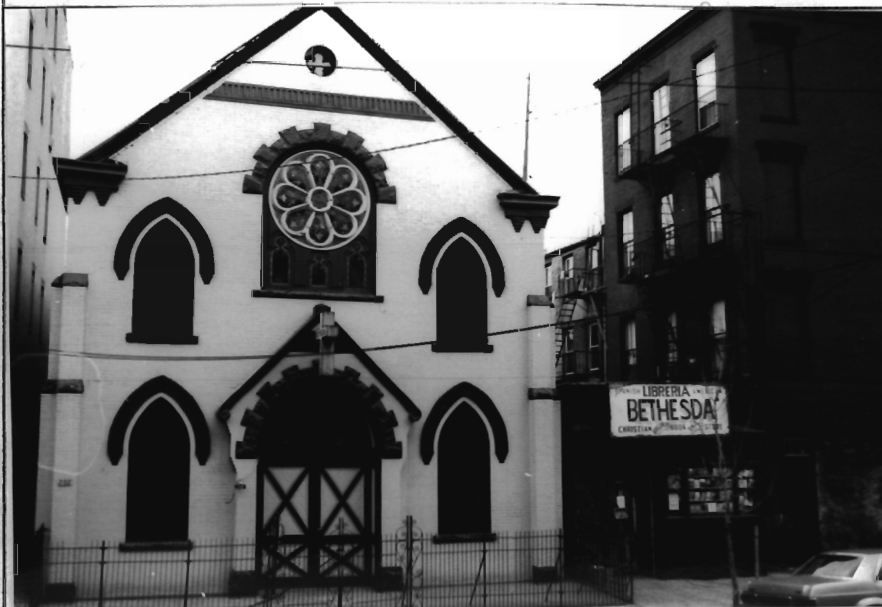
Style: Gothic Revival

Exterior Wall Fabric: Painted brick (yellow & red) with stone arches over entry & window above.

Fenestration: Quatrefoil window in gable lancet windows on sides. Rose windows above entrance.

Butresses at corners; protruding frame around doorway; sides of building are stuccoed with pilaster like projections.

Has fence around front with gate at left side.

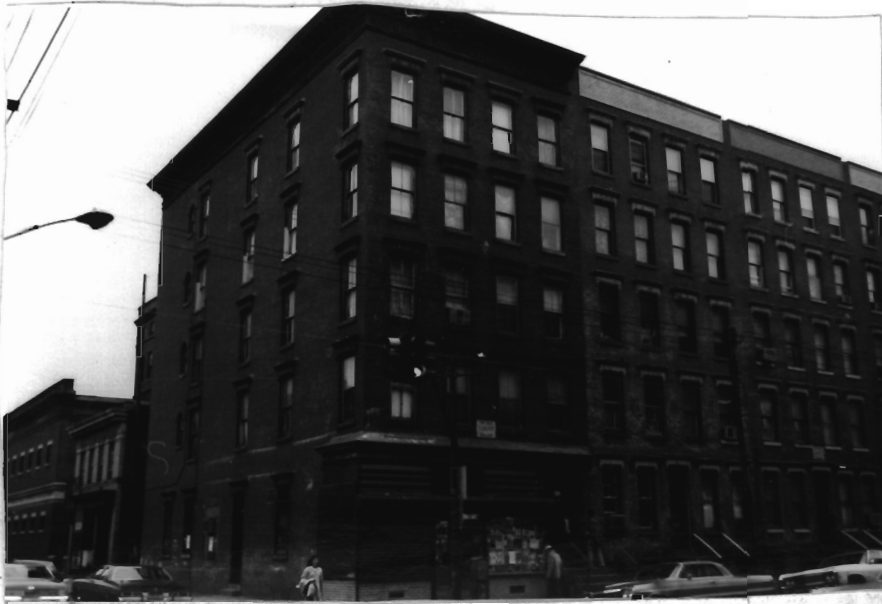
800, 02, 04 Willow
neg. #: 27-4

Six, five-storey brick buildings, four bays wide, with Italianate detail. Intact cornices at #800-808. #800 also retains a corner storefront, with a central entry on Willow Ave. Five steps lead up to the main residential entries. These buildings also feature stone water tables and footed, Italianate window sills.

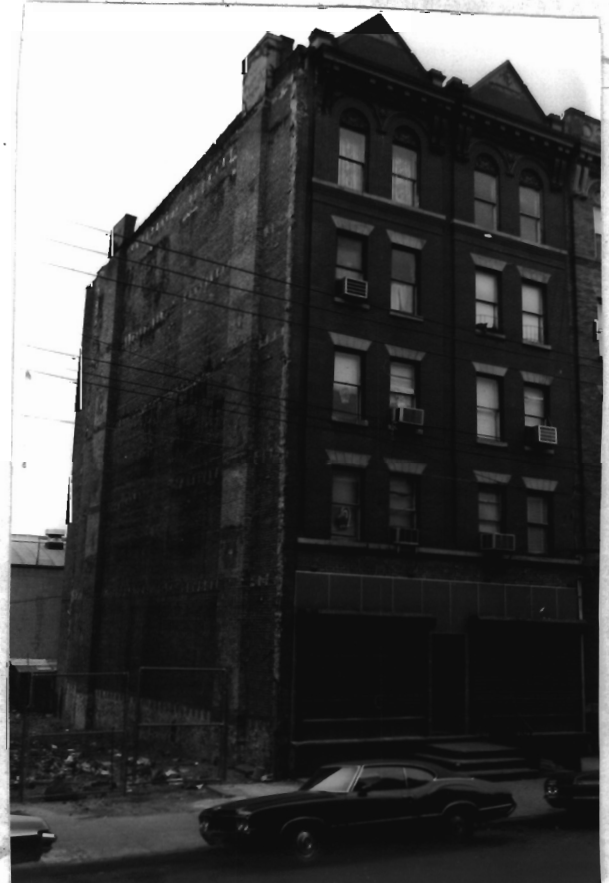
812 (vacant), 814 Willow
neg. #: 27-7

Eclectic, five-storey brick building with four bays, divided vertically. Pedimented parapets are surmounted by bracketted cornices. Fifth-storey windows have blind arches. Main entry is centrally placed. Architectural style suggests construction date in late 1880's.

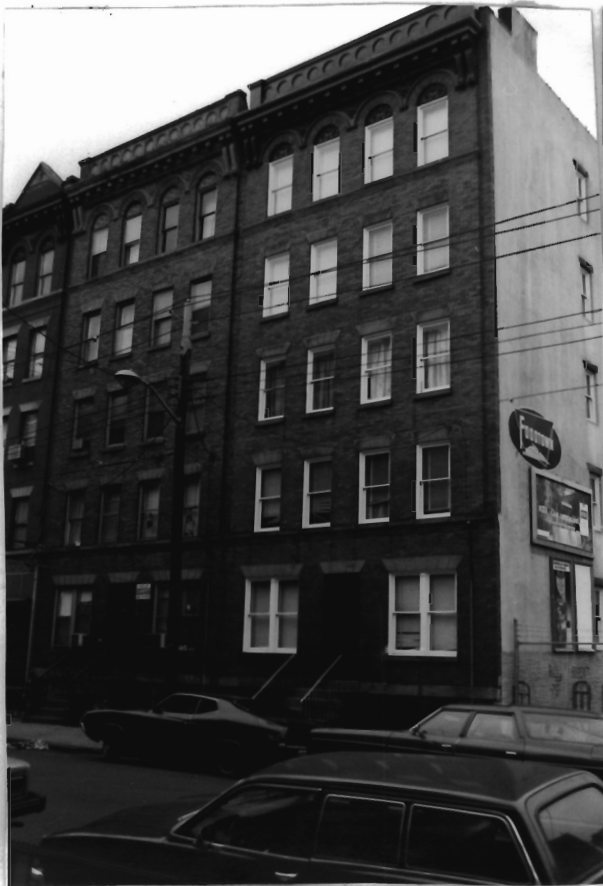
816, 18 Willow
neg. #: 27-8

Eclectic, five-storey buildings of unpainted tan brick each four bays wide, surmounted by bracketted cornices. Fifth storey windows have blind arches. Main entries are centrally-placed, window lintels are of contrasting stone. Architectural style suggests late 1880's construction date.

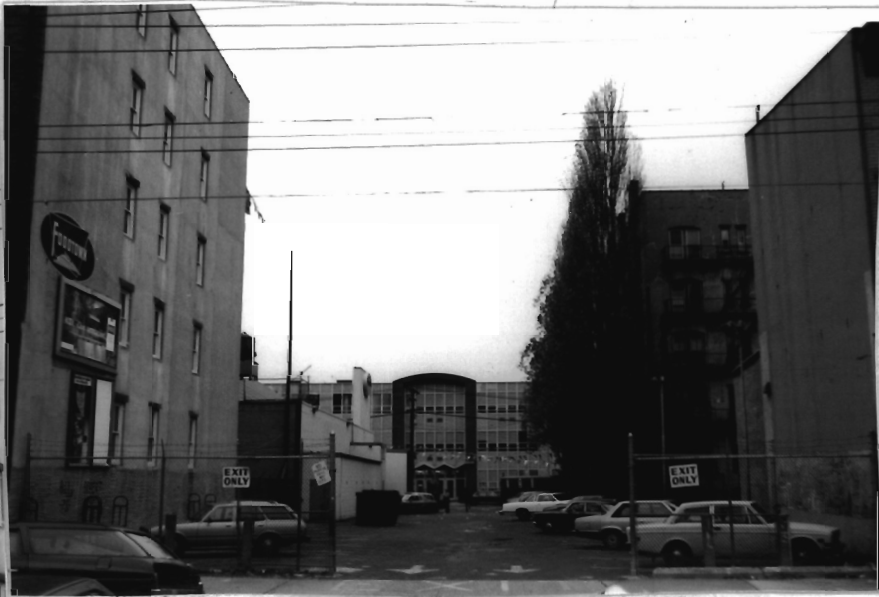
820-26 (vacant) Willow
neg. #: 27-9

820-826 Willow Avenue, vacant lots.

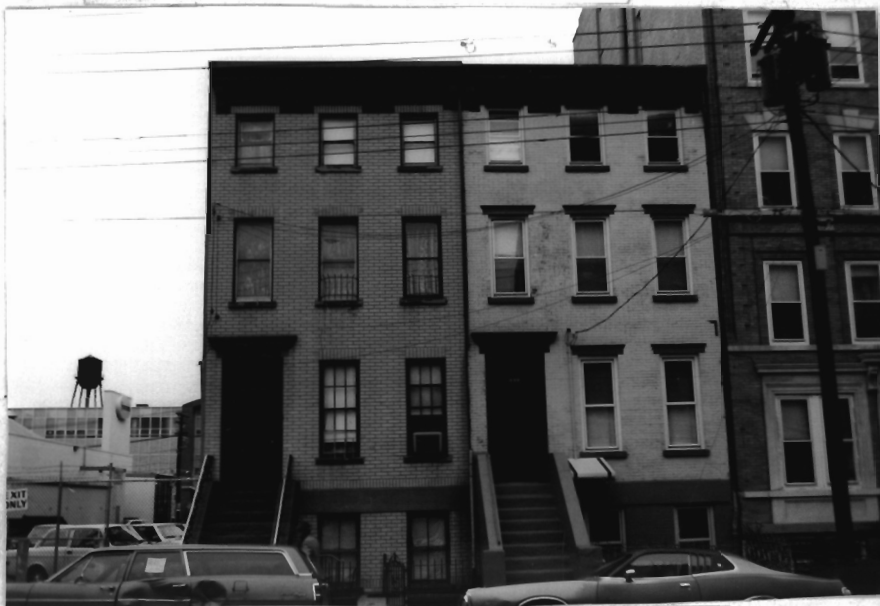
828, 30 Willow
neg. #: 27-10

Two, three-storey Italianate buildings with high basements. Denticulated cornices; window heights survive intact, as do main entries. Lintels survive at #830; doorway lintels survive at both.

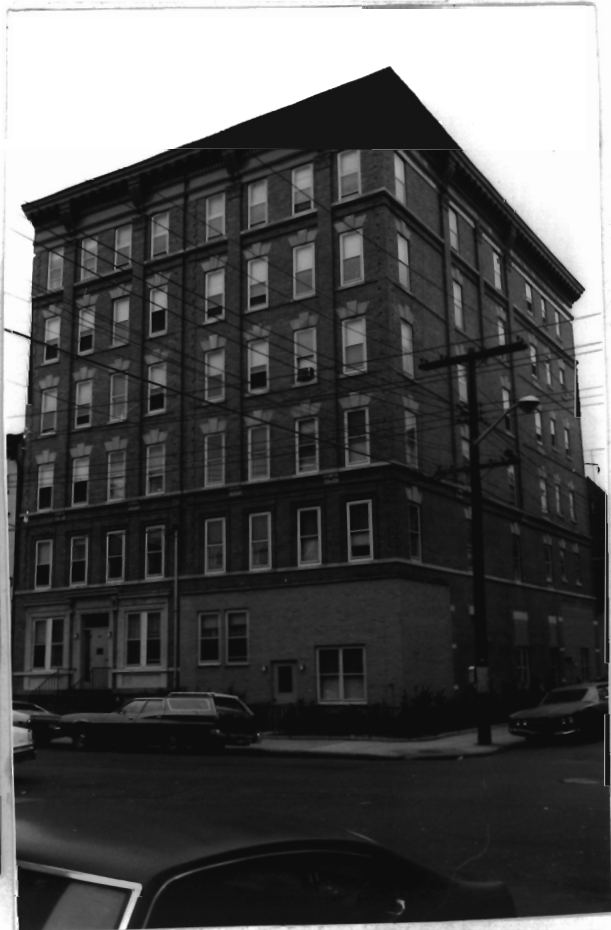
832, 34 Willow
neg. #: 27-11

Ground floor entry, which may have matched that of #832, has been bricked in; all masonry ornamentation and window configurations have been insensitively altered.

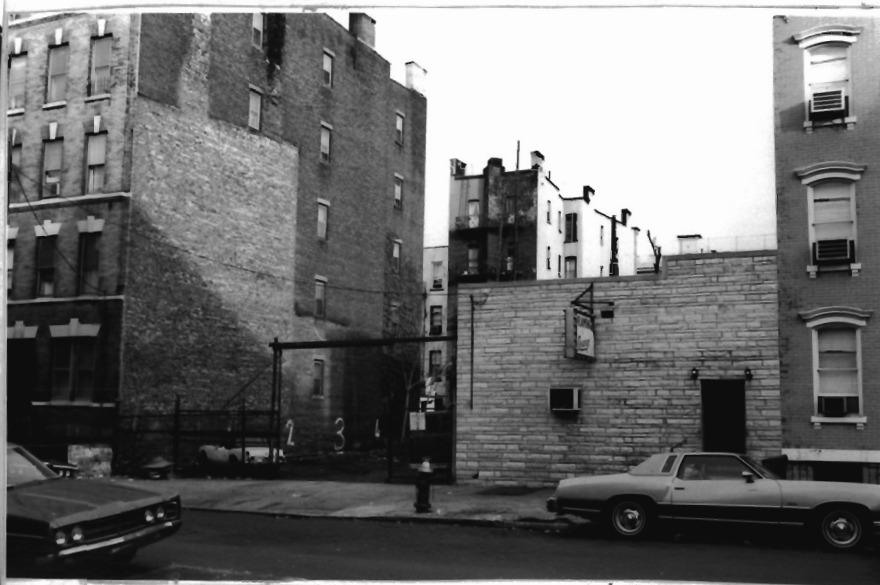
841, 839 Willow
neg. #: 23-14

Two, five storey-high buildings of Classical Revival detail.

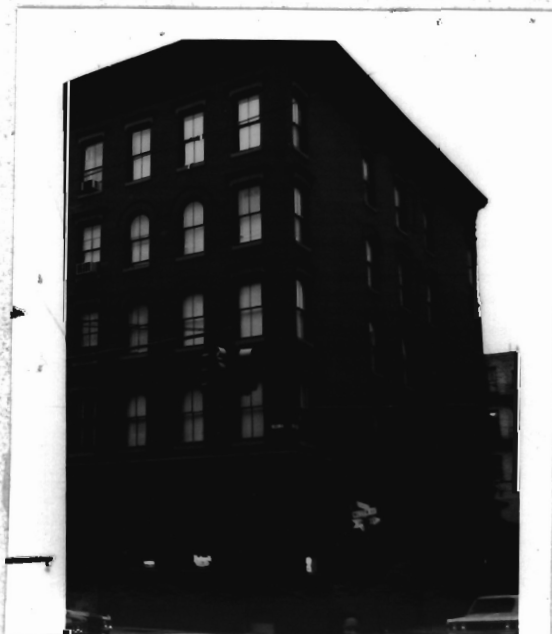
801 Willow

Five-storey, half-block streets cape of Eclectic buildings, each four bays wide, with Classical Revival details. Bracketted cornices have Adamseque ornamentation on the fascia. Window lintels at the fifth and second stories have feature blind arches. Each building has intact, centrally-placed main doorways, surmounted by pediments. These entries are flanked by paired, rectangular windows with lintels. #801 (at corner) ground floor has been infilled in brick.
